## Appendix N Exceedance Report

**Incident Report on Action Level or Limit Level Non-compliance**

Project	Integrated Waste Management Facilities, Phase 1		
Date	01 Dec 2021 (Lab result received on 8 Dec 2021)		
Time	08:00 – 11:25 (Mid-Ebb) 14:08 – 17:38 (Mid-Flood)		
Mid-Ebb			
Monitoring Location	B1, B2, B3

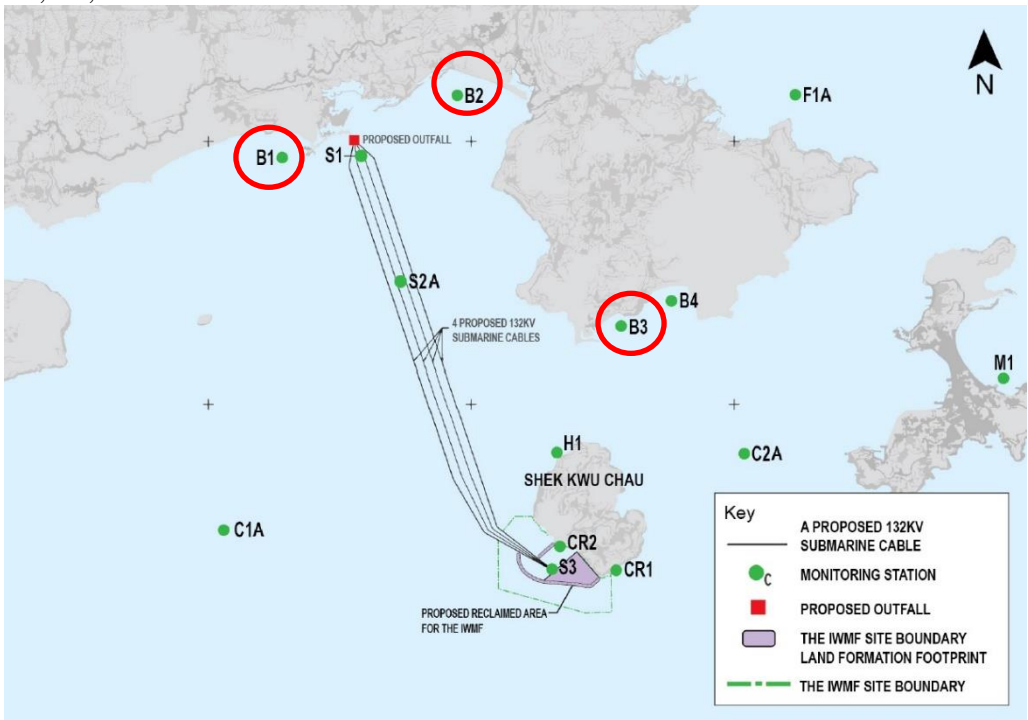
Parameter	Suspended Solid (SS)		
Action & Limit Levels	Action Level		Limit Level
	≥ 11.8 mg/L (120% of C1A)		≥ 12.8 mg/L (130% of C1A)
Measurement Level	Impact Station(s) of Exceedance	Measurement Level	Impact Station(s) without Exceedance

21.8 mg/L (B1) 21.0 mg/L (B2) 19.3 mg/L (B3)	9.8 mg/L (C1A) 10.0 mg/L (C2A)	9.5 mg/L (B4) 10.5 mg/L (F1) 9.0 mg/L (H1) 9.3 mg/L (M1) 8.7 mg/L (CR1) 9.8 mg/L (CR2)
Possible reason for Action or Limit Level Non-compliance	<p>Works undertaken on 1 December 2021 include 2.5 tonne armour weighing and dropping test, levelling of underlayer rock at BWA CH870 – 900, landfilling works for below +6.00mPD, landfill works for above +6.00mPD, installation of instrumentation, piling pre-drilling works, piling works, piling works for driven pile, piling works for pre-bored socketed H-pile, existing caisson extension and armour scour protection.</p> <p>Dominant sea current direction was found to be from Northwest to Southeast at waters around Shek Kwu Chau.</p> <p>Exceedances of limit level were found at B1, B2 and B3. B1, B2 and B3 are located at unrelated stream direction (neither upstream nor downstream, far away) to the works location. Exceedances at these monitoring stations are deemed to be unrelated to the Project.</p>

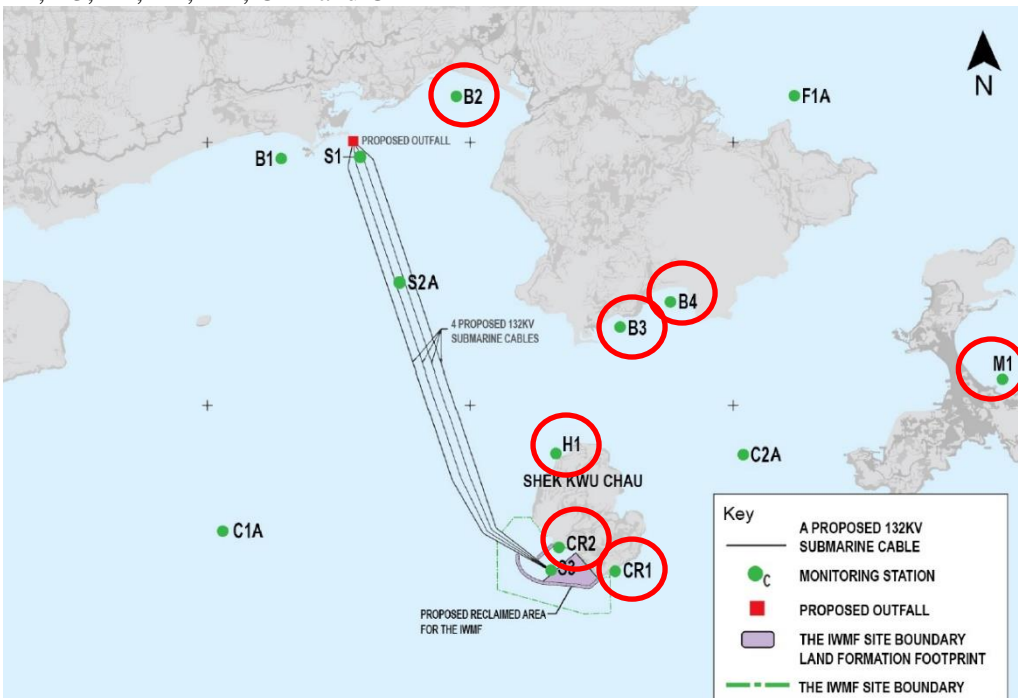
<p>Monitoring Location</p>

<p>Parameter</p>	<p>Suspended Solid (SS)</p>		
<p>Action &amp; Limit Levels</p>	<p>Action Level  <math>\geq 8.0</math> mg/L</p>		<p>Limit Level  <math>\geq 10.0</math> mg/L</p>
<p>Measurement Level</p>	<p>Impact Station(s) of Exceedance</p> <p>8.8 mg/L (B2)              8.0 mg/L (B3)              8.8 mg/L (B4)              8.7 mg/L (H1)              17.7 mg/L (M1)              17.3 mg/L (CR1)              20.2 mg/L (CR2)</p>	<p>Control Stations</p> <p>9.0 mg/L (C1A)              6.3 mg/L (C2A)</p>	<p>Impact Station(s) without Exceedance</p> <p>7.8 mg/L (B1)              7.5 mg/L (F1A)</p>
<p>Possible reason for Action or Limit Level Non-compliance</p>	<p>Works scheduled on site on 01 Dec 2021 include leveling of underlayer rock at BWA CH870 – 900, installation of blockwork for marine access facility, landfilling works for below +6.00MPD, landfilling works for above +6.00MPD, installation of instrumentation, piling pre-drilling works, piling works, piling works for driven pile, piling works for pre-bored socketed H-pile and existing caisson extension and armour scour protection.</p> <p>Dominant sea current direction was found to be from Southeast to Northwest at waters around Shek Kwu Chau.</p> <p>Exceedances of action level were found at B2, B3, B4, H1. Exceedances of limit level were found at M1, CR1 and CR2.</p> <p>B2, B3, B4 and M1 are located at unrelated stream direction (neither upstream nor downstream, far away) to the works location, exceedances of these monitoring stations are deemed to be unrelated to the Project.</p> <p>CR1 and CR2 are located close to the Project site and H1 is the downstream of the Project site during Flood tide while no marine work was conducted on 01 Dec 2021.</p>

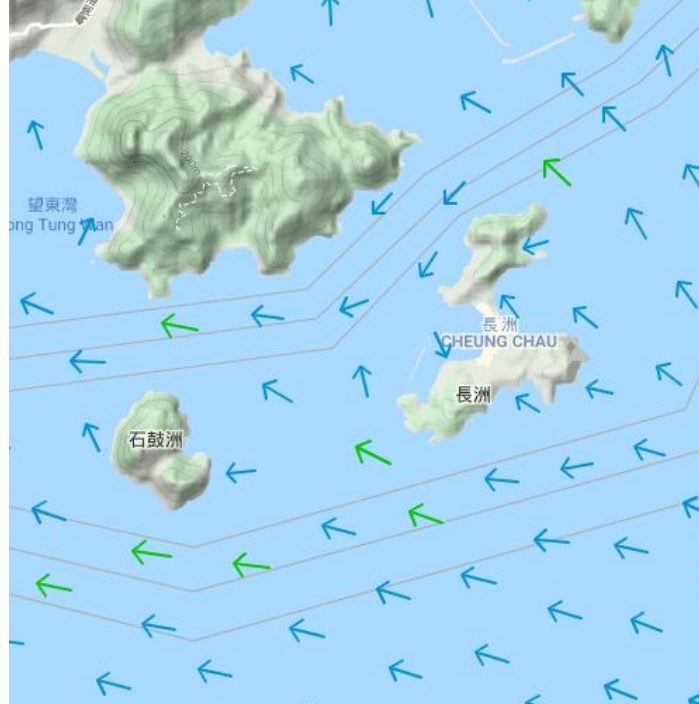
Current direction during mid-flood sampling on 01 Dec 2021:

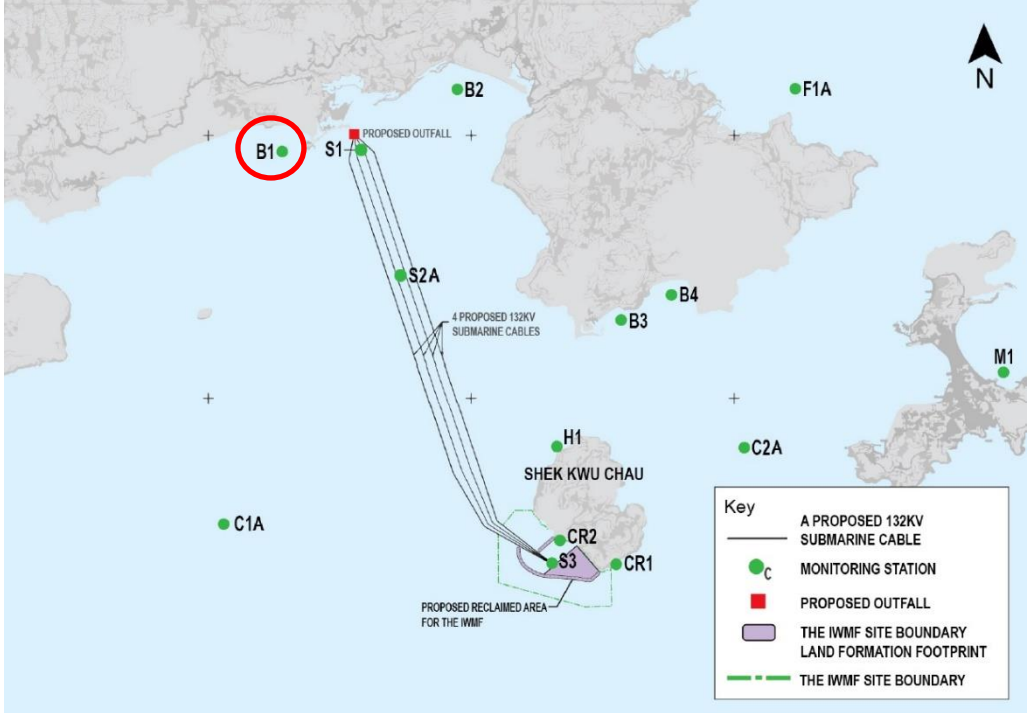
<p>Monitoring Location</p>

<p>Parameter</p>	<p>Suspended Solid (SS)</p>		
<p>Action &amp; Limit Levels</p>	<p>Action Level  <math>\geq 8.0</math> mg/L</p>		<p>Limit Level  <math>\geq 10.0</math> mg/L</p>
<p>Measurement Level</p>	<p>Impact Station(s) of Exceedance              8.0 mg/L (B1)</p>	<p>Control Stations              5.0 mg/L (C1A)              5.8 mg/L (C2A)</p>	<p>Impact Station(s) without Exceedance              7.3 mg/L (B2)              7.8 mg/L (B3)              7.5 mg/L (B4)              6.0 mg/L (F1A)              6.8 mg/L (H1)              6.2 mg/L (M1)              6.8 mg/L (CR1)              6.7 mg/L (CR2)</p>
<p>Possible reason for Action or Limit Level Non-compliance</p>	<p>Works scheduled on site on 03 Dec 2021 include Leveling of underlayer rock at BWA CH870 – 900, installation of blockwork for marine access facility, landfilling works for below +6.00mPD, landfilling works for above +6.00mPD, installation of instrumentation, piling pre-drilling works, piling works, piling works for driven pile, piling works for pre-bored socketed H-pile and existing caisson extension and armour scour protection.</p> <p>Dominant sea current direction was found to be from Southeast to Northwest at waters around Shek Kwu Chau.</p> <p>An exceedance of action level was found at B1.</p> <p>B1 is located at unrelated stream direction (neither upstream nor downstream, far away) to the works location. The exceedance at this monitoring station is deemed to be unrelated to the Project.</p> <p>The installation of caisson No.19 was completed on 18 Mar 2021, the reclamation area was enclosed.</p>

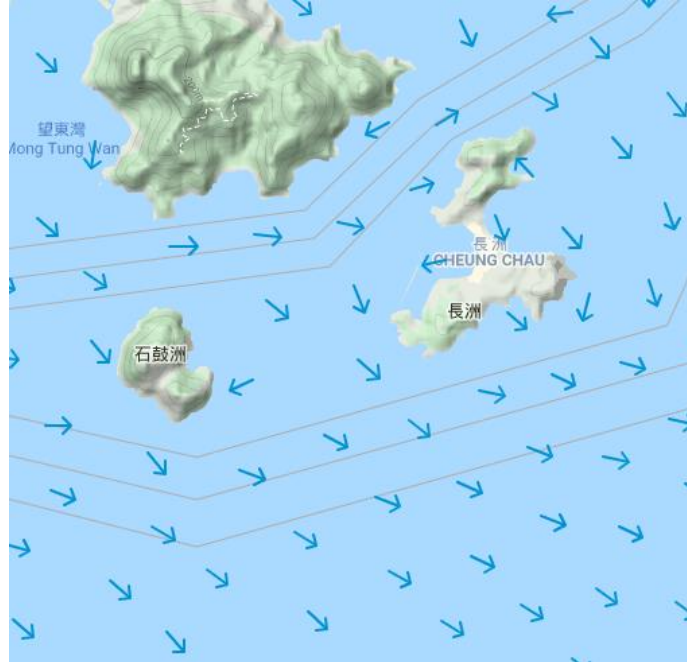
Current direction during mid-ebb sampling on 03 Dec 2021:

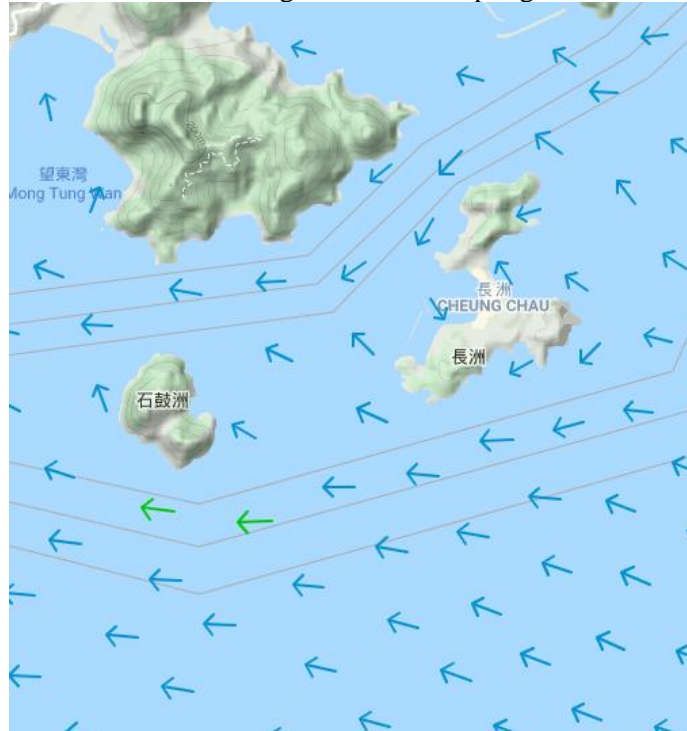
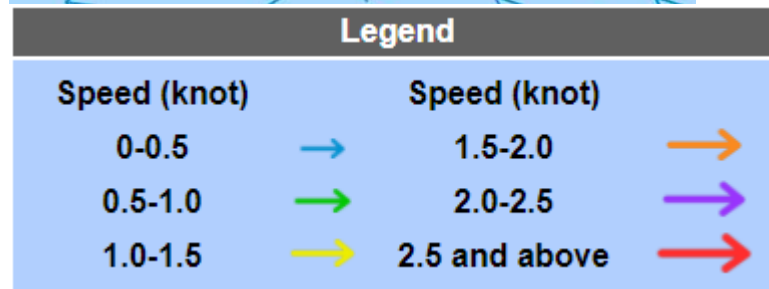
Current direction during mid-flood sampling on 03 Dec 2021:

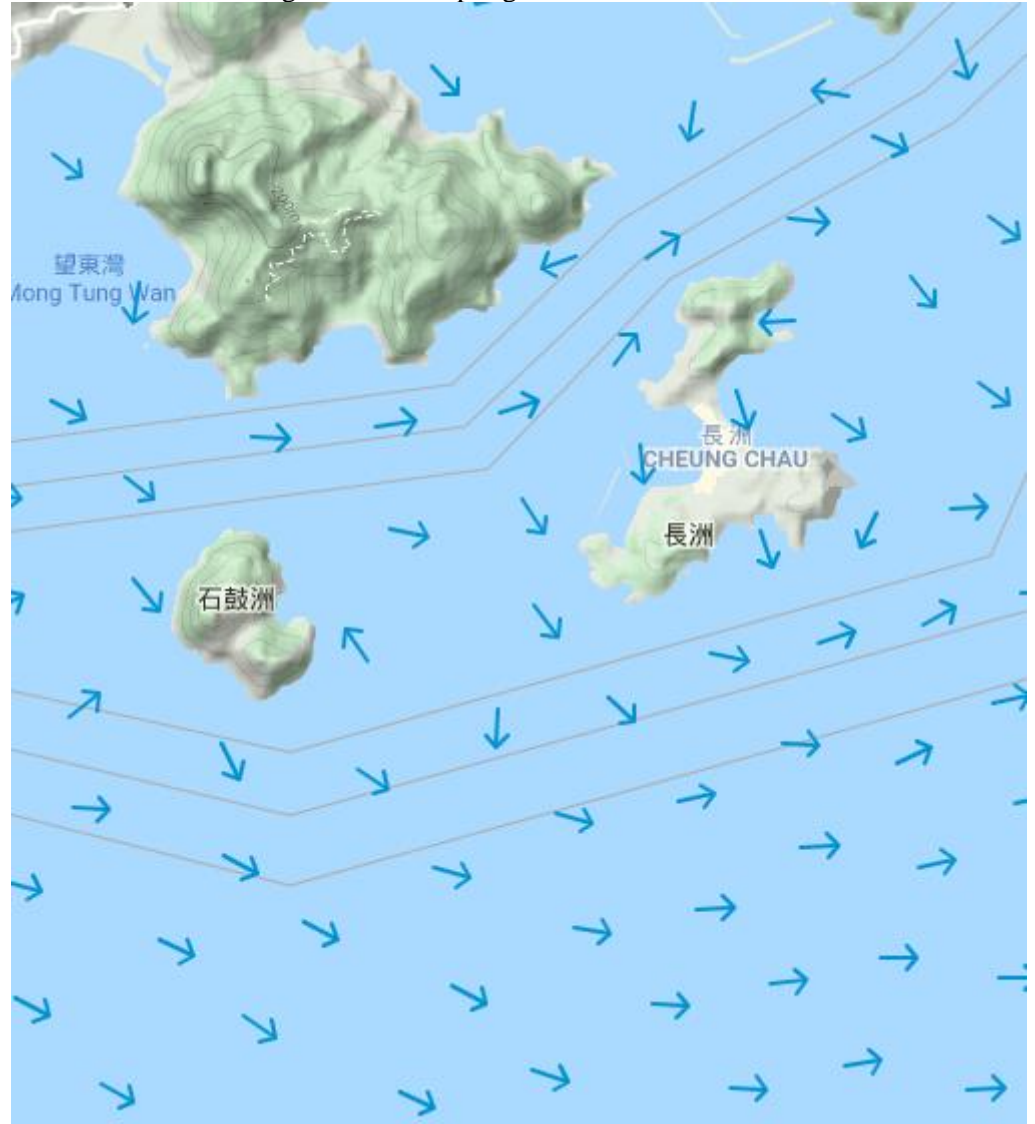
Current direction during mid-ebb sampling on 06 Dec 2021:

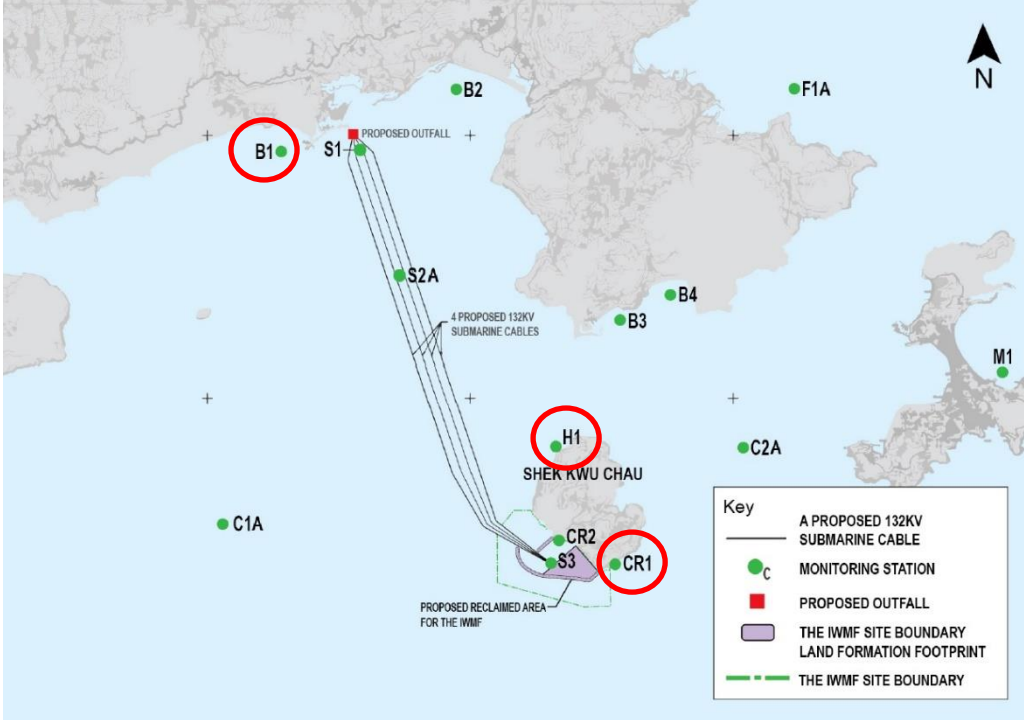
Mid-Flood			
Monitoring Location	B1, H1 and CR1

Parameter	Suspended Solid (SS)		
Action & Limit Levels	Action Level		Limit Level
	≥ 15.2 mg/L (120% of C2A)		≥ 16.5 mg/L (130% of C2A)
Measurement Level	Impact Station(s) of Exceedance	Control Stations	Impact Station(s) without Exceedance

16.0 mg/L (B1) 20.0 mg/L (H1) 19.7 mg/L (CR1)	13.2 mg/L (C1A) 12.7 mg/L (C2A)	10.5 mg/L (B2) 14.3 mg/L (B3) 9.8 mg/L (B4) 12.0 mg/L (CR2) 12.3 mg/L (M1) 12.3 mg/L (F1A)
Possible reason for Action or Limit Level Non-compliance	<p>Works scheduled on site on 08 Dec 2021 include leveling of 500kg armour rock at Breakwater B CH60 - CH150, leveling of underlayer rock at BWA CH900 - CH930, installation of blockwork for marine access facility, landfilling works for below +6.00mPD, landfilling works for above +6.00mPD, installation of instrumentation, piling pre-drilling works, piling works, piling works for driven pile, piling works for pre-bored socketed H-pile and existing caisson extension and armour scour protection.</p> <p>Dominant sea current direction was found to be from Southeast to Northwest at waters around Shek Kwu Chau.</p> <p>Exceedances of action level was found at B1 and exceedances of limit level were found at H1 and CR1.</p> <p>B1 is located far away from the works location and H1 and CR1 are located at unrelated stream direction. No marine work was conducted on site on 8 Dec 2021.</p> <p>The installation of caisson No.19 was completed on 18 Mar 2021, the reclamation area was enclosed.</p>

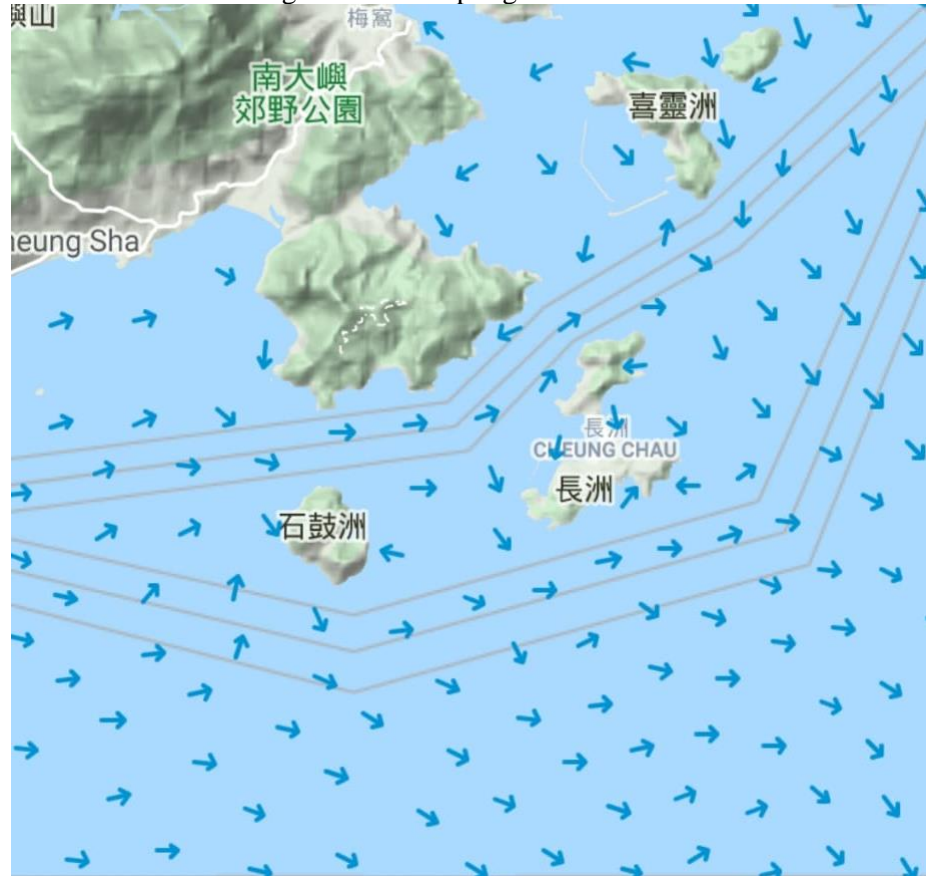
Current direction during mid-ebb sampling on 10 Dec 2021:

Legend			
Speed (knot)		Speed (knot)	
0-0.5		1.5-2.0	
0.5-1.0		2.0-2.5	
1.0-1.5		2.5 and above

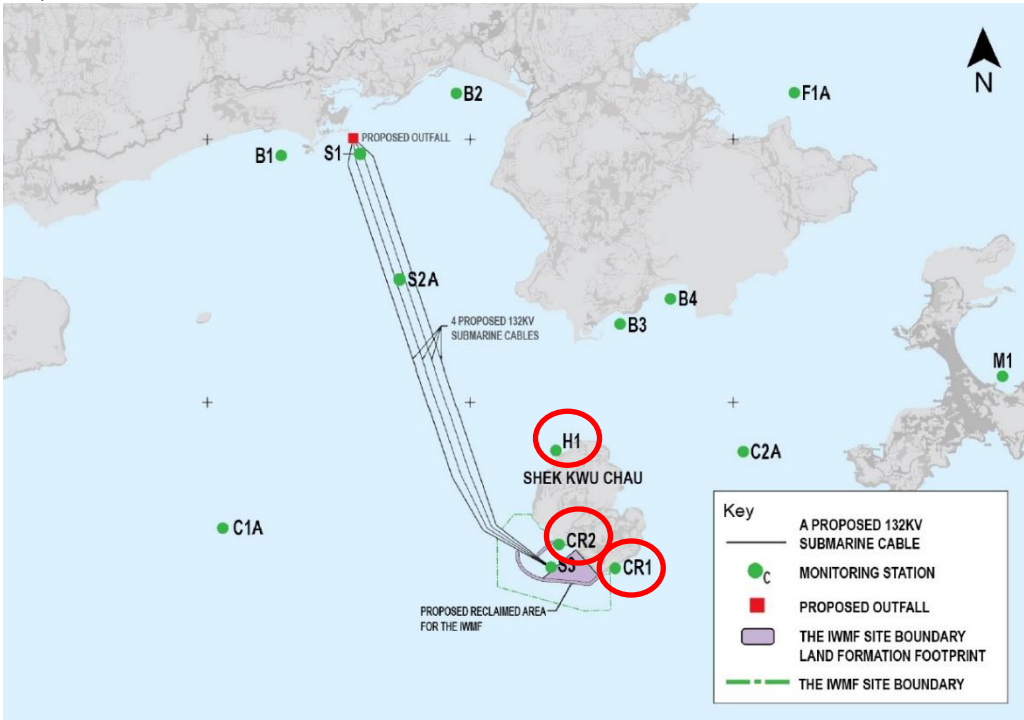
Project	Integrated Waste Management Facilities, Phase 1		
Date	10 Dec 2021		
Time	10:34 – 14:04 (Mid-Flood)		
Mid-Flood			
Monitoring Location	H1, CR1 and CR2

Parameter	Dissolved oxygen (DO)		
Action & Limit Levels	Action Level		Limit Level
	≤ 7.13 mg/L		≤ 4 mg/L
Measurement Level	Impact Station(s) of Exceedance	Control Stations	Impact Station(s) without Exceedance

6.29 mg/L (H1) 6.45 mg/L (CR1) 6.22 mg/L (CR2)	7.59 mg/L (C1A) 6.61 mg/L (C2A)	8.24 mg/L (B1) 8.12 mg/L (B2) 8.03 mg/L (B3) 8.15 mg/L (B4) 7.49 mg/L (F1A) 7.45 mg/L (M1)
Possible reason for Action or Limit Level Non-compliance	<p>Works scheduled on site on 10 Dec 2021 include leveling of 500kg armour rock at Breakwater B CH60 - CH150, laying of 900kg armour rock at Seawall A CH320 - CH440, installation of Caisson 49K1, installation of blockwork for marine access facility, landfilling works for below +6.00mPD, landfilling works for above +6.00mPD, installation of instrumentation, piling pre-drilling works, piling works, piling works for driven pile, piling works for pre-bored socketed H-pile, existing caisson extension and armour scour protection.</p> <p>Dominant sea current direction was found to be from Northwest to Southeast at waters around Shek Kwu Chau.</p> <p>Exceedances of Action level were found at H1, CR1 and CR2.</p> <p>CR1 and CR2 is located within the Project site and H1 is the downstream of the Project site during Flood tide while no marine work was conducted on 10 Dec 2021.</p>

<p>The installation of caisson No.19 was completed on 18 Mar 2021, the reclamation area was enclosed.</p> <p>According to the field observation by sampling team during sampling event, no silt plume or stain of chemical spillage was observed in the Project site and the weather was fine during the sampling event.</p> <p>No major observation of improper site practices that contributed to the increase of the chemical oxygen demand (COD) were recorded during the weekly inspection on 14 Dec 2021.</p> <p>The exceedances of Action level at location H1, CR1 and CR2 were possibly caused by the natural fluctuation in DO level. With reference to the water quality monitoring data documented in Annual Marine Water Quality Report of 2020 (<a href="https://www.epd.gov.hk/epd/sites/default/files/epd/english/environmentinhk/water/hk_wqrc/files/waterquality/annual-report/marinereport2020.pdf">https://www.epd.gov.hk/epd/sites/default/files/epd/english/environmentinhk/water/hk_wqrc/files/waterquality/annual-report/marinereport2020.pdf</a>) issued by EPD, the DO level of three monitoring stations (i.e. SM11, SM12 and SM13) that were adjacent to the Project site was ranged from 4.2mg/L to 8.6mg/L. The measured DO levels at monitoring stations H1, CR1 and CR2 were within the range of DO level recorded by the EPD.</p> <p>After the investigation, the exceedances on 10 Dec 2021 at H1, CR1 and CR2 are deemed to be unrelated to the Project.</p>

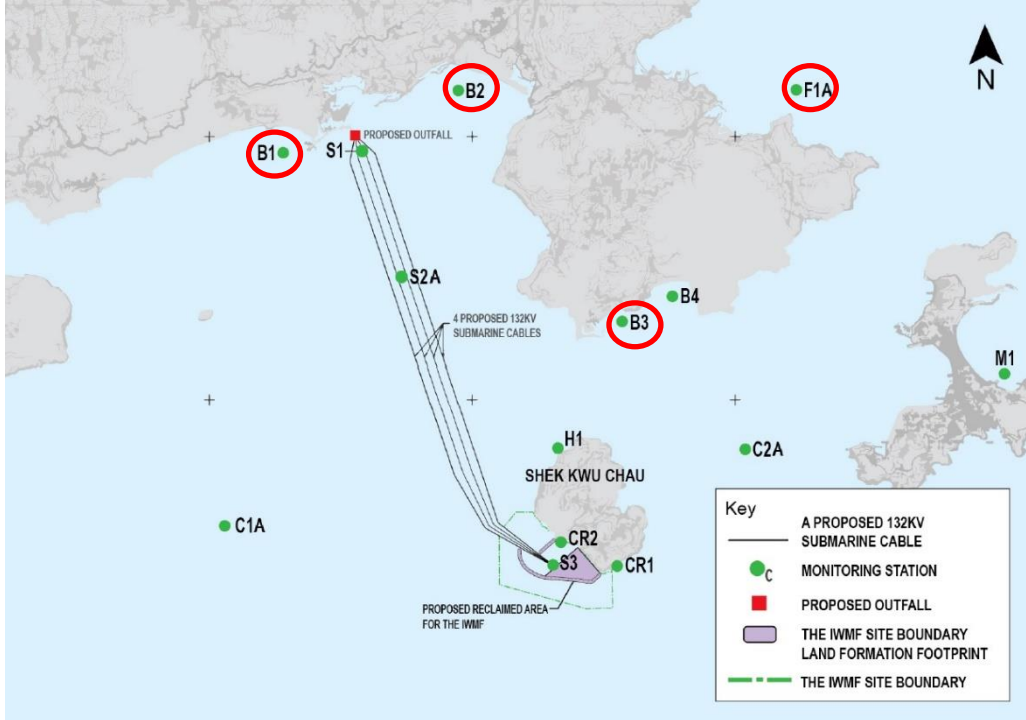
Project	Integrated Waste Management Facilities, Phase 1		
Date	15 Dec 2021 (Lab result received on 21 Dec 2021)		
Time	08:07 – 11:37 (Mid-Ebb)		
Mid-Ebb			
Monitoring Location	B1, B2, B3 and F1A

Parameter	Suspended Solid (SS)		
Action & Limit Levels	Action Level		Limit Level
	≥ 9.2 mg/L (120% of C1A)		≥ 10.0 mg/L
Measurement Level	Impact Station(s) of Exceedance	Control Stations	Impact Station(s) without Exceedance

14.0 mg/L (B1) 11.8 mg/L (B2) 11.0 mg/L (B3) 16.0 mg/L (F1A)	7.7 mg/L (C1A) 6.5 mg/L (C2A)	6.8 mg/L (B4) 7.8 mg/L (H1) 8.7 mg/L (M1) 8.7 mg/L (CR1) 8.5 mg/L (CR2)
Possible reason for Action or Limit Level Non-compliance	<p>Works scheduled on site on 15 Dec 2021 include infilling of G200 rock at Caisson 49K1; laying of 900kg armour rock at Seawall A (CH320 - CH440; CH660 - CH670); leveling of underlayer rock at BWA CH920 – 950, installation of blockwork for marine access facility, landfilling works for below +6.00mPD, landfilling works for above +6.00mPD, installation of instrumentation, piling pre-drilling works, piling works, piling works for driven pile, piling works for pre-bored socketed H-pile and existing caisson extension and armour scour protection.</p> <p>Dominant sea current direction was found to be from Northwest to Southeast at waters around Shek Kwu Chau.</p> <p>Exceedances of limit level were found at B1, B2, B3 and F1A.</p> <p>B1, B2, B3 and F1A are located at unrelated stream direction (neither upstream nor downstream, far away) to the works location. The exceedances at these monitoring stations are deemed to be unrelated to the Project.</p>

<p>The installation of caisson No.19 was completed on 18 Mar 2021, the reclamation area was enclosed.</p> <p>According to the field observation by sampling team during sampling event, no silt plume was observed in the Project site and the weather was fine cloudy during the sampling event.</p> <p>No major observation of improper site practices that contributed to the increase of the suspended solids were recorded during the weekly inspection on 23 Dec 2021.</p> <p>After the investigation, the exceedances on 15 Dec 2021 at B1, B2, B3 and F1A are deemed to be unrelated to the Project.</p>
--	--

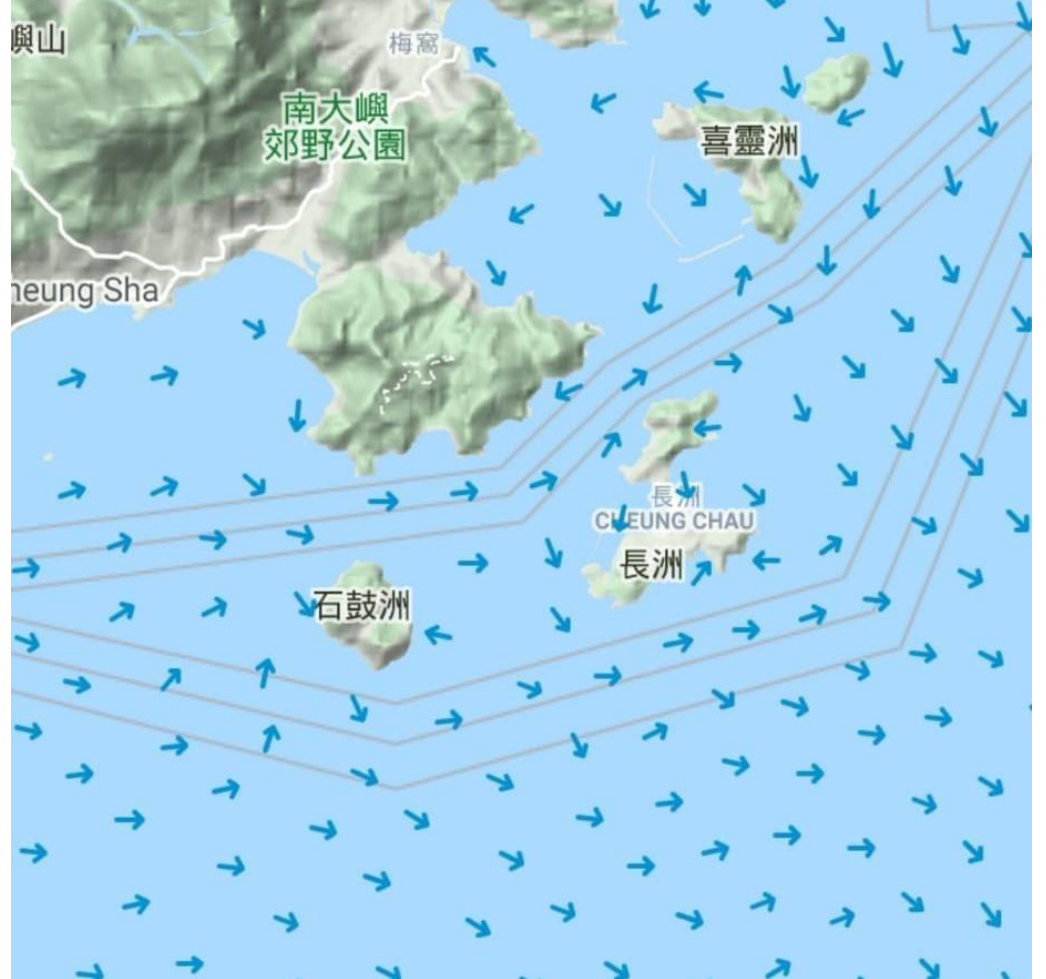
Current direction during mid-ebb sampling on 15 Dec 2021:

Legend			
Speed (knot)		Speed (knot)	
0-0.5		1.5-2.0	
0.5-1.0		2.0-2.5	
1.0-1.5		2.5 and above

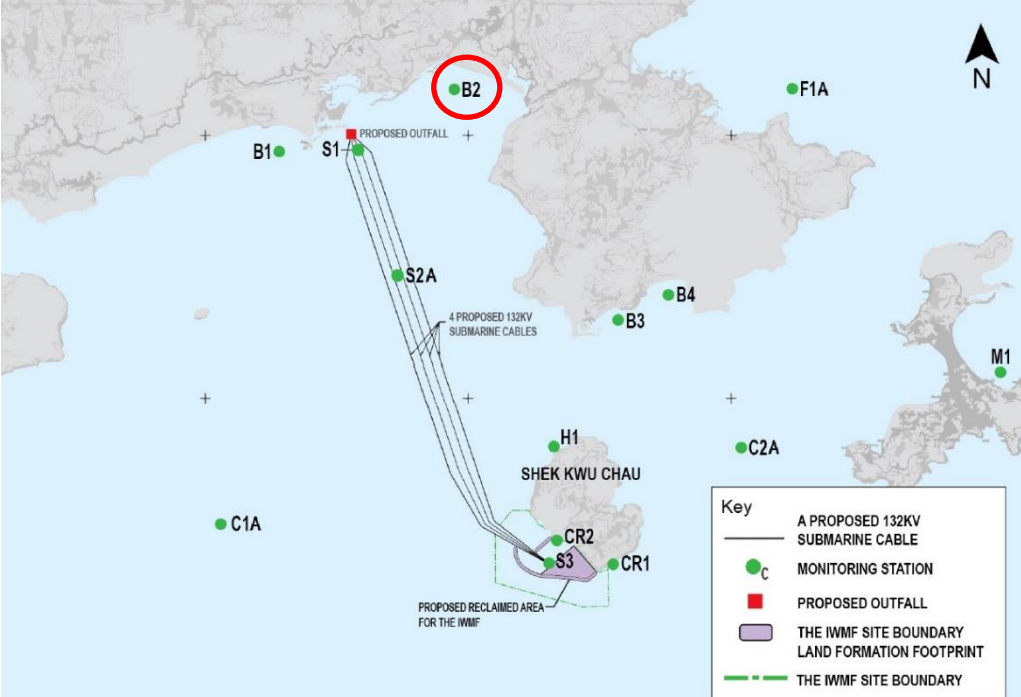
<p>Monitoring Location</p>

<p>Parameter</p>	<p>Suspended Solid (SS)</p>		
<p>Action &amp; Limit Levels</p>	<p>Action Level ≥ 11.8 mg/L (120% of C2A)</p>		<p>Limit Level ≥ 12.7 mg/L (130% of C2A)</p>
<p>Measurement Level</p>	<p>Impact Station(s) of Exceedance 12.8 mg/L (B2)</p>	<p>Control Stations 11.3 mg/L (C1A) 9.8 mg/L (C2A)</p>	<p>Impact Station(s) without Exceedance 8.5 mg/L (B1) 8.0 mg/L (B3) 9.0 mg/L (B4) 10.5 mg/L (F1A) 11.0 mg/L (H1) 9.3 mg/L (M1) 10.7 mg/L (CR1) 9.0 mg/L (CR2)</p>
<p>Possible reason for Action or Limit Level Non-compliance</p>	<p>Works scheduled on site on 17 Dec 2021 include laying of 1T armour rock at Seawall A CH300 - CH350, laying of 900kg armour rock at Seawall A CH350 - CH440, leveling of underlayer rock at BWA CH920 - 950, installation of blockwork for marine access facility, landfilling works for below +6.00mPD, landfilling works for above +6.00mPD, installation of instrumentation, piling pre-drilling works, piling works, piling works for driven pile, piling works for pre-bored socketed H-pile and existing caisson extension and armour scour protection.</p> <p>Dominant sea current direction was found to be from Southeast to Northwest at waters around Shek Kwu Chau.</p> <p>An exceedance of limit level was found at B2.</p> <p>B2 is located at unrelated stream direction (neither upstream nor downstream, far away) to the works location. The exceedance at this monitoring station is deemed to be unrelated to the Project.</p>

<p>The installation of caisson No.19 was completed on 18 Mar 2021, the reclamation area was enclosed.</p> <p>According to the field observation by sampling team during sampling event, no silt plume was observed in the Project site and the weather was cloudy during the sampling event.</p> <p>No major observation of improper site practices that contributed to the increase of the suspended solids were recorded during the weekly inspection on 23 Dec 2021.</p> <p>After the investigation, the exceedance on 17 Dec 2021 at B2 is deemed to be unrelated to the Project.</p>
--	---

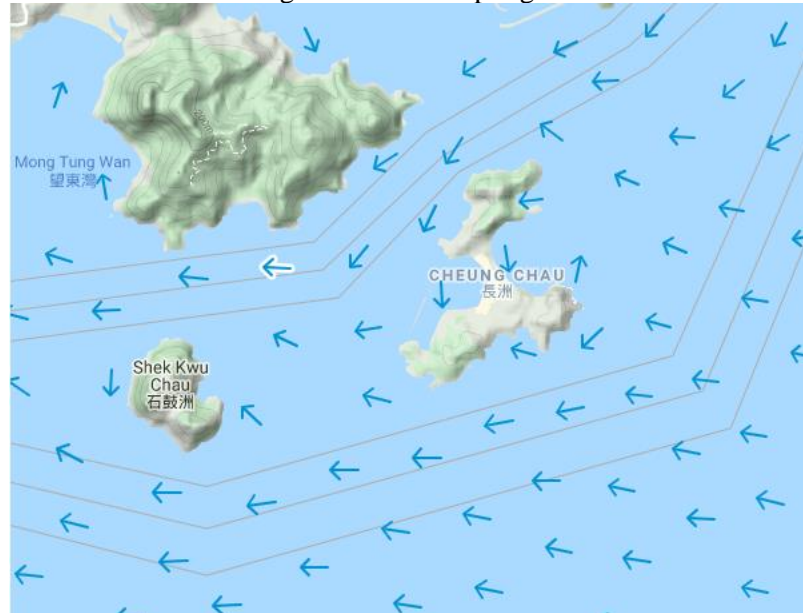
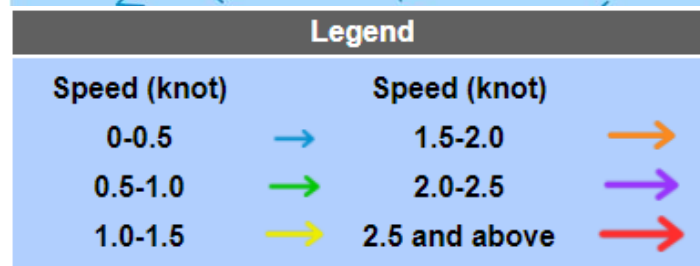
Current direction during mid-flood sampling on 17 Dec 2021:

(Sourced from <http://current.hydro.gov.hk/en/map.html>)

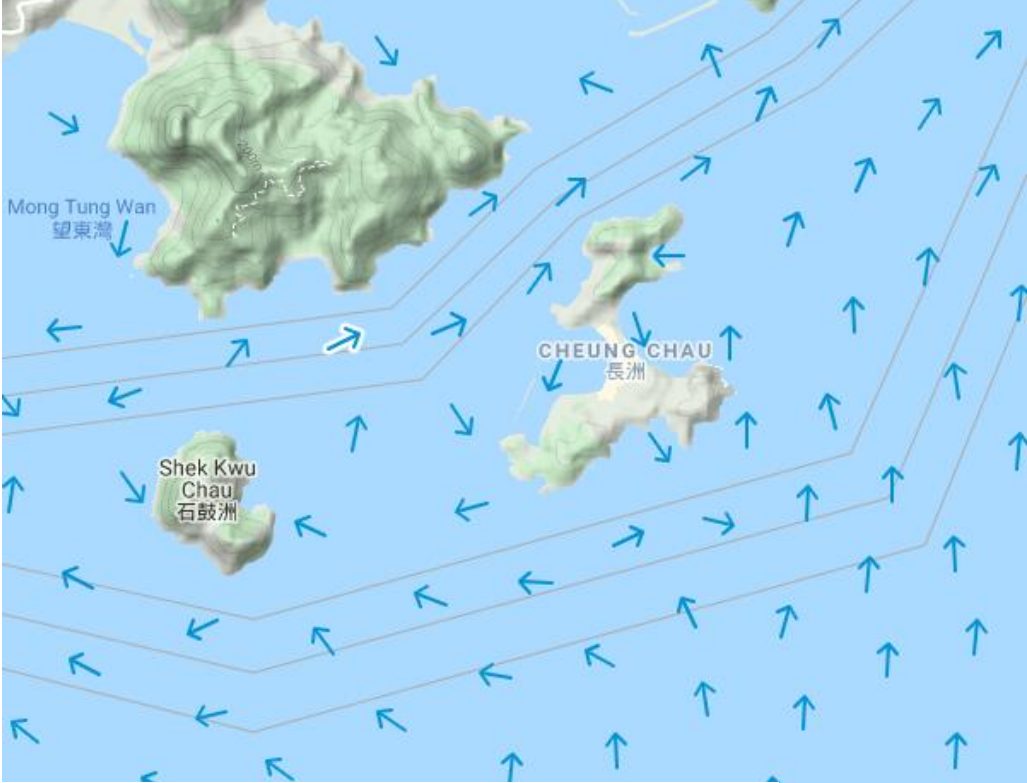
<p>Remarks</p>	<p>Current direction during mid-flood sampling on 22 Dec 2021:</p>

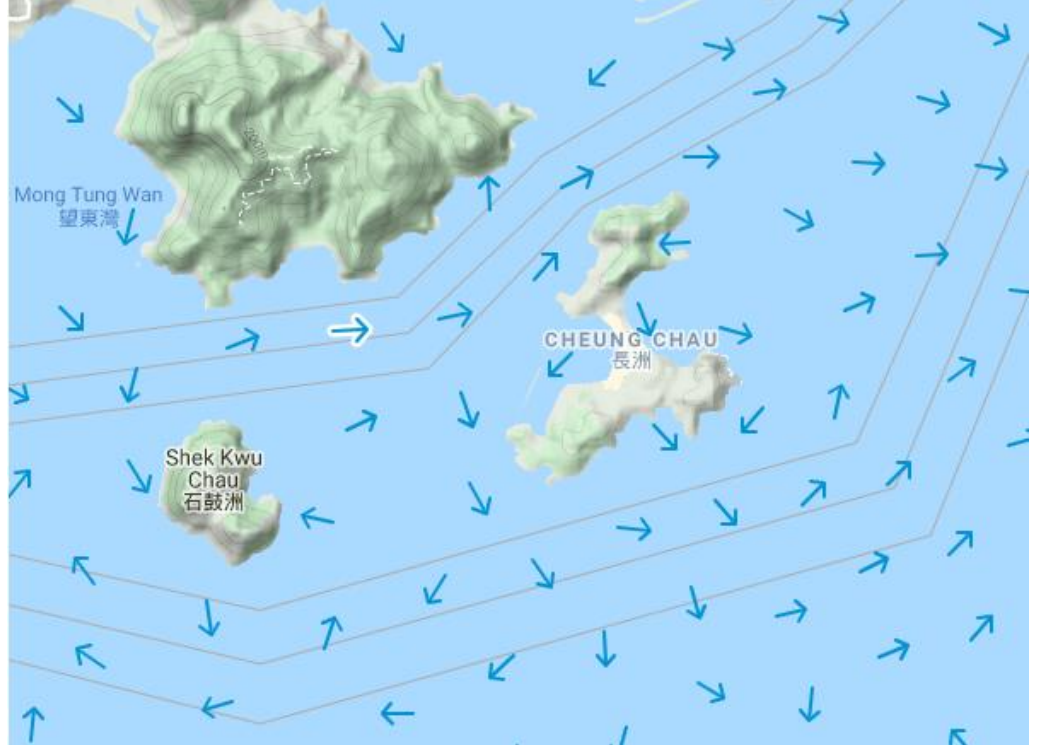
Current direction during mid-ebb sampling on 24 Dec 2021:

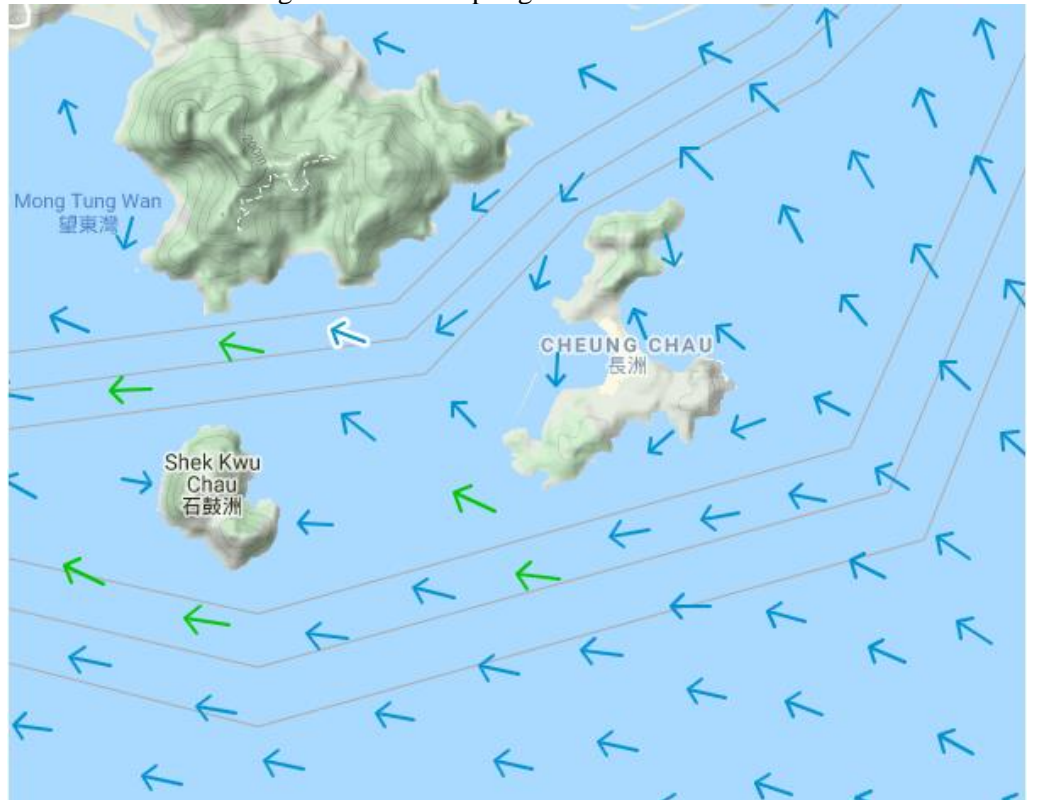
Current direction during mid-flood sampling on 24 Dec 2021:

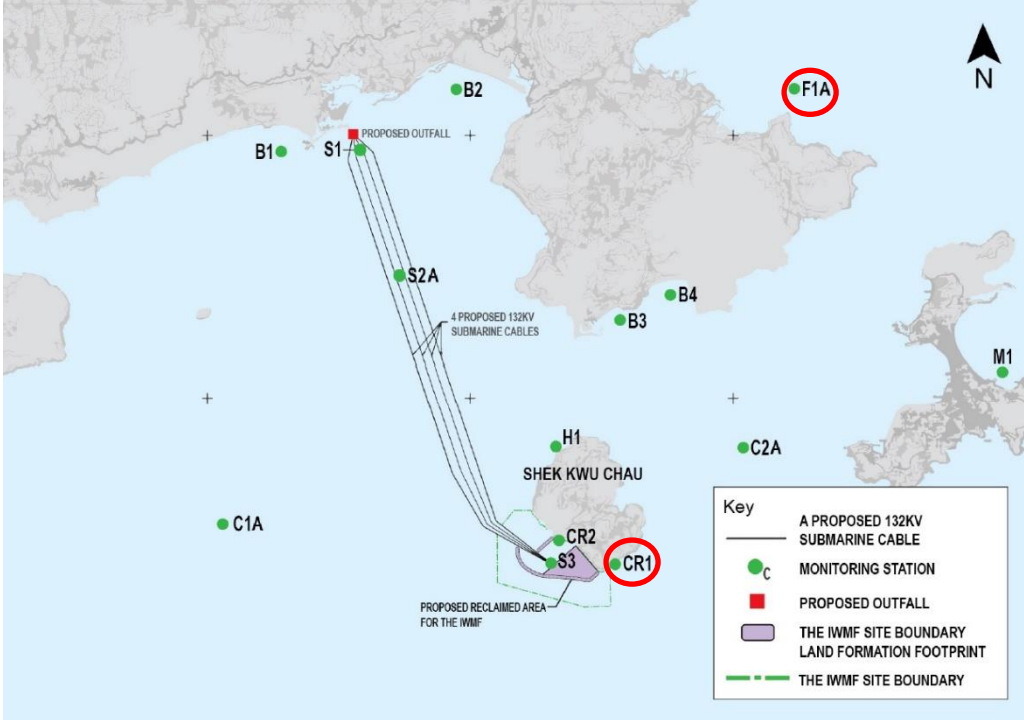
Mid-Ebb			
Monitoring Location	F1A and CR1

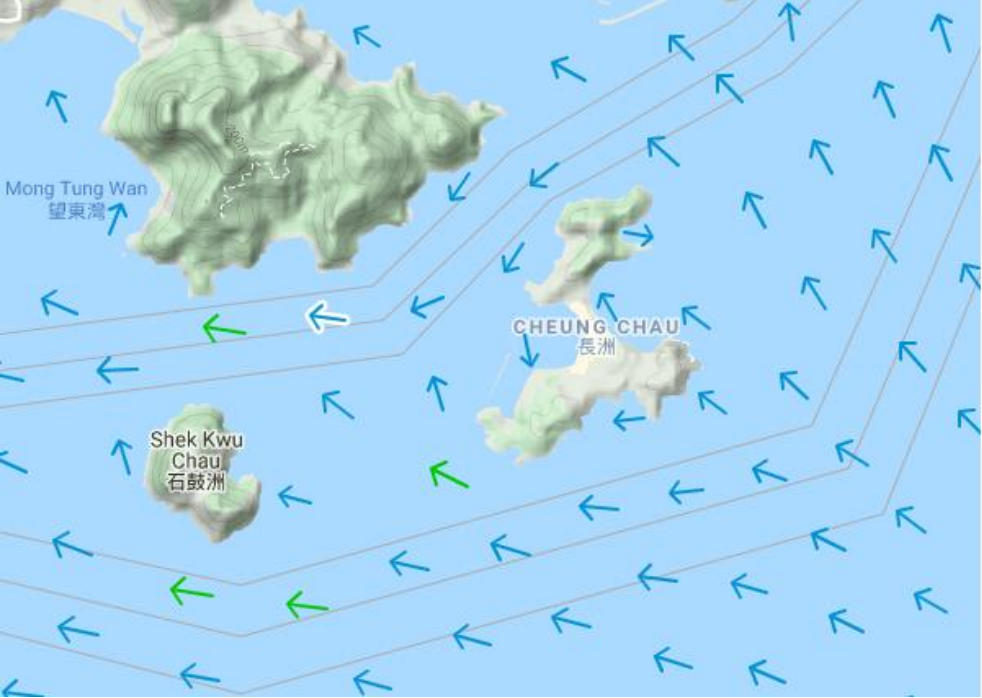
<p>CR1: No clear photos could be taken at the site after the sunset due to the darkness of surrounding environment.</p>
Remarks	<p>Current direction during mid-flood sampling on 27 Dec 2021:</p>

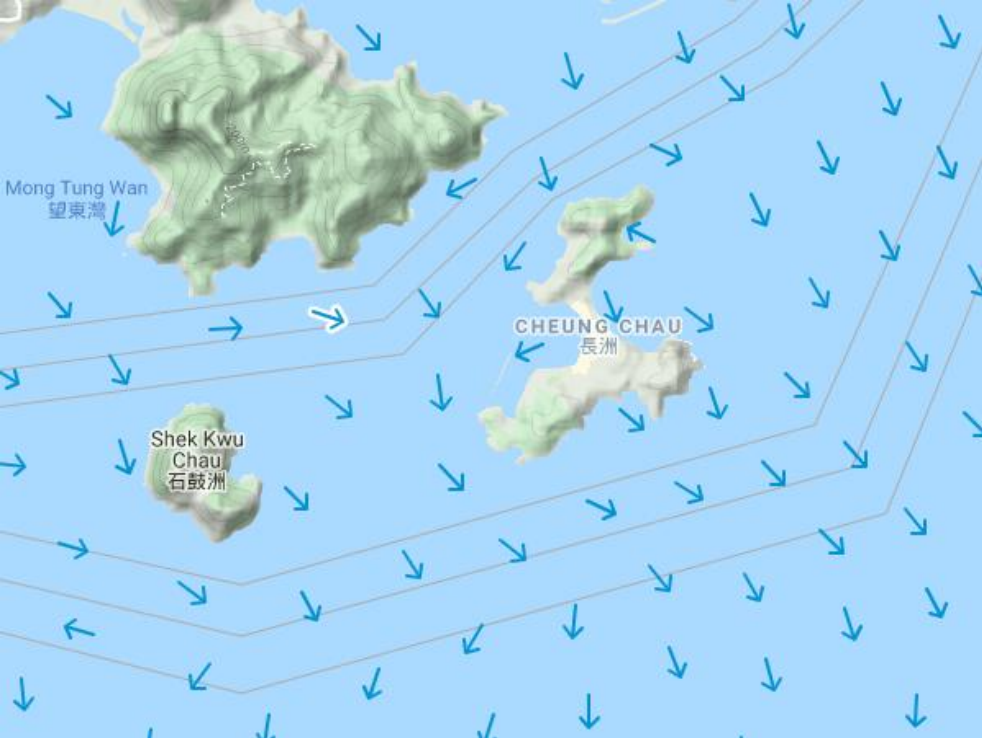
<p>Current direction during mid-ebb sampling on 27 Dec 2021:</p>

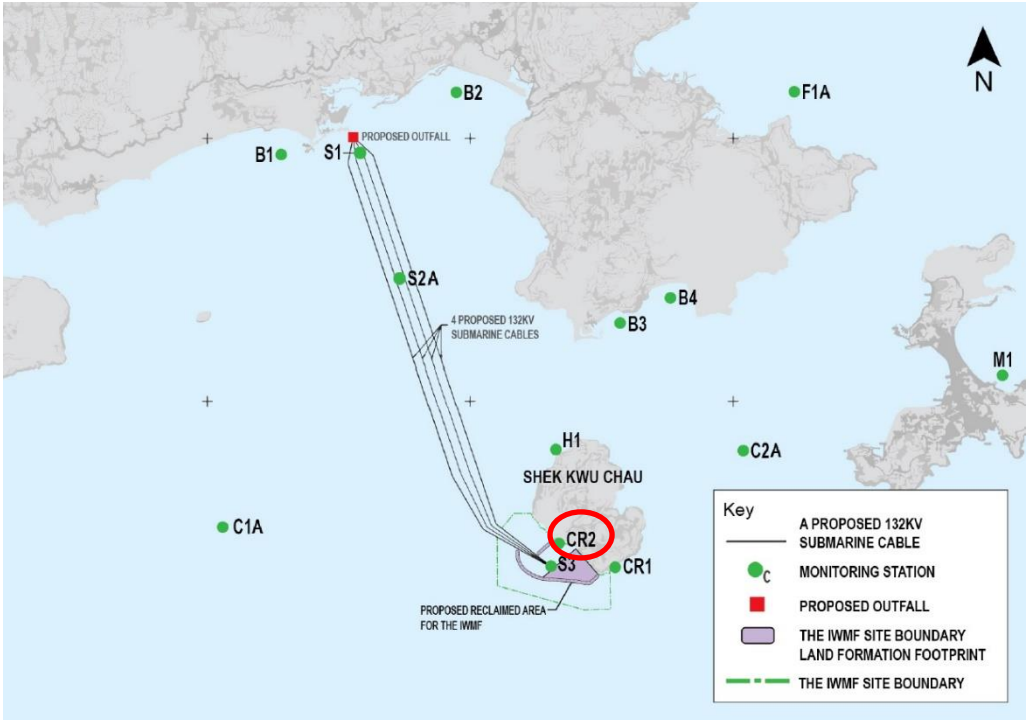
Project	Integrated Waste Management Facilities, Phase 1		
Date	31 Dec 2021 (Lab result received on 06 January 2022)		
Time	13:54 – 17:24 (Mid-Flood) 08:33 – 12:03 (Mid-Ebb)		
Mid-Flood			
Monitoring Location	CR2

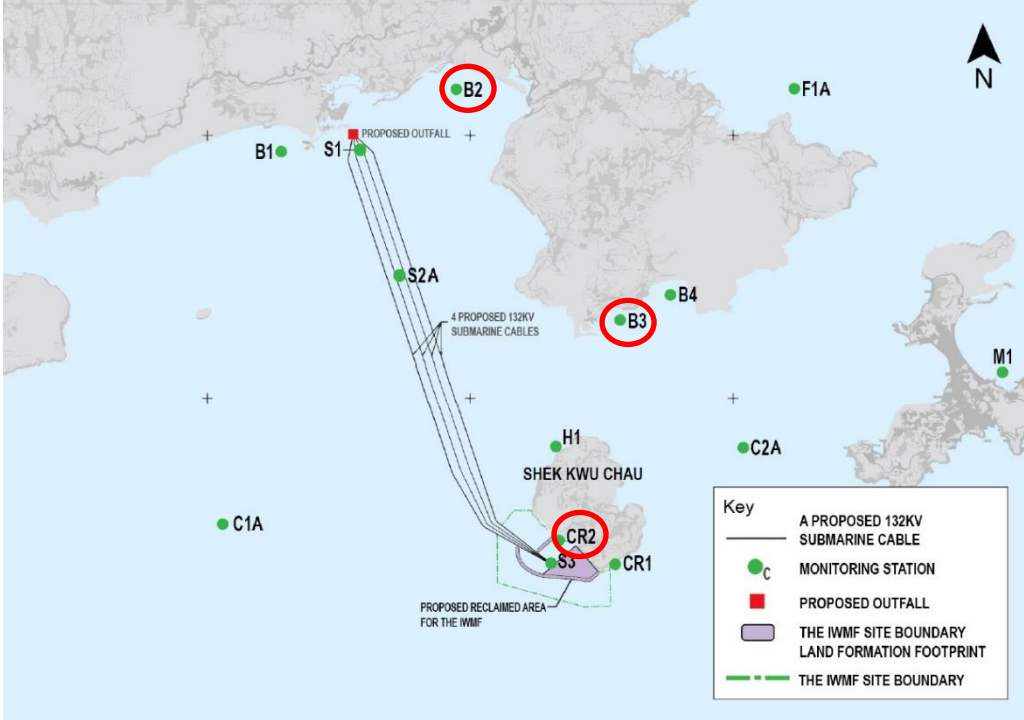
Mid-Ebb			
Monitoring Location	B2, B3 and CR2

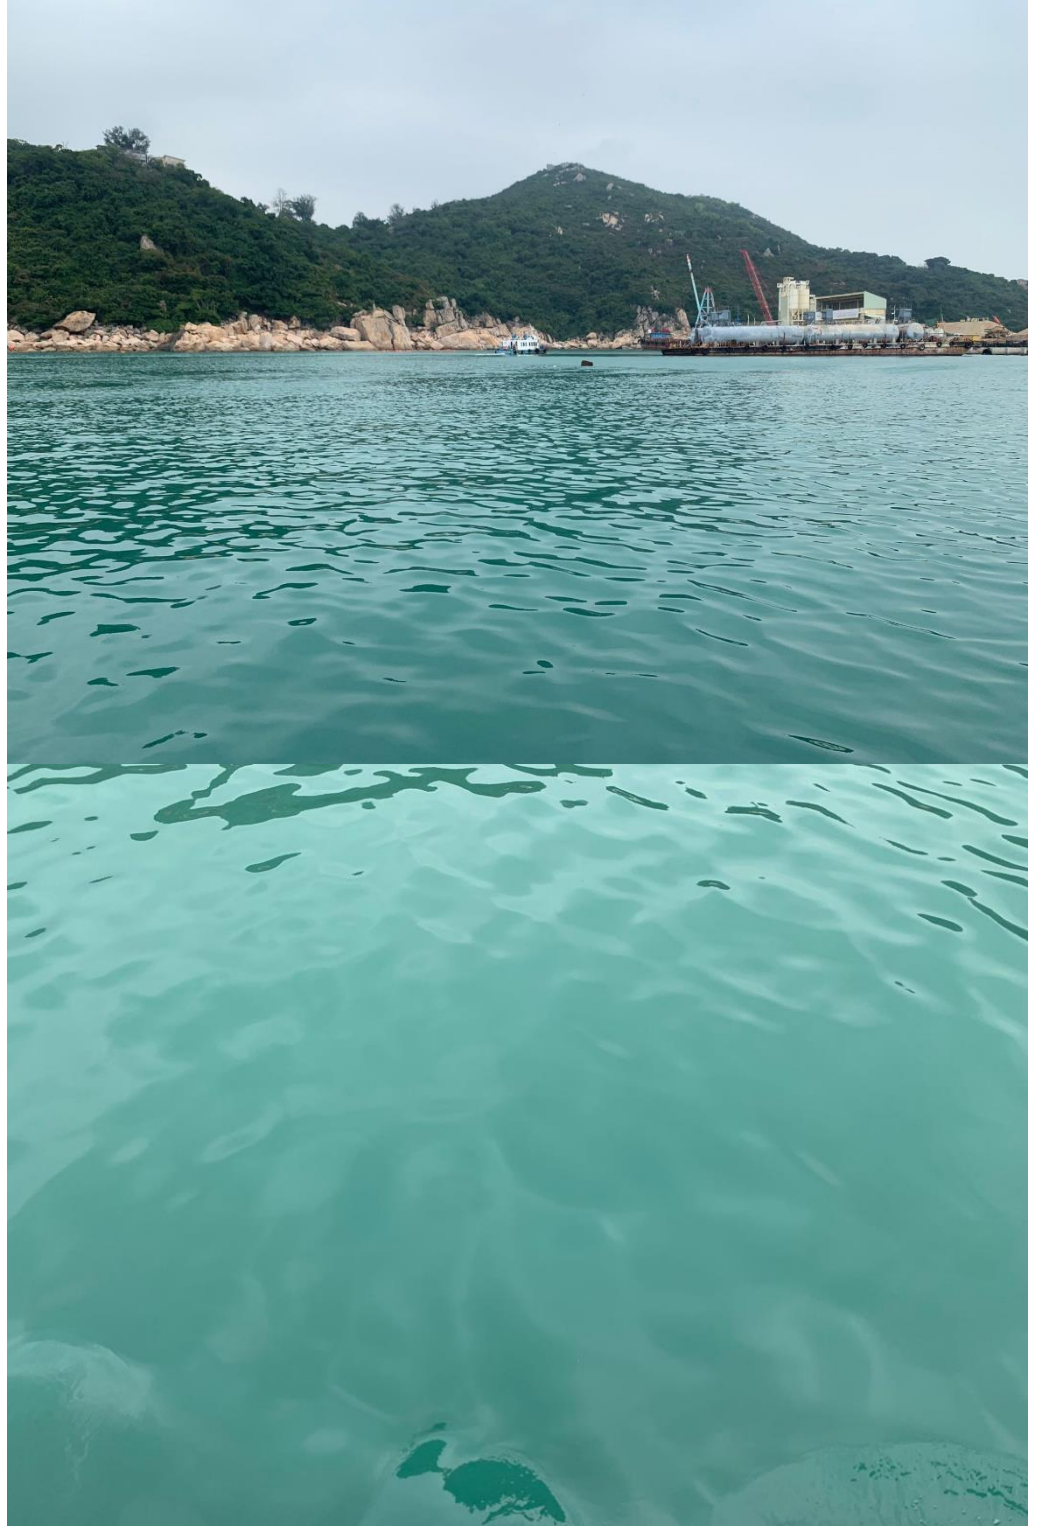
CR2:

Monitoring photos of  
stations with exceedance

<p>CR2 is located close to the works location within the Project site while no major marine work was conducted on 31 Dec 2021.</p> <p>The installation of caisson No. 19 was completed on 18 Mar 2021, the reclamation area was enclosed.</p> <p>According to the field observation by sampling team during sampling event, no silt plume was observed in the Project site and weather was fine during the sampling event.</p> <p>No major observation of improper site practices that contributed to the increase of the suspended solids were recorded during the weekly inspection on 29 Dec 2021 and 04 Jan 2022.</p> <p>After the investigation, the exceedances on 31 Dec 2021 at CR2 is deemed to be unrelated to the Project.</p>
--	---
