## Appendix N Exceedance Report

**Incident Report on Action Level or Limit Level Non-compliance**

Project	Integrated Waste Management Facilities, Phase 1		
Date	01 Dec 2021 (Lab result received on 8 Dec 2021)		
Time	08:00 – 11:25 (Mid-Ebb) 14:08 – 17:38 (Mid-Flood)		
Mid-Ebb			
Monitoring Location	B1, B2, B3

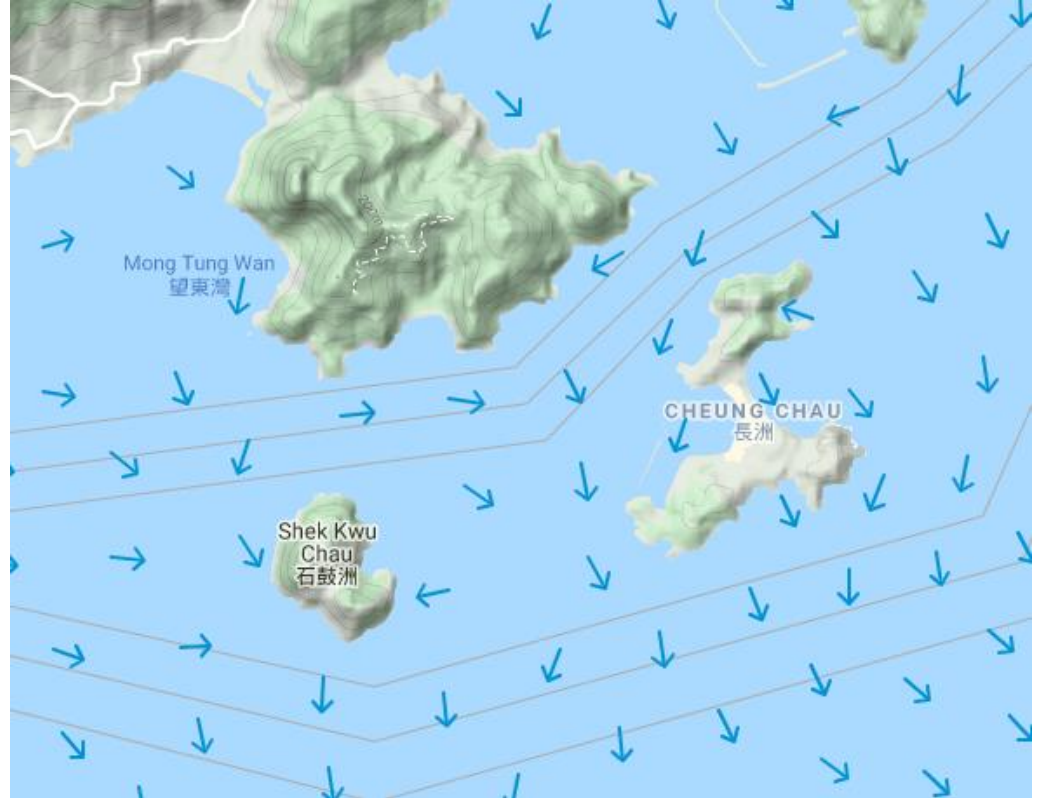
Current direction during mid-ebb sampling on 31 Dec 2021:
