Appendix N Exceedance Report

Incident Report on Action Level or Limit Level Non-compliance

Project	Integrated Waste Management Facilities, Phase 1		
Date	03 December 2018 (Lab result received on 06 December 2018)		
Time	13:57 – 17:27 (Mid-Flood)		
Mid-Flood			
Monitoring Location	B1, B2, B3, F1 & H1

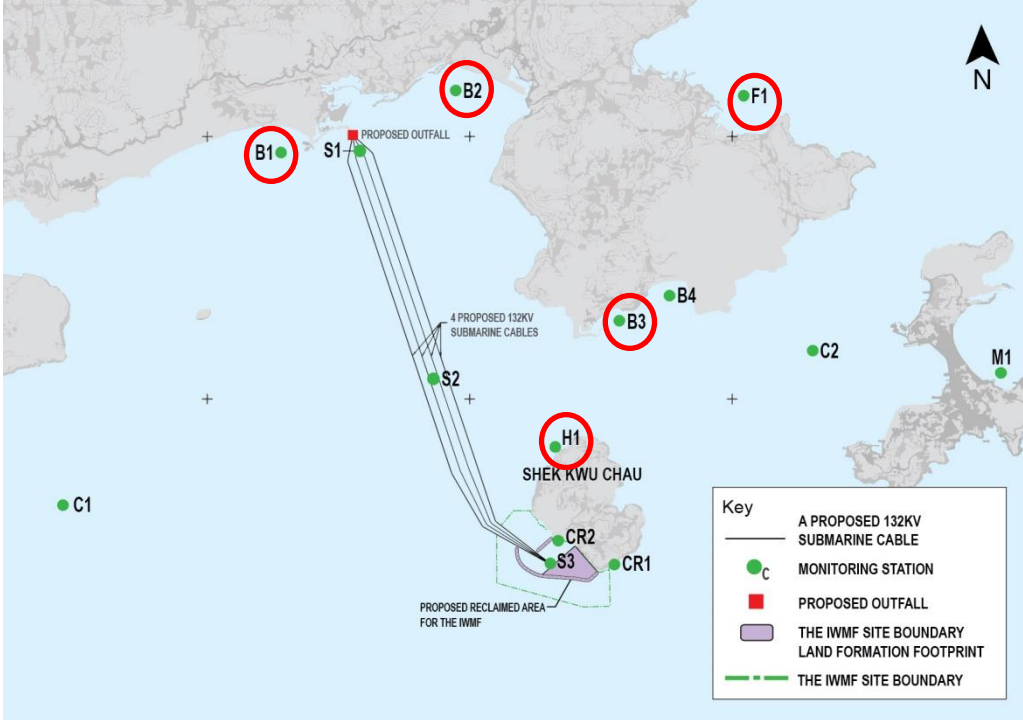
Parameter	Suspended Solid (SS)		
Action & Limit Levels	Action Level		Limit Level
	≥ 8.0 mg/L		≥ 10.0 mg/L
Measurement Level	Impact Station(s) of Exceedance	Control Stations	Impact Station(s) without Exceedance

8.5 mg/L (B1) 8.0 mg/L (B2) 8.0 mg/L (B3) 8.0 mg/L (F1) 8.2 mg/L (H1)	6.7 mg/L (C1) 6.5 mg/L (C2)	5.8 mg/L (B4) 6.5 mg/L (M1) 7.5 mg/L (CR1) 6.8 mg/L (CR2)
Possible reason for Action or Limit Level Non-compliance	<p>Works scheduled on site on 03/12 include ground investigation (GI) work of 2 borehole drilling, DCM sample coring for pre-construction site trial and laying of geotextile with sand placing for ballasting at caisson seawall area.</p> <p>Dominating sea current direction was found to be from Southeast to Northwest at waters around Shek Kwu Chau.</p> <p>B1, B2, B3 and F1 are located at unrelated stream direction (neither upstream nor downstream, far away) to the works location, exceedance of these monitoring locations are deemed to be unrelated to the Project.</p> <p>CR1 and CR2, the closest monitoring stations to the site location when comparing to H1 (upstream monitoring station), exhibited a much smaller SS level. No observation of silt plume was made during the sampling event. Silt curtain checking was implemented by the contractor and checking result showed that no deficiency of silt curtain was found on that day. It might suggest that the high SS level exceedance at</p>

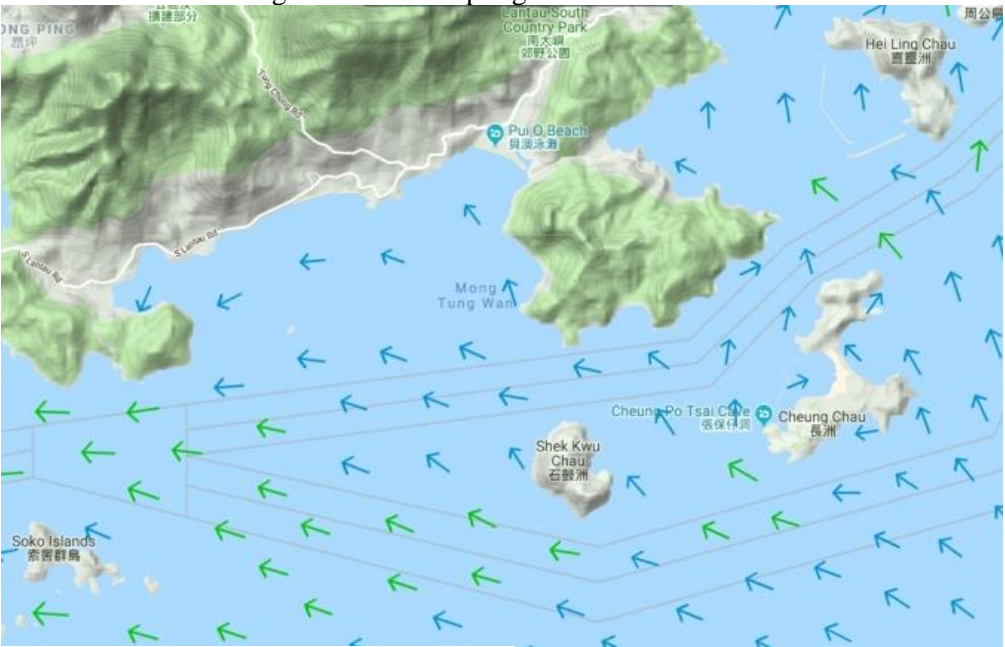
<p>Remarks</p>	<p>Current direction during mid-flood sampling on 03/12:</p>

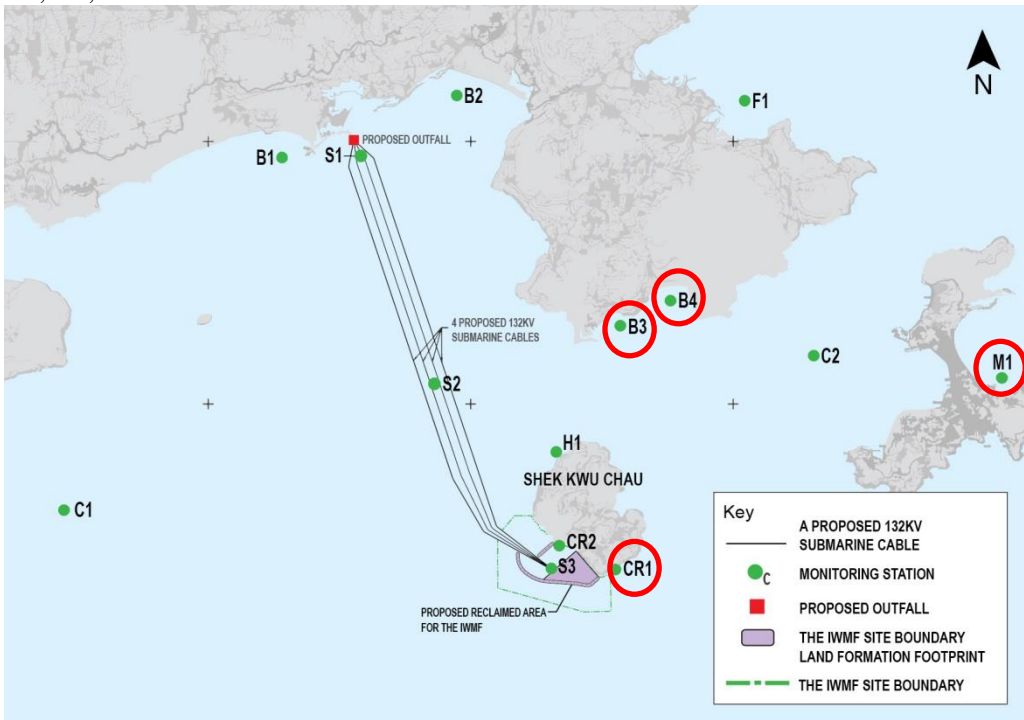
Project	Integrated Waste Management Facilities, Phase 1		
Date	5 December 2018 (Lab result received on 10 December 2018)		
Time	09:19 – 12:49 (Mid-Ebb) 15:02 – 18:32 (Mid-Flood)		
Mid-Ebb			
Monitoring Location	B3, B4, M1 & CR1

Parameter	Suspended Solid (SS)		
Action & Limit Levels	Action Level		Limit Level
	≥ 8.0 mg/L		≥ 10.0 mg/L
Measurement Level	Impact Station(s) of Exceedance	Control Stations	Impact Station(s) without Exceedance

9.3 mg/L (B3) 8.8 mg/L (B4) 10.7 mg/L (M1) 8.8 mg/L (CR1)	6.3 mg/L (C1) 9.8 mg/L (C2)	7.5 mg/L (B1) 7.8 mg/L (B2) 7.5 mg/L (F1) 7.7 mg/L (H1) 5.3 mg/L (CR2)
Possible reason for Action or Limit Level Non-compliance	<p>Works scheduled on site on 05/12 include ground investigation (GI) work of 2 borehole drilling, DCM sample coring for pre-construction site trial and laying of sand blanket at caisson seawall area.</p> <p>Dominating sea current direction was found to be from Northwest to Southeast at waters around Shek Kwu Chau.</p> <p>B3, B4 and M1 are located at unrelated stream direction (neither upstream nor downstream, far away) to the works location, exceedance of these monitoring locations are deemed to be unrelated to the Project.</p> <p>CR1 is located at downstream direction to the works location, while no observation of silt plume was made during the sampling event. Silt curtain checking was implemented by the contractor and checking result showed that no deficiency of silt curtain was found on that day. It might suggest that the high SS level exceedance at</p>

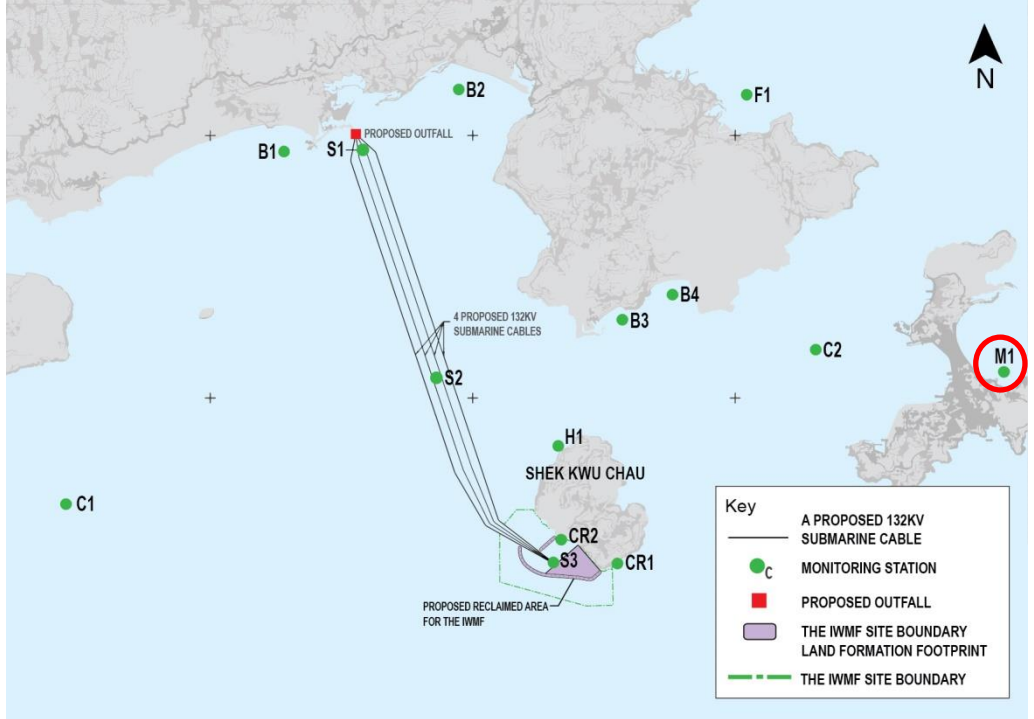
<p>Mid-Flood</p>			
<p>Monitoring Location</p>	<p>M1</p>

<p>The map shows the project site in the vicinity of Shek Kwu Chau. It includes several monitoring stations labeled B1 through F1, H1, M1, CR1, and CR2. A proposed outfall is marked as S1. Four proposed 132KV submarine cables are shown connecting the outfall area to the site. A proposed reclaimed area for the IWMF is outlined in green. The IWMF site boundary and land formation footprint are also shown. A key in the bottom right corner defines the symbols: a solid line for a proposed 132KV submarine cable, a green circle with a 'C' for a monitoring station, a red square for a proposed outfall, a purple shaded area for the IWMF site boundary, a solid purple line for the land formation footprint, and a dashed green line for the IWMF site boundary.</p>		
<p>Parameter</p>	<p>Suspended Solid (SS)</p>		
<p>Action & Limit Levels</p>	<p>Action Level ≥ 10.0 mg/L (120% of C2)</p>	<p>Limit Level ≥ 10.8 mg/L (130% of C2)</p>

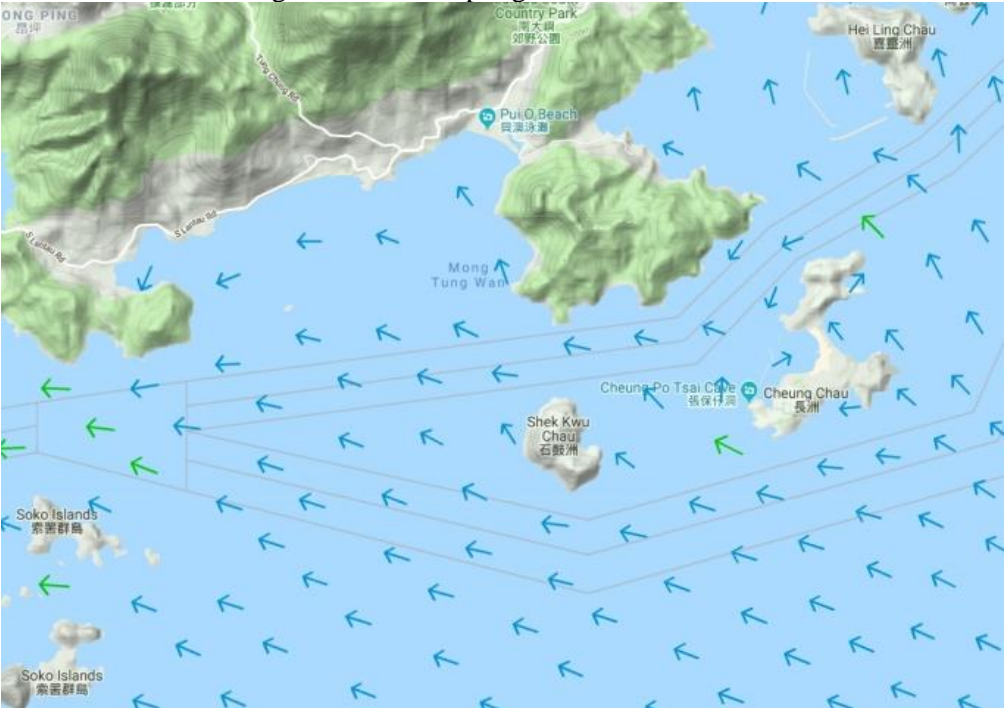
<p>Remarks</p>	<p>Current direction during mid-flood sampling on 5/12:</p>

<p>Dominating sea current direction was found to be from Southeast to Northwest at waters around Shek Kwu Chau.</p> <p>M1 is located at unrelated stream direction (neither upstream nor downstream, far away) to the works location, exceedance of this monitoring location is deemed to be unrelated to the Project.</p> <p>Silt curtain checking was implemented by contractor and checking result showed no deficiency of silt curtain was found.</p> <p>Site tidiness in the present barges in the Project site were checked during weekly site inspection on 4/12, where sand on the pontoon surface was nearly overflowed to the sea on FTB 19 and a big lump of sand was observed at the edge of the barge surface on 祥記 7. However, according to the rationale in the previous paragraph, these two observations were not considered as the source of SS exceedance.</p>
<p>Actions taken / to be taken</p>	<p>The Contractor was reminded to clean up the sand more frequently and hence to avoid the sand was leaked outside the silt curtain. The Contractor was reminded to use an elongated soft hose to avoid the sand accumulation on the pontoon surface during sand blanket laying process.</p> <p>Examination of environmental performance of the Project will be continued during the weekly inspection, and the Contractor is reminded to implement all applicable mitigation measures as per the Updated EM&A Manual.</p>

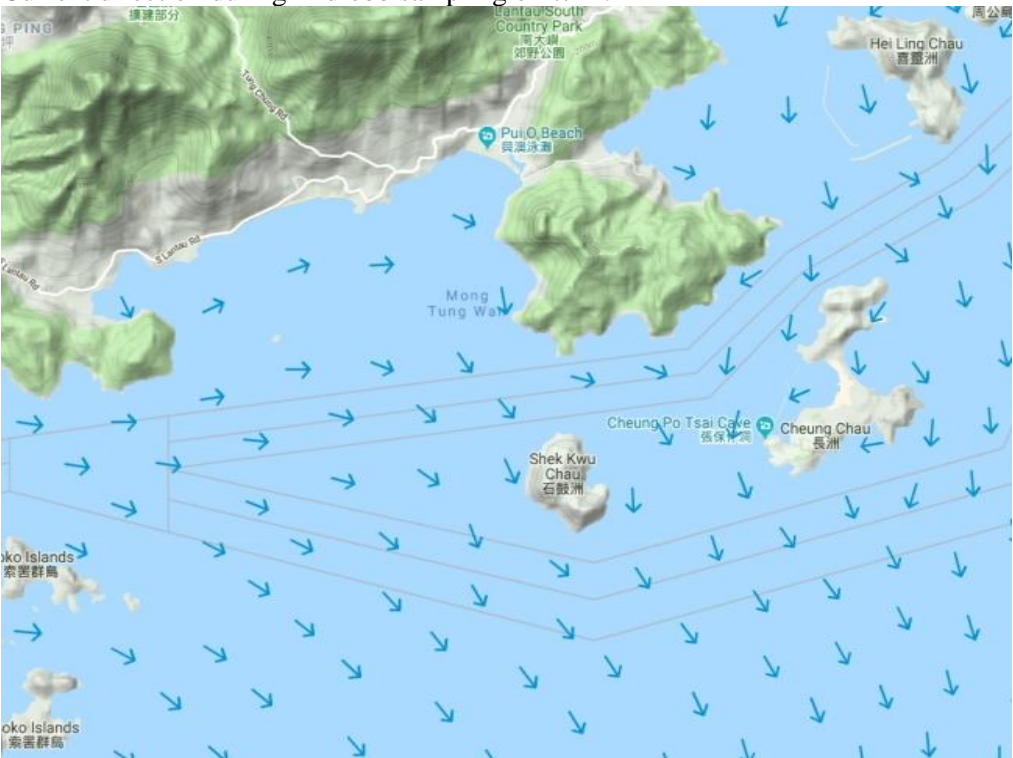
<p>Remarks</p>	<p>Current direction during mid-ebb sampling on 7/12:</p>

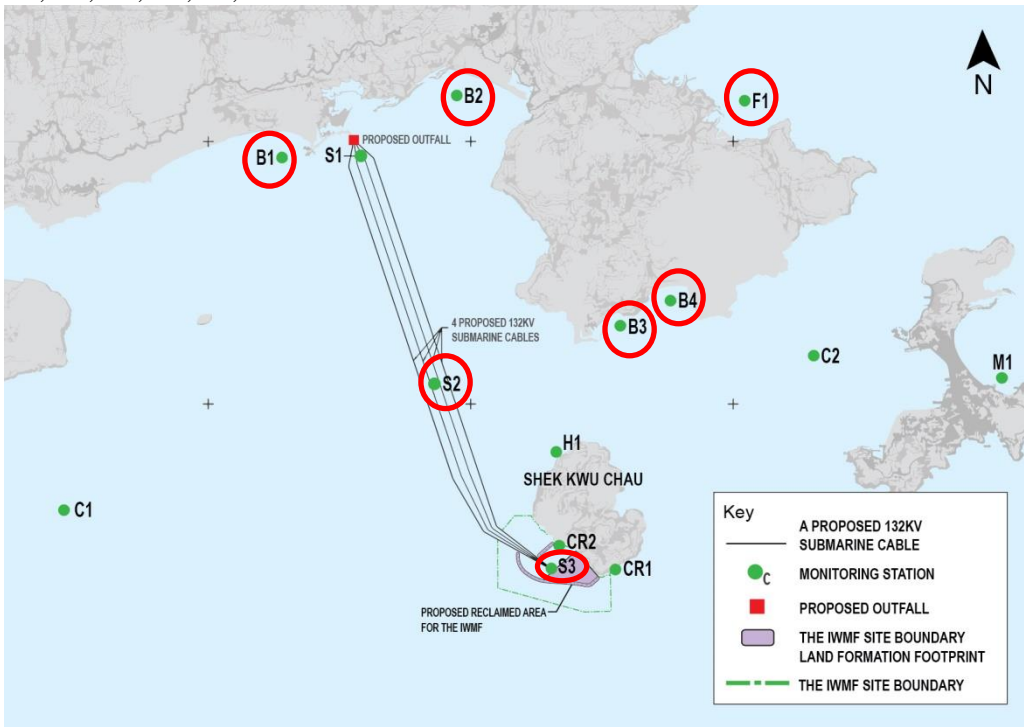
Project	Integrated Waste Management Facilities, Phase 1		
Date	10 December 2018 (Lab result received on 13 December 2018)		
Time	08:00 – 10:52 (Mid-Flood) 12:37 – 16:07 (Mid-Ebb)		
Mid-Flood			
Monitoring Location	B1, B2, B3, B4, F1, S2 & S3

Parameter	Suspended Solid (SS)		
Action & Limit Levels	Action Level		Limit Level
	≥ 11.2 mg/L (120% of C2)		≥ 12.1 mg/L (130 % of C2)
Measurement Level	Impact Station(s) of Exceedance	Control Stations	Impact Station(s) without Exceedance

13.0 mg/L (B1) 13.8 mg/L (B2) 14.0 mg/L (B3) 13.3 mg/L (B4) 12.2 mg/L (F1) 15.3 mg/L (S2) 13.5 mg/L (S3)	7.0 mg/L (C1) 9.3 mg/L (C2)	8.8 mg/L (H1) 7.3 mg/L (M1) 11.0 mg/L (CR1) 8.7 mg/L (CR2) 10.5 mg/L (S1)
Possible reason for Action or Limit Level Non-compliance	<p>Works scheduled on site on 10/12 include ground investigation (GI) work of 2 borehole drilling and DCM sample coring for pre-construction site trial, which shall not be a major source of SS concentration increase considering the limited scale and nature of works.</p> <p>Dominating sea current direction was found to be from Southeast to Northwest at waters around Shek Kwu Chau.</p> <p>B1, B2, B3, B4, F1 and S2 are located at unrelated stream direction (neither upstream nor downstream, far away) to the works location, exceedance of these monitoring locations are deemed to be unrelated to the Project.</p> <p>S3 is located close to the works location within the Project site, while no observation of silt plume was made during the sampling event. The absence of site works and</p>

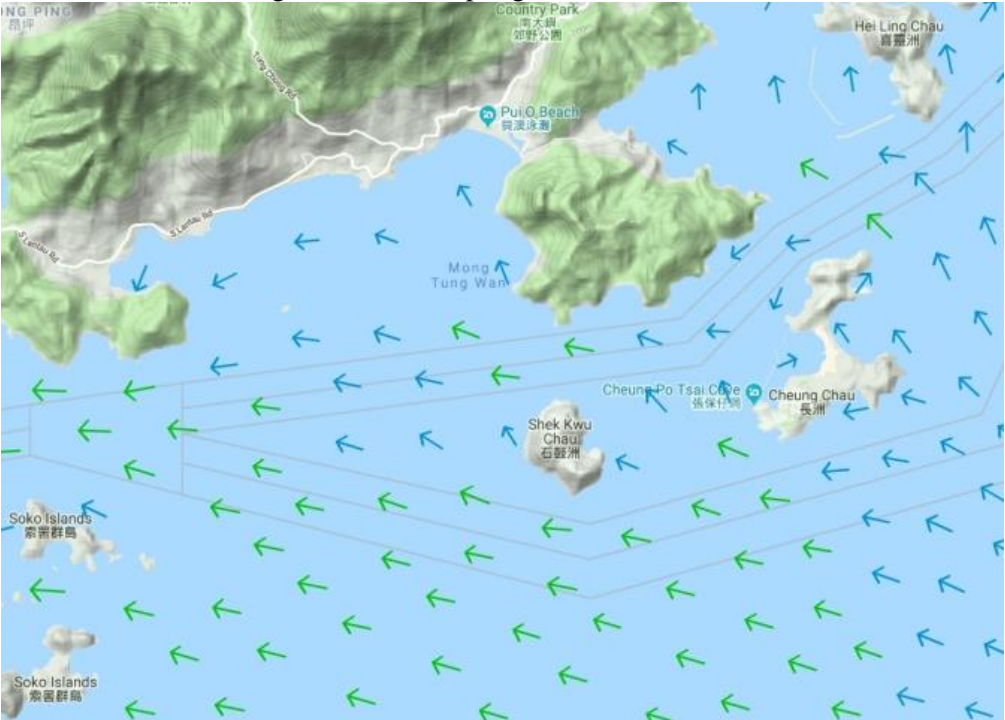
<p>Remarks</p>	<p>Current direction during mid-flood sampling on 10/12:</p>

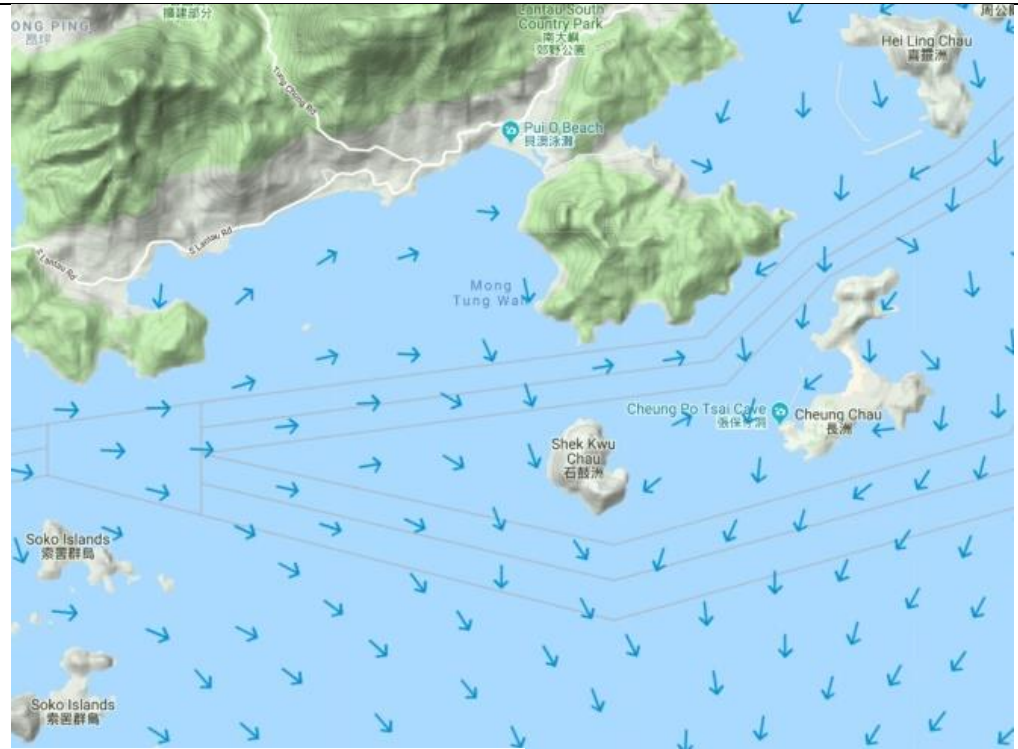
<p>Current direction during mid-ebb sampling on 10/12:</p>

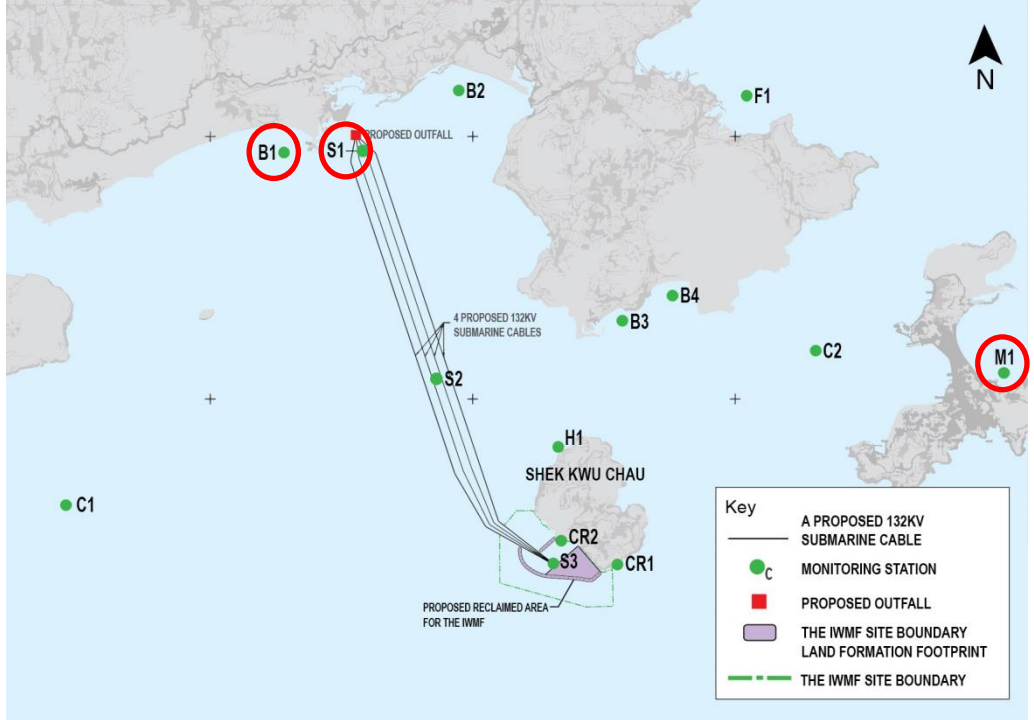
<p>Mid-Ebb</p>			
<p>Monitoring Location</p>	<p>B1, M1 & S1</p>

<p>The map shows the project site with various monitoring stations marked with green dots. Stations B1, M1, and S1 are circled in red. A proposed outfall is marked with a red square. Submarine cables are shown as lines connecting the outfall to the site. The site boundary is indicated by a purple line, and the land formation footprint is shown with a dashed green line. A north arrow is present in the top right corner.</p>		
<p>Parameter</p>	<p>Suspended Solid (SS)</p>		
<p>Action & Limit Levels</p>	<p>Action Level</p>		<p>Limit Level</p>
	<p>≥ 15.0 mg/L (120% of C1)</p>		<p>≥ 16.3 mg/L (130% of C1)</p>
<p>Measurement Level</p>	<p>Impact Station(s) of Exceedance</p>	<p>Control Stations</p>	<p>Impact Station(s) without Exceedance</p>
	<p>18.5 mg/L (B1) 17.0 mg/L (M1) 16.8 mg/L (S1)</p>	<p>12.5 mg/L (C1) 13.2 mg/L (C2)</p>	<p>11.5 mg/L (B2) 14.3 mg/L (B3) 11.8 mg/L (B4) 11.7 mg/L (F1) 12.0 mg/L (H1) 10.7 mg/L (CR1) 12.5 mg/L (CR2) 11.2 mg/L (S2) 13.0 mg/L (S3)</p>

<p>of geotextile with sand placing for ballasting and laying of sand blanket at caisson seawall area.</p> <p>Dominating sea current direction was found to be from Northwest to Southwest waters around Shek Kwu Chau.</p> <p>B1, S1 and M1 are located at unrelated stream direction (neither upstream nor downstream, far away) to the works location, exceedance of these monitoring locations are deemed to be unrelated to the Project. Silt curtain checking was implemented by the contractor and checking result showed that no deficiency of silt curtain was found on that day.</p> <p>Site tidiness in the present barges in the Project site were checked during weekly site inspection on 14/12, where there was no major observation of improper site practice that might contribute to the increase in SS level was observed during the inspection.</p>
<p>Actions taken / to be taken</p>	<p>Examination of environmental performance of the Project will be continued during the weekly inspection, and the Contractor is reminded to implement all applicable mitigation measures as per the Updated EM&A Manual.</p>

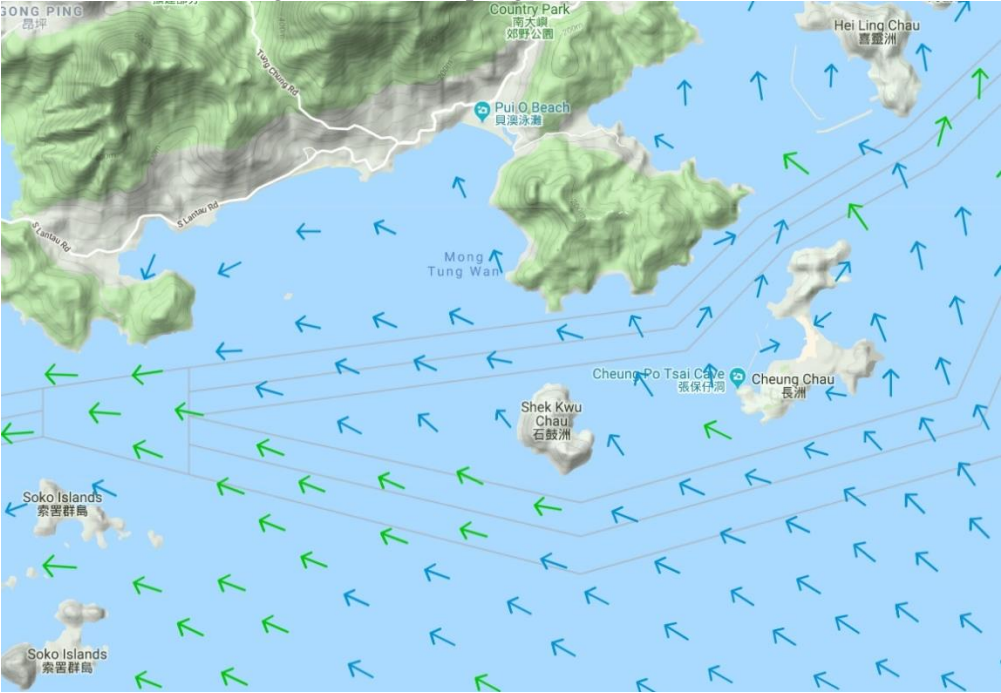
<p>Remarks</p>	<p>Current direction during mid-flood sampling on 12/12:</p>

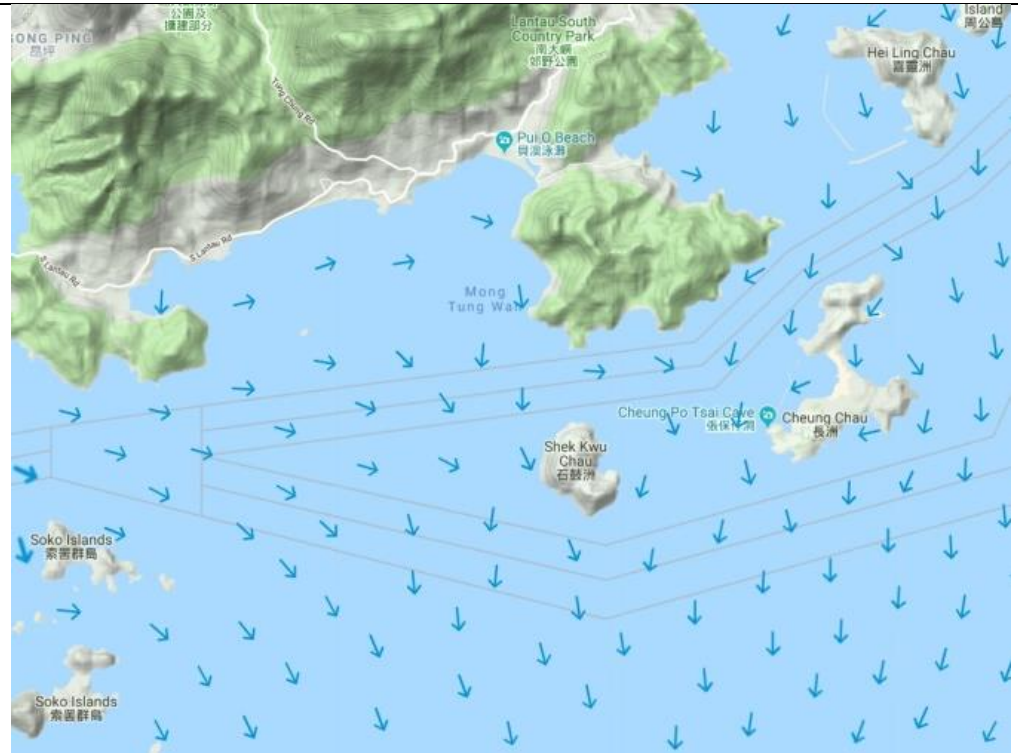
<p>Current direction during mid-ebb sampling on 12/12:</p>

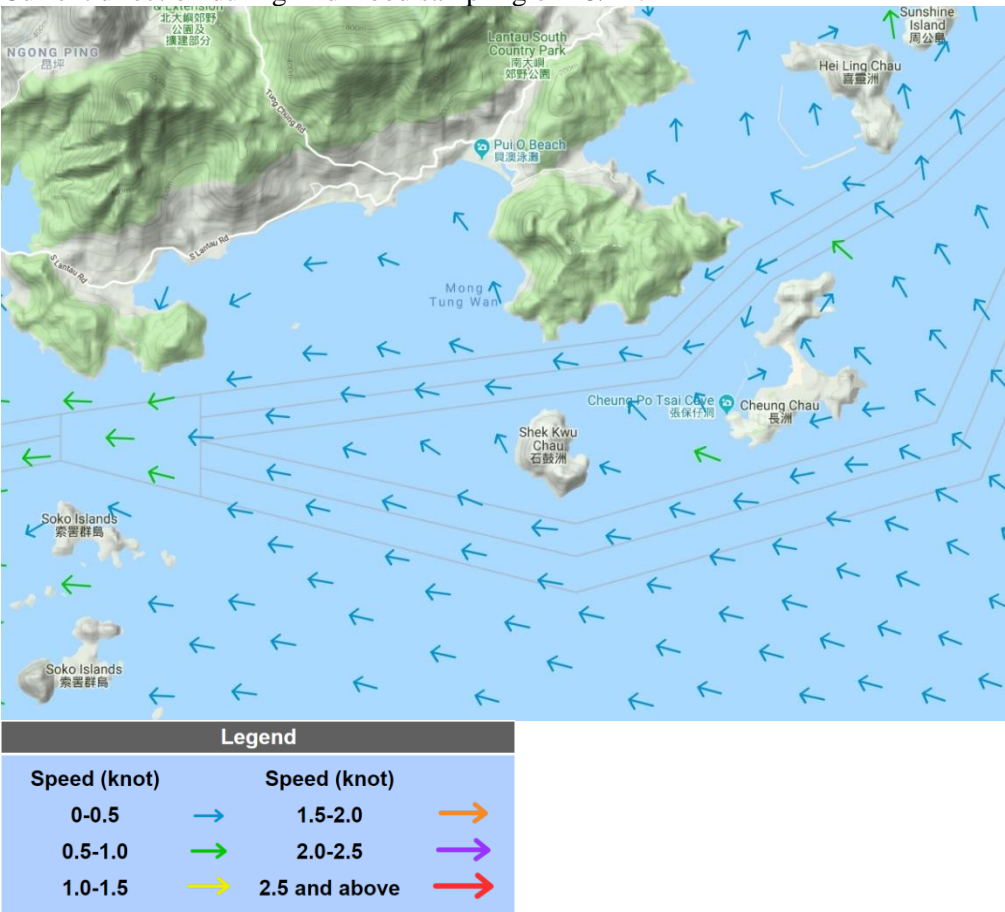
<p>Remarks</p>	<p>Current direction during mid-flood sampling on 15/12:</p>

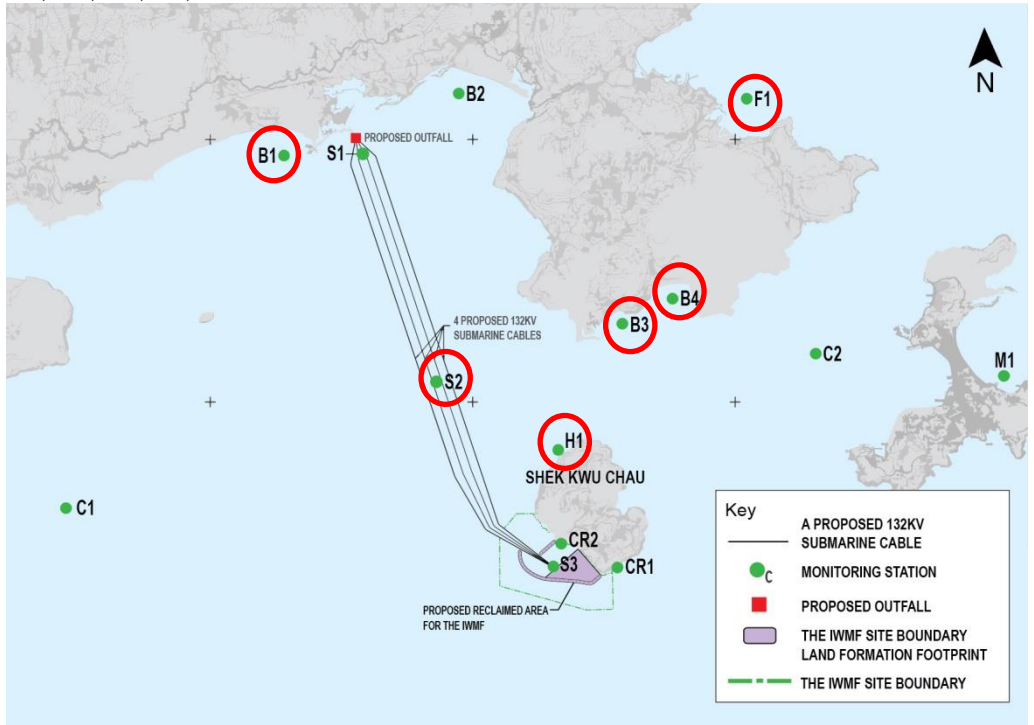
<p>The map shows the Shek Kwu Chau area with various monitoring stations marked with green dots. Stations B1, B3, B4, F1, H1, and S2 are circled in red. A red square indicates the proposed outfall. Four lines represent the proposed 132KV submarine cables. A purple shaded area shows the IWMF site boundary and land formation footprint. A green dashed line shows the IWMF site boundary. A key in the bottom right corner explains the symbols: A PROPOSED 132KV SUBMARINE CABLE (black line), MONITORING STATION (green dot), PROPOSED OUTFALL (red square), THE IWMF SITE BOUNDARY LAND FORMATION FOOTPRINT (purple shaded area), and THE IWMF SITE BOUNDARY (green dashed line). A north arrow is also present.</p>

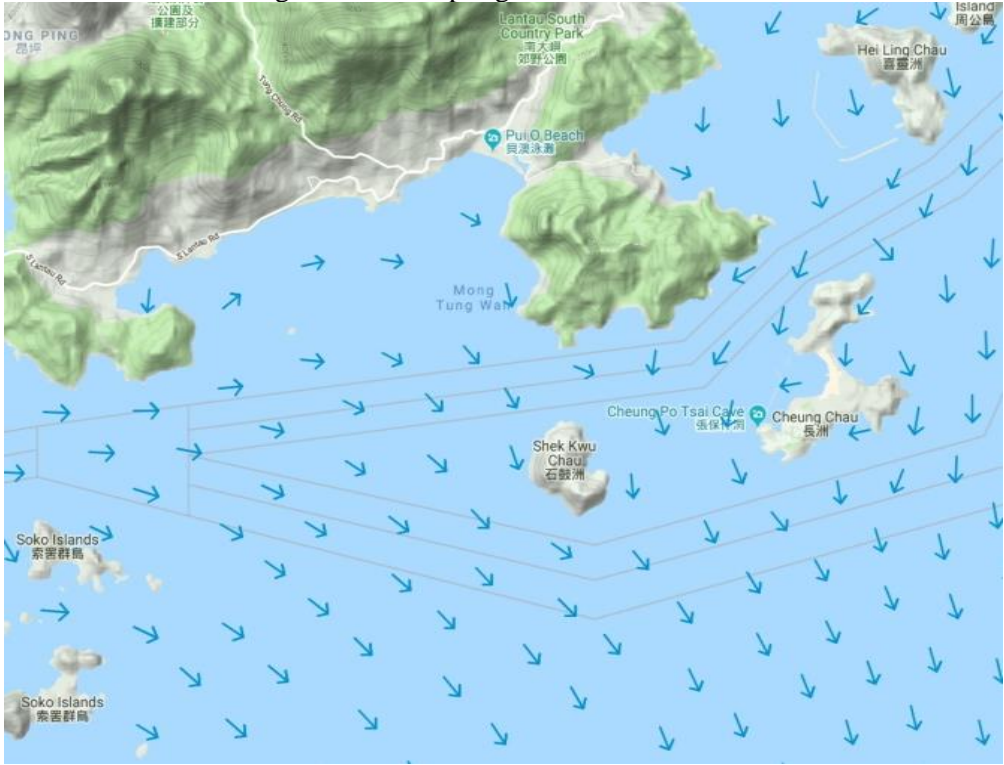
<p>Remarks</p>	<p>Current direction during mid-ebb sampling on 17/12:</p>

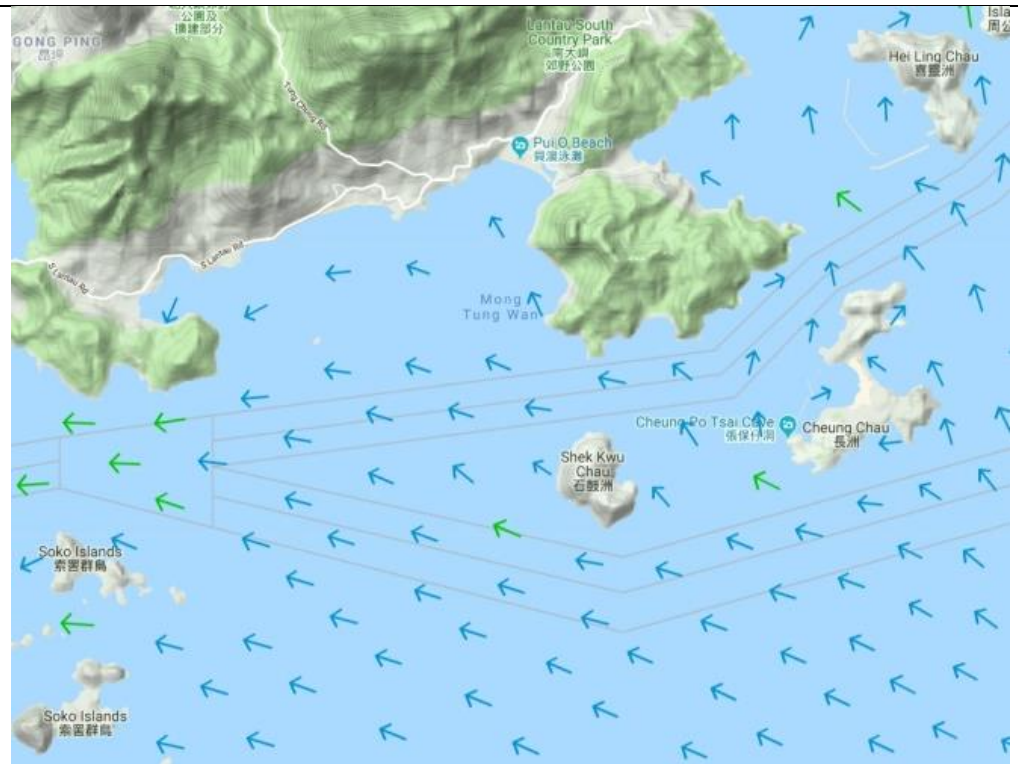
<p>Current direction during mid-flood sampling on 17/12:</p>

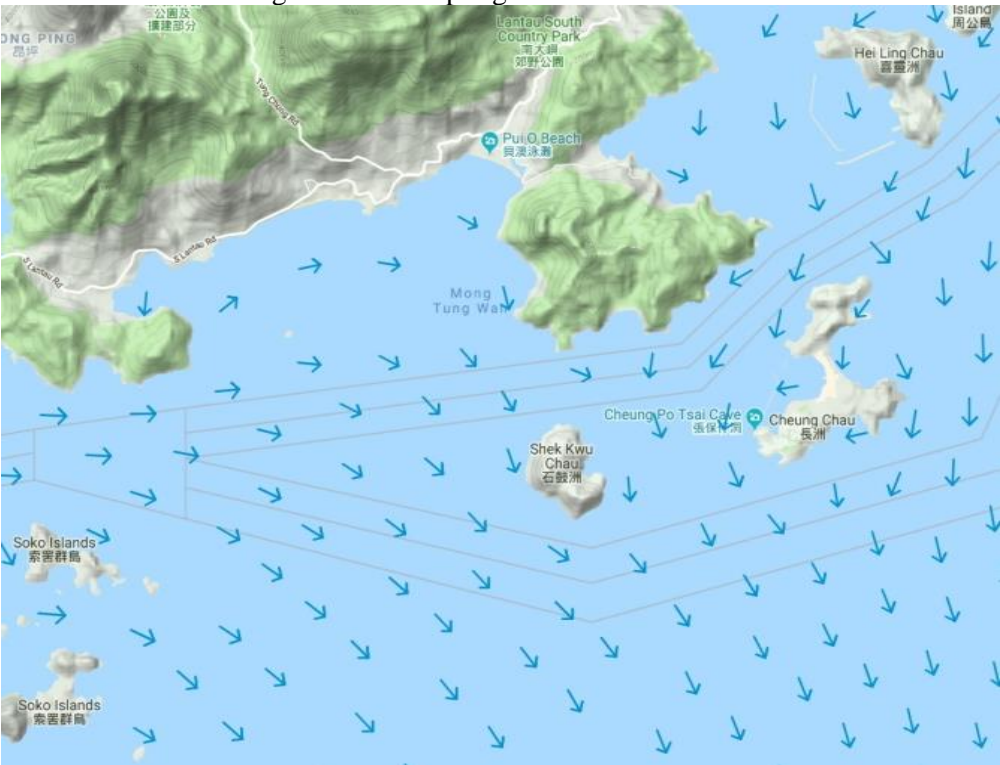
<p>However, a track of observable silt plume at the back of the pelican barge deployed for sand blanket laying works was found around 3:00 pm.</p>								
<p>Actions taken / to be taken</p>	<p>After switching off the engine of the pelican barge, the observable silt plume had vanished. The Contractor confirmed the observable silt plume was related to the engine operation of pelican barge in shallow water. The Contractor designed to use the tugboat to manoeuvre the pelican barge especially in shallow water. The environmental department of the Contractor was reminded to keep paying attention to avoid the repeating of such incidents.</p> <p>Examination of environmental performance of the Project will be continued during the weekly inspection, and the Contractor is reminded to implement all applicable mitigation measures as per the Updated EM&A Manual.</p>								
<p>Remarks</p>	<p>Current direction during mid-ebb sampling on 19/12:</p>

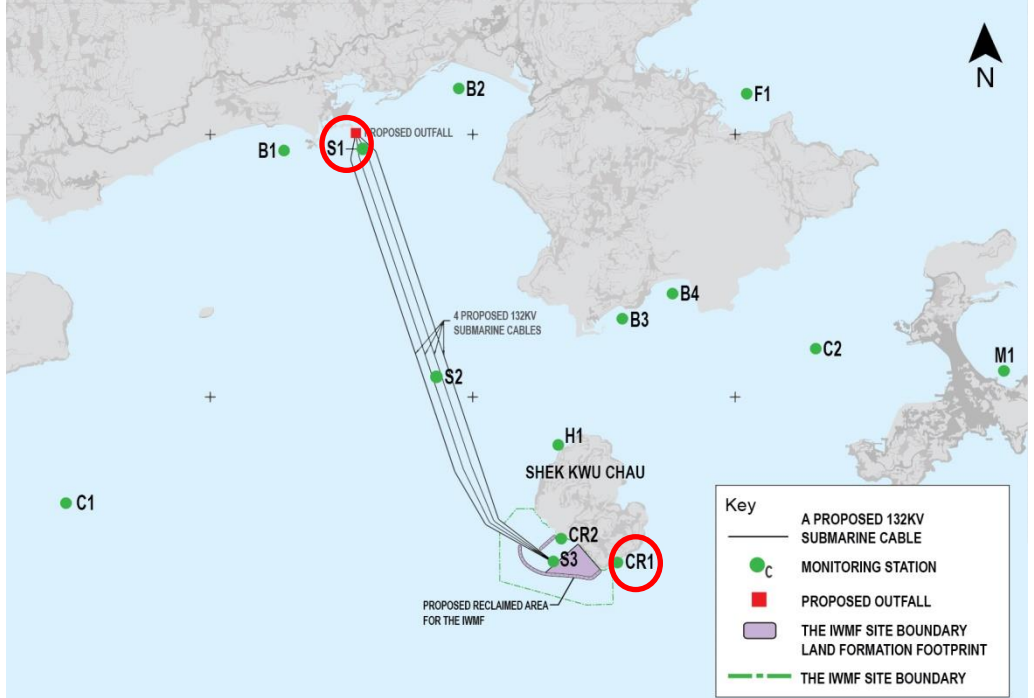
<p>Monitoring Location</p>	<p>CR1 & S1</p>

<p>Parameter</p>	<p>Suspended Solid (SS)</p>		
<p>Action & Limit Levels</p>	<p>Action Level ≥ 8.0 mg/L</p>		<p>Limit Level ≥ 10.0 mg/L</p>
<p>Measurement Level</p>	<p>Impact Station(s) of Exceedance 8.5 mg/L (CR1) 9.8 mg/L (S1)</p>	<p>Control Stations 5.5 mg/L (C1) 6.7 mg/L (C2)</p>	<p>Impact Station(s) without Exceedance 7.3 mg/L (B1) 7.8 mg/L (B2) 7.8 mg/L (B3) 5.8 mg/L (B4) 5.8 mg/L (F1) 6.3 mg/L (H1) 5.3 mg/L (M1) 7.8 mg/L (CR2) 7.5 mg/L (S2) 7.7 mg/L (S3)</p>
<p>Possible reason for Action or Limit Level Non-compliance</p>	<p>From MMO monitoring records on 27/12, two DCM barges (ESC-61 & ESC-62) and two dumb lighters (DT 12 & FTB 19) were in operations on that day. No deficiency of silt curtain was found before the start of construction activity.</p> <p>Silt curtain checking was implemented by the Contractor and checking results showed no deficiency of silt curtain was found on that day.</p> <p>Site tidiness in the present barges in the Project site were checked during weekly site inspection on 27/12, where was no major observation of improper site practice that might contribute to the increase in SS level was observed during the inspection.</p>

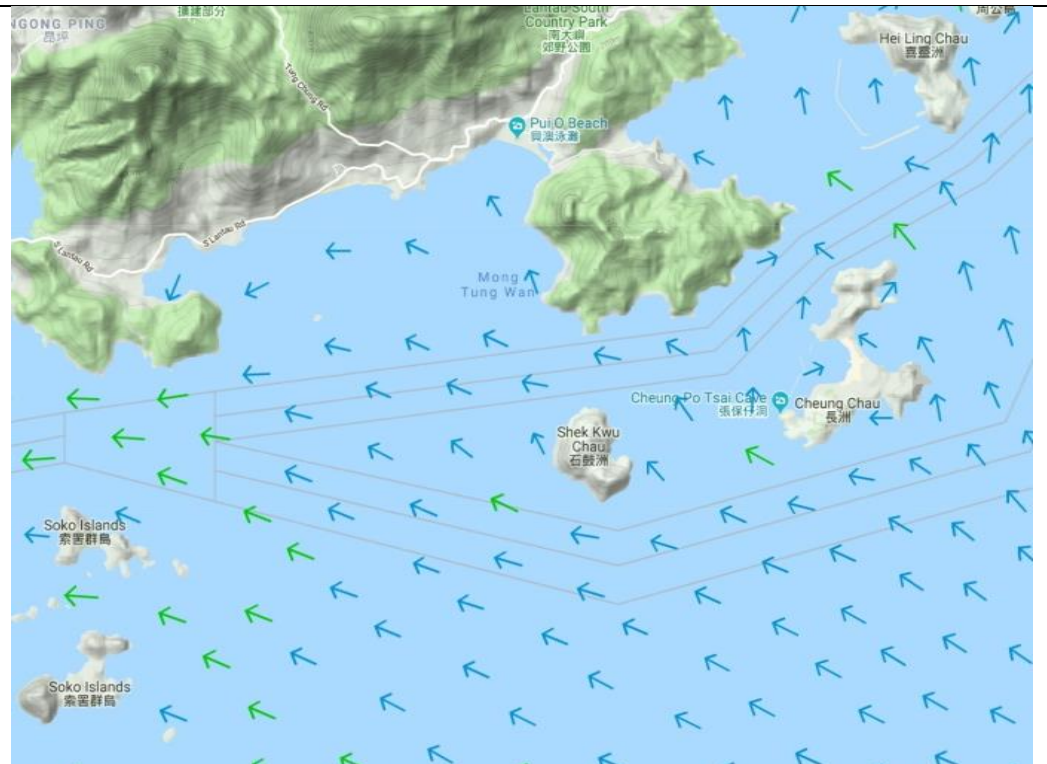
<p>Actions taken / to be taken</p>	<p>Asking the Contractor to provide more information.</p>		
<p>Remarks</p>	<p>Current direction during mid-flood sampling on 27/12:</p>

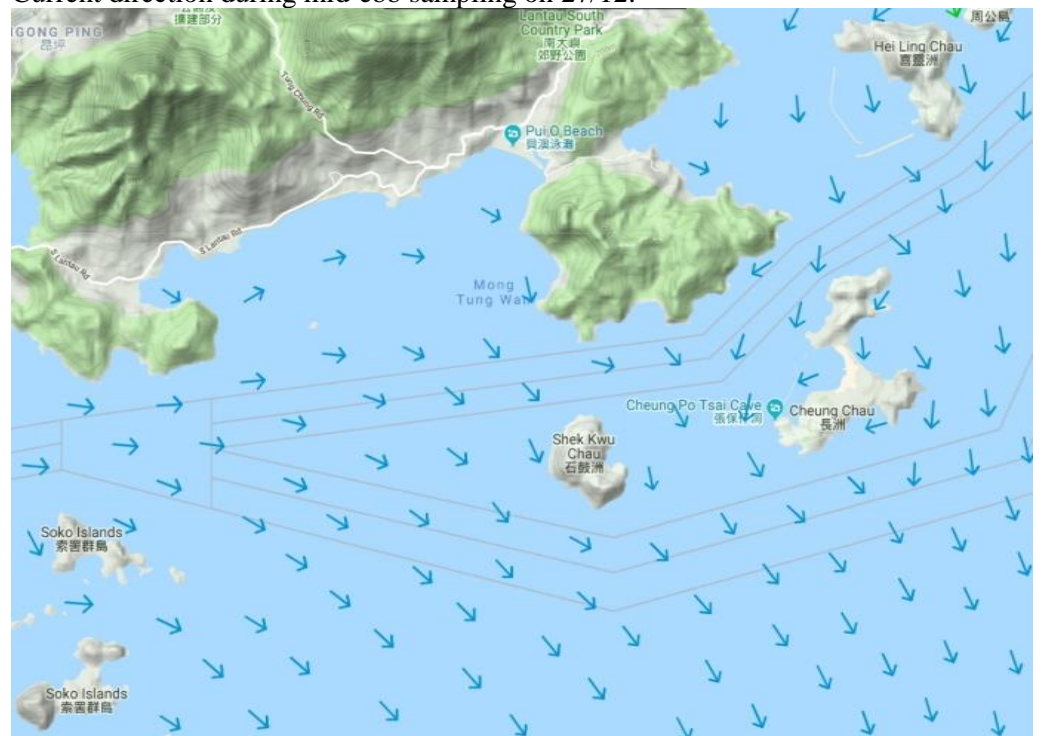
Current direction during mid-ebb sampling on 27/12:

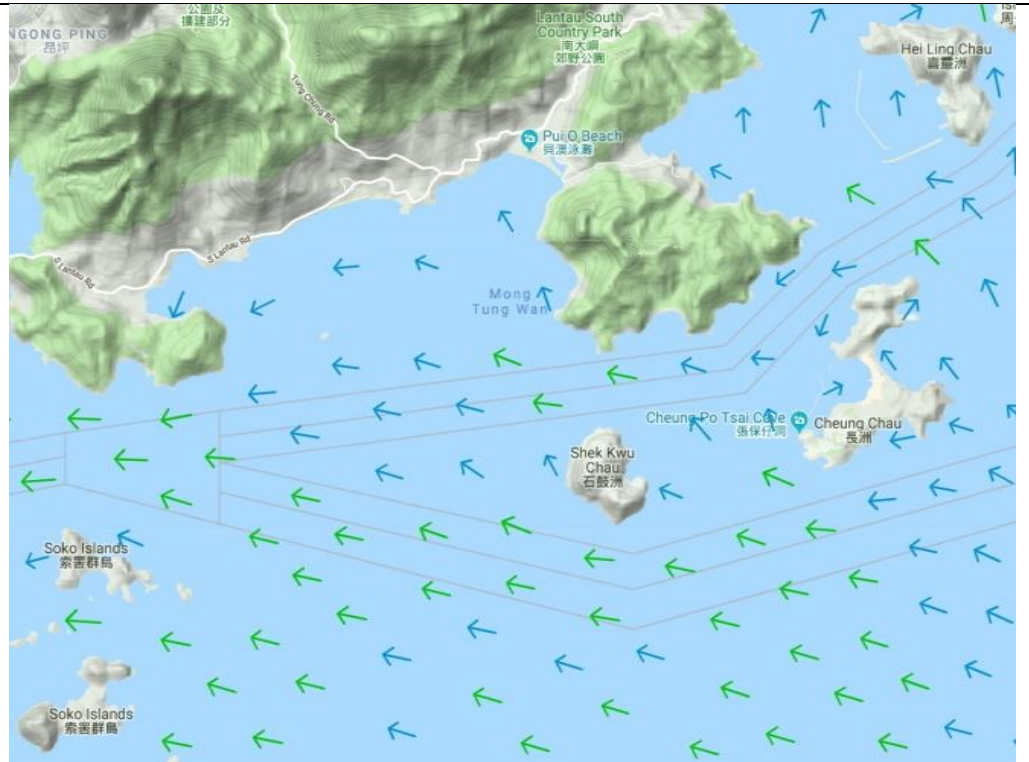
Actions taken / to be taken	Asking the Contractor to provide more information.		
Remarks	Current direction during mid-ebb sampling on 29/12:

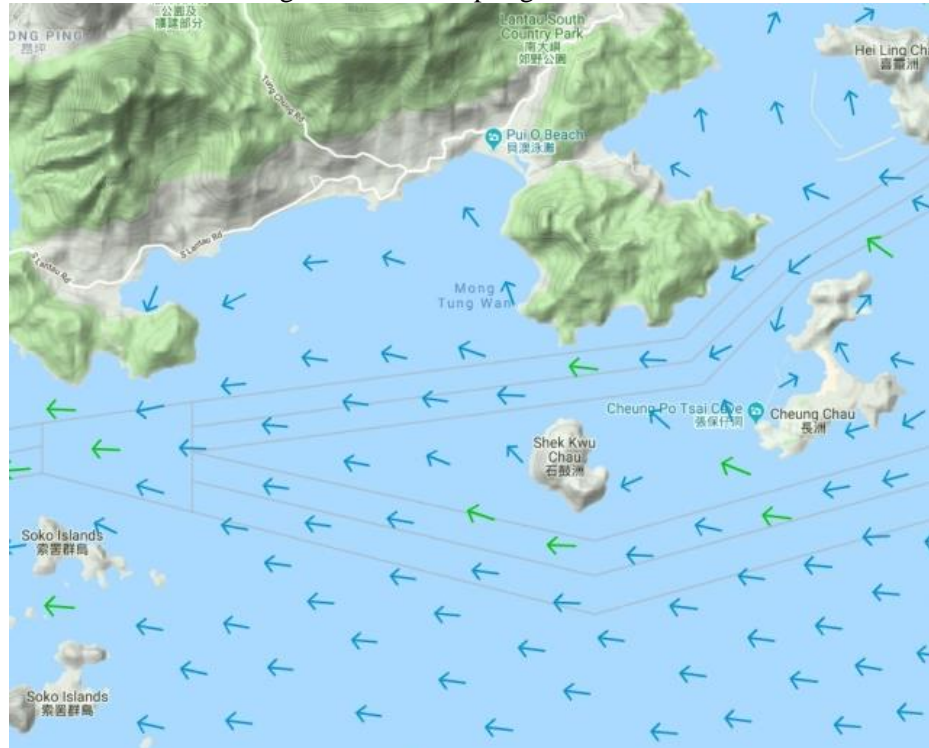
Current direction during mid-flood sampling on 31/12:
