Appendix N Exceedance Report

Incident Report on Action Level or Limit Level Non-compliance

Project	Integrated Waste Management Facilities, Phase 1		
Date	27 December 2018 (Lab result received on 05 January 2019)		
Time	08:59 – 12:29 (Mid-Flood) 14:26 – 17:56 (Mid-Ebb)		
Mid-Flood			
Monitoring Location	B1, B2, CR1 & CR2

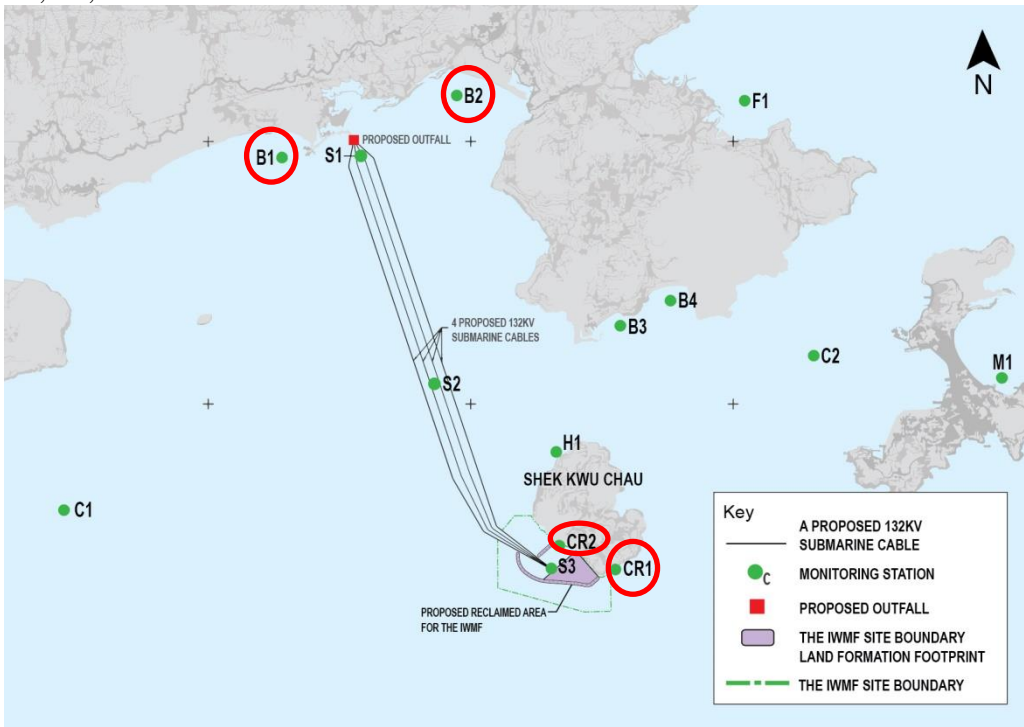
Parameter	Suspended Solid (SS)		
Action & Limit Levels	Action Level		Limit Level
	≥ 8.0 mg/L		≥ 10.0 mg/L
Measurement Level	Impact Station(s) of Exceedance	Control Stations	Impact Station(s) without Exceedance

9.3 mg/L (B1) 8.5 mg/L (B2) 9.2 mg/L (CR1) 10.3 mg/L (CR2)	7.8 mg/L (C1) 6.3 mg/L (C2)	4.0 mg/L (B3) 6.0 mg/L (B4) 6.8 mg/L (F1) 5.8 mg/L (H1) 7.2 mg/L (M1) 7.5 mg/L (S1) 7.2 mg/L (S2) 6.3 mg/L (S3)
Possible reason for Action or Limit Level Non-compliance	Works scheduled on site on 27/12 include Cone Penetration Test works, sand blanket laying at caisson seawall area and DCM cluster installation at caisson seawall area. Dominating sea current direction was found to be from Southeast to Northwest at waters around Shek Kwu Chau. B1 & B2 are located at unrelated stream direction (neither upstream nor downstream, far away) to the works location, exceedance of these monitoring locations are deemed to be unrelated to the Project. From MMO monitoring records on 27/12, two DCM barges (ESC-61 & ESC-62) and two dumb lighters (Shun Tat D12 & FTB 19) were in operations on that day. No deficiency of silt curtain was found before the start of construction activity.

<p>CR1 is located at upstream and CR2 is located close to the works location within the Project site, while silt curtain checking on ESC-61, ESC-62 & Shun Tat D12 were implemented by the Contractor and checking results showed no deficiency of silt curtain was found on that day. The sand blanket laying works scheduled in FTB19 was stopped on that day due to the damage of the cage type silt curtain. It might suggest that the high SS exceedances at CR1 & CR2 are deemed to be unrelated to the Project.</p> <p>Site tidiness in the present barges in the Project site were checked during weekly site inspection on 27/12, where was no major observation of improper site practice that might contribute to the increase in SS level was observed during the inspection.</p>		
<p>Actions taken / to be taken</p>	<p>Examination of environmental performance of the Project will be continued during the weekly inspection, and the Contractor is reminded to implement all applicable mitigation measures as per the Updated EM&A Manual.</p>

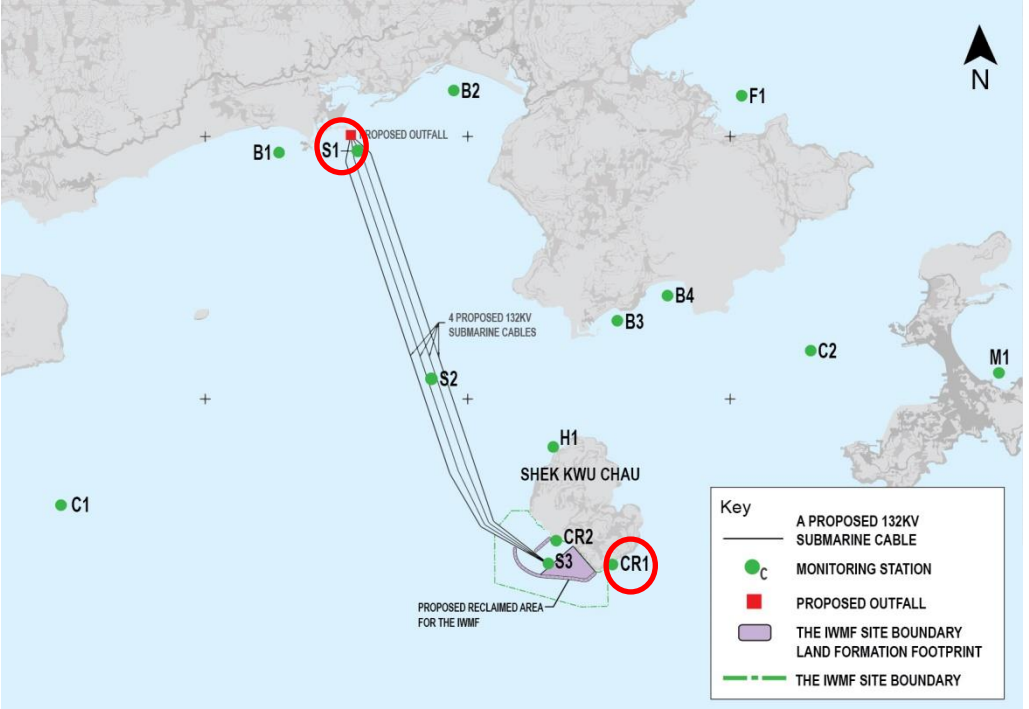
<p>Mid-Ebb</p>			
<p>Monitoring Location</p>	<p>CR1 & S1</p>

<p>The map shows the Shek Kwu Chau area with various monitoring stations marked with green dots (B1, B2, B3, B4, C1, C2, F1, H1, M1, S1, S2, S3). A red square indicates the proposed outfall. Four lines represent the proposed 132KV submarine cables. A purple shaded area shows the IWMF site boundary, and a green dashed line shows the IWMF site boundary. CR1 and S1 are circled in red.</p>		
<p>Parameter</p>	<p>Suspended Solid (SS)</p>		
<p>Action & Limit Levels</p>	<p>Action Level</p>		<p>Limit Level</p>
	<p>≥ 8.0 mg/L</p>		<p>≥ 10.0 mg/L</p>
<p>Measurement Level</p>	<p>Impact Station(s) of Exceedance</p>	<p>Control Stations</p>	<p>Impact Station(s) without Exceedance</p>
	<p>8.5 mg/L (CR1) 9.8 mg/L (S1)</p>	<p>5.5 mg/L (C1) 6.7 mg/L (C2)</p>	<p>7.3 mg/L (B1) 7.8 mg/L (B2) 7.8 mg/L (B3) 5.8 mg/L (B4) 5.8 mg/L (F1) 6.3 mg/L (H1) 5.3 mg/L (M1) 7.8 mg/L (CR2) 7.5 mg/L (S2) 7.7 mg/L (S3)</p>

<p>Dominating sea current direction was found to be from Northwest to Southeast at waters around Shek Kwu Chau.</p> <p>S1 is located at unrelated stream direction (neither upstream nor downstream, far away) to the works location, exceedance of this monitoring location is deemed to be unrelated to the Project.</p> <p>From MMO monitoring records on 27/12, two DCM barges (ESC-61 & ESC-62) and two dumb lighters (Shun Tat D12 & FTB 19) were in operations on that day. No deficiency of silt curtain was found before the start of construction activity.</p> <p>CR1 is located at downstream direction while silt curtain checking on ESC-61, ESC-62 & Shun Tat D12 were implemented by the Contractor and checking results showed no deficiency of silt curtain was found on that day. The sand blanket laying works scheduled in FTB19 was stopped on that day due to the damage of the cage type silt curtain. It might suggest that the high SS exceedance at CR1 is deemed to be unrelated to the Project.</p> <p>Site tidiness in the present barges in the Project site were checked during weekly site inspection on 27/12, where was no major observation of improper site practice that might contribute to the increase in SS level was observed during the inspection.</p>

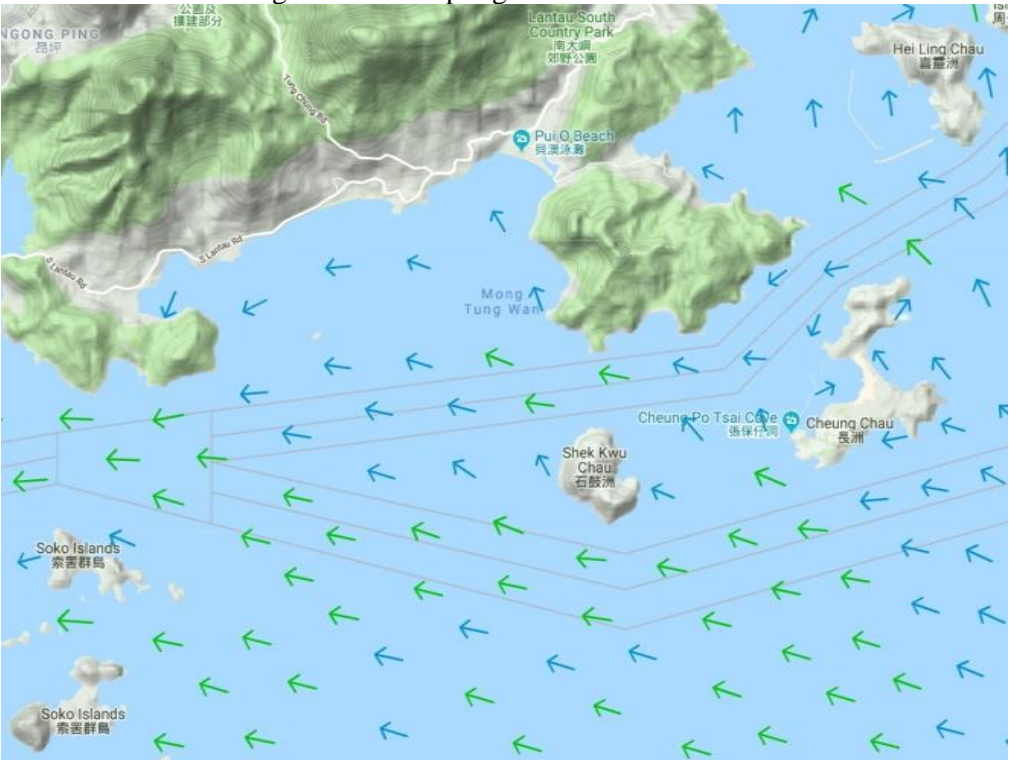
<table><tr> <th>Speed (knot)</th> <th>Direction</th> <th>Speed (knot)</th> <th>Direction</th> </tr><tr> <td>0-0.5</td> <td>Blue arrow</td> <td>1.5-2.0</td> <td>Orange arrow</td> </tr><tr> <td>0.5-1.0</td> <td>Green arrow</td> <td>2.0-2.5</td> <td>Purple arrow</td> </tr><tr> <td>1.0-1.5</td> <td>Yellow arrow</td> <td>2.5 and above</td> <td>Red arrow</td> </tr></table>

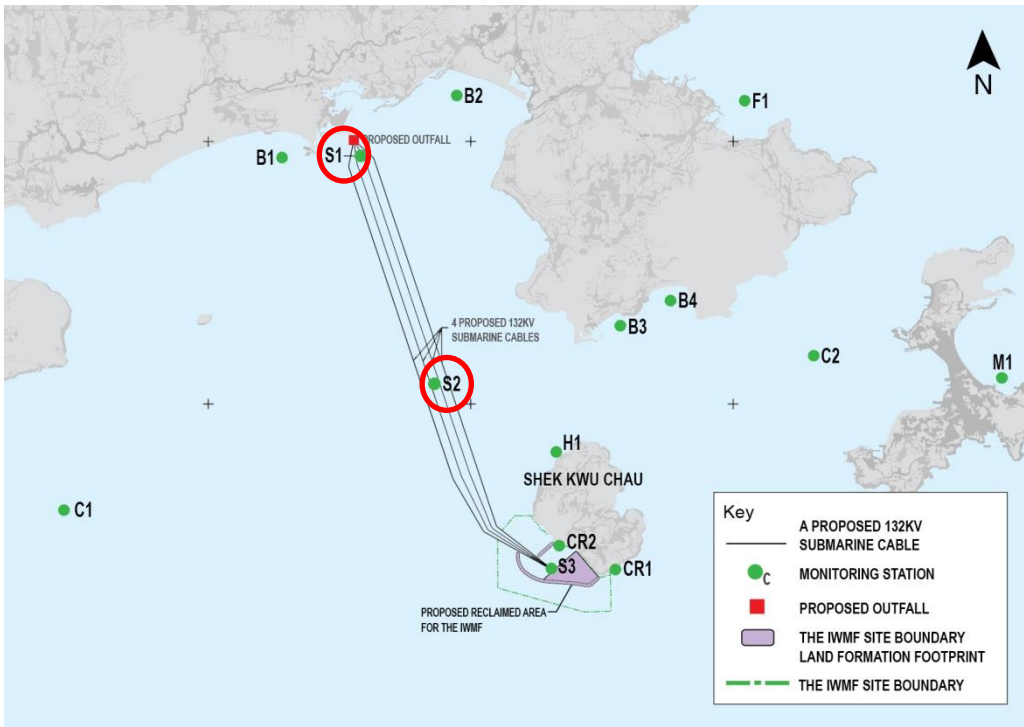
Project	Integrated Waste Management Facilities, Phase 1		
Date	31 December 2018 (Lab result received on 09 January 2019)		
Time	08:00 – 09:30 (Mid-Ebb) 12:31 – 16:00 (Mid-Flood)		
Mid-Ebb			
Monitoring Location	S1 & S2

Parameter	Suspended Solid (SS)		
Action & Limit Levels	Action Level		Limit Level
	≥ 13.2 mg/L (120% of C1)		≥ 14.3 mg/L (130% of C1)
Measurement Level	Impact Station(s) of Exceedance	Control Stations	Impact Station(s) without Exceedance

16.0 mg/L (S1) 15.5 mg/L (S2)	11.0 mg/L (C1) 8.8 mg/L (C2)	9.3 mg/L (B1) 9.0 mg/L (B2) 9.5 mg/L (B3) 10.8 mg/L (B4) 11.3 mg/L (F1) 9.5 mg/L (H1) 10.3 mg/L (M1) 11.2 mg/L (CR1) 9.5 mg/L (CR2) 11.5 mg/L (S3)
Possible reason for Action or Limit Level Non-compliance	<p>Works scheduled on site on 31/12 include Cone Penetration Test works and sand blanket laying at caisson seawall area.</p> <p>Dominating sea current direction was found to be from Northwest to Southeast at waters around Shek Kwu Chau.</p> <p>S1 & S2 are located at unrelated stream direction (neither upstream nor downstream, far away) to the works location, exceedance of these monitoring stations are deemed to be unrelated to the Project.</p> <p>From MMO monitoring records on 31/12, two DCM barges (ESC-61 & ESC-62) and</p>

<p>two dumb lighters (Shun Tat D12 & FTB 19) were in operations on that day while no deficiency of silt curtain was found before the start of construction activity.</p> <p>Silt curtain checking on FTB-19 & Shun Tat D12 were implemented by the Contractor and checking results showed no deficiency of silt curtain was found on that day. The DCM installation works scheduled in ESC-61 & ESC-62 were suspended on that day due to adverse weather condition.</p> <p>Site tidiness in the present barges in the Project site were checked during weekly site inspection on 27/12, where was no major observation of improper site practice that might contribute to the increase in SS level was observed during the inspection.</p>		
<p>Actions taken / to be taken</p>	<p>Examination of environmental performance of the Project will be continued during the weekly inspection, and the Contractor is reminded to implement all applicable mitigation measures as per the Updated EM&A Manual.</p>

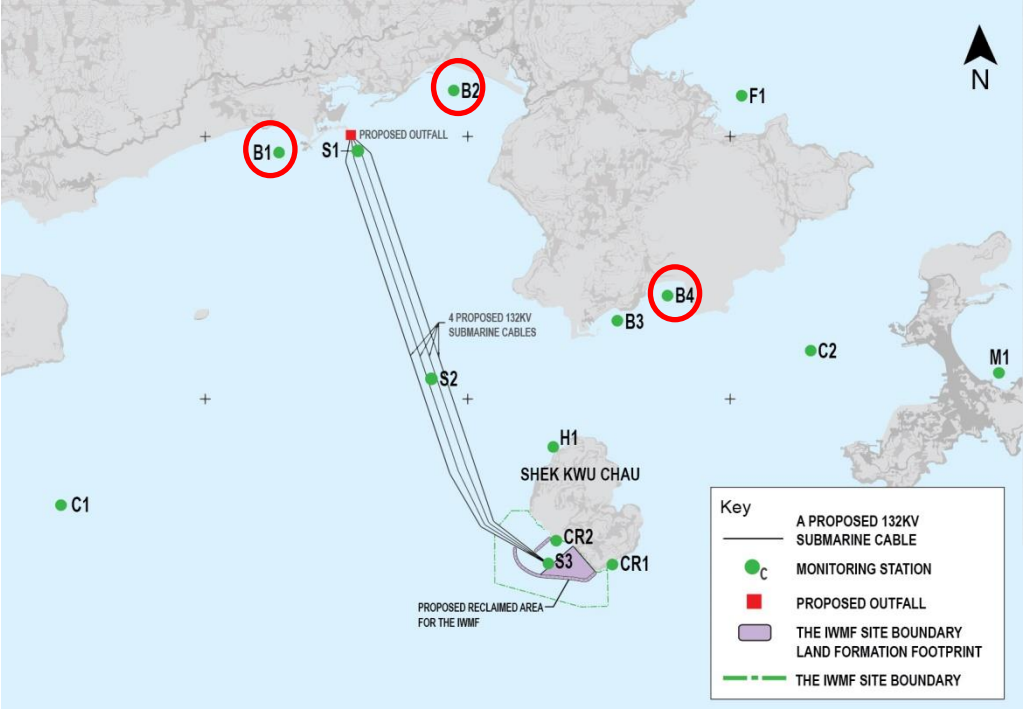
<p>Mid-Flood</p>			
<p>Monitoring Location</p>	<p>B1, B2 & B4</p>

<p>Parameter</p>	<p>Suspended Solid (SS)</p>		
<p>Action & Limit Levels</p>	<p>Action Level</p>		<p>Limit Level</p>
	<p>≥ 13.8 mg/L (120% of C2)</p>		<p>≥ 15.0 mg/L (130% of C2)</p>
<p>Measurement Level</p>	<p>Impact Station(s) of Exceedance</p>	<p>Control Stations</p>	<p>Impact Station(s) without Exceedance</p>
	<p>16.0 mg/L (B1) 15.8 mg/L (B2) 16.3 mg/L (B4)</p>	<p>11.2 mg/L (C1) 11.5 mg/L (C2)</p>	<p>11.8 mg/L (B3) 12.2 mg/L (F1) 13.3 mg/L (H1) 10.8 mg/L (M1) 7.8 mg/L (CR1) 11.8 mg/L (CR2) 12.5 mg/L (S1) 13.0 mg/L (S2) 12.0 mg/L (S3)</p>
<p>Possible reason for Action or Limit Level Non-compliance</p>	<p>Works scheduled on site on 31/12 include Cone Penetration Test works and sand blanket laying at caisson seawall area.</p> <p>Dominating sea current direction was found to be from Southeast to Northwest at</p>

<p>waters around Shek Kwu Chau.</p> <p>B1, B2 & B4 are located at unrelated stream direction (neither upstream nor downstream, far away) to the works location, exceedance of these monitoring locations are deemed to be unrelated to the Project.</p> <p>From MMO monitoring records on 31/12, two DCM barges (ESC-61 & ESC-62) and two dumb lighters (Shun Tat D12 & FTB 19) were in operations on that day while no deficiency of silt curtain was found before the start of construction activity.</p> <p>Silt curtain checking on Shun Tat D12 & FTB-19 were implemented by the Contractor and checking results showed no deficiency of silt curtain was found on that day. The DCM installation works scheduled in ESC-61 & ESC-62 were suspended on that day due to adverse weather condition.</p> <p>Site tidiness in the present barges in the Project site were checked during weekly site inspection on 27/12, where was no major observation of improper site practice that might contribute to the increase in SS level was observed during the inspection.</p>

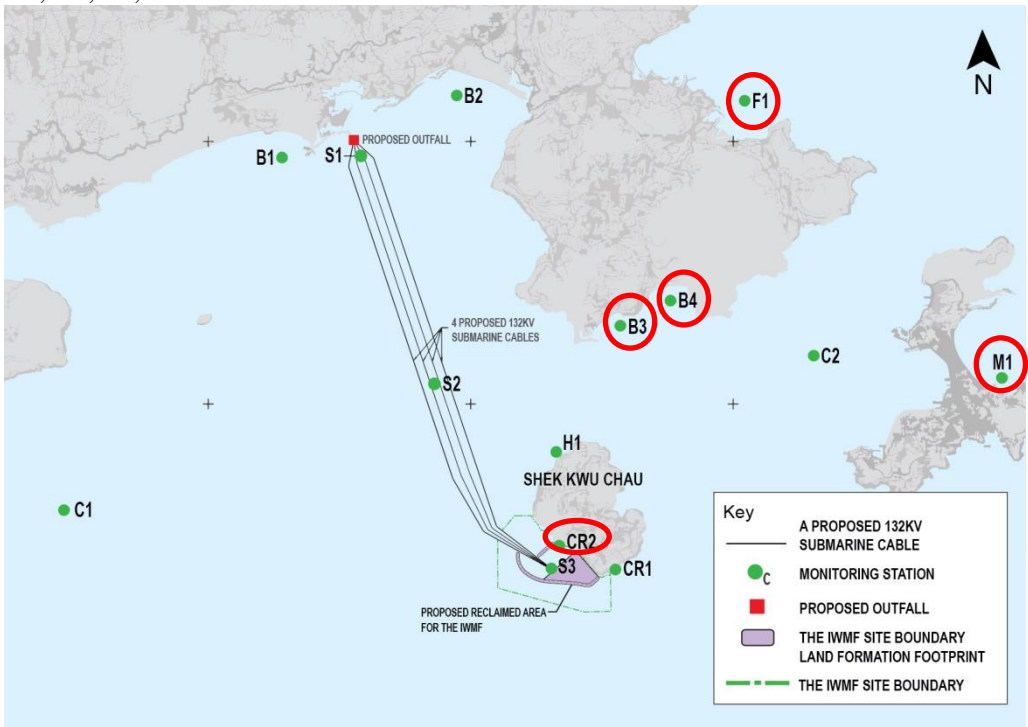
Project	Integrated Waste Management Facilities, Phase 1		
Date	02 January 2019 (Lab result received on 09 January 2019)		
Time	08:07 – 11:37 (Mid-Ebb) 13:49 – 17:19 (Mid-Flood)		
Mid-Ebb			
Monitoring Location	B3, B4, F1, M1 & CR2

Parameter	Suspended Solid (SS)		
Action & Limit Levels	Action Level		Limit Level
	≥ 9.6 mg/L (120% of C1)		≥ 10.4 mg/L (130% of C1)
Measurement Level	Impact Station(s) of Exceedance	Control Stations	Impact Station(s) without Exceedance

16.5 mg/L (B3) 14.5 mg/L (B4) 15.5 mg/L (F1) 17.0 mg/L (M1) 11.0 mg/L (CR2)	8.0 mg/L (C1) 15.7 mg/L (C2)	7.3 mg/L (B1) 7.8 mg/L (B2) 9.2 mg/L (H1) 8.3 mg/L (CR1) 8.0 mg/L (S1) 9.0 mg/L (S2) 9.0 mg/L (S3)
Possible reason for Action or Limit Level Non-compliance	<p>Works scheduled on site on 02/01 include ground investigation (GI) work of Borehole drilling, Cone Penetration Test work at Static Loading Test area and sand blanket laying at caisson seawall area.</p> <p>Dominating sea current direction was found to be from Northwest to Southeast at waters around Shek Kwu Chau.</p> <p>B3, B4, F1 & M1 are located at unrelated stream direction (neither upstream nor downstream, far away) to the works location, exceedance of these monitoring stations are deemed to be unrelated to the Project.</p> <p>From MMO monitoring records on 02/01, MMO teams were arranged to one DCM barges (ESC-61) and two derrick barges (Shun Tat D12 & FTB 19) on that day while no deficiency of silt curtain was found before the start of construction activity.</p>

<p>CR2 is located close to the works location within the Project site while silt curtain checking on ESC-61 (09:45 & 16:45) & Shun Tat D12 (09:00) were implemented by the Contractor and checking results showed that no deficiency of silt curtain was found on that day. The DCM installation works scheduled in ESC-61 were suspended due to high swell and deteriorating weather condition on site. It might suggest that the high SS exceedance at CR2 is deemed to be unrelated to the Project.</p> <p>Site tidiness in the present barges in the Project site were checked during weekly site inspection on 02/01, where was no improper site practice that might contribute to the increase in SS level was observed during the inspection.</p>		
<p>Actions taken / to be taken</p>	<p>Examination of environmental performance of the Project will be continued during the weekly inspection, and the Contractor is remained to implement all applicable mitigation measures as per the Updated EM&A Manual.</p>

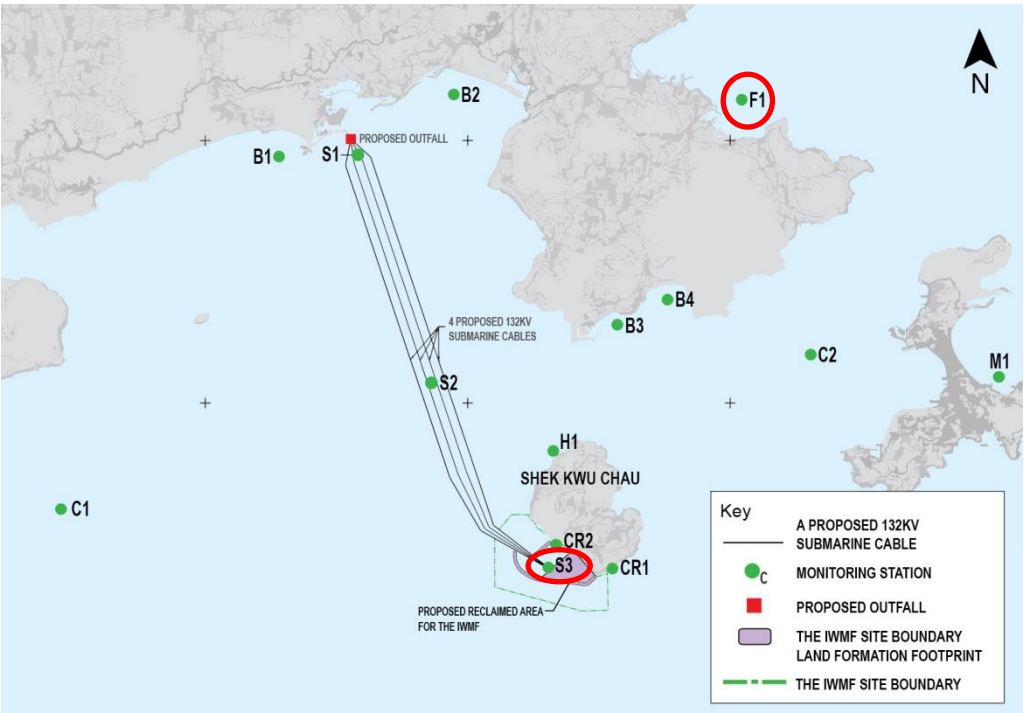
<p>Mid-Flood</p>			
<p>Monitoring Location</p>	<p>F1 & S3</p>

<p>The map shows the project site with various monitoring stations marked with green dots. A red square indicates the proposed outfall. Four blue lines represent the proposed 132KV submarine cables. A red circle highlights monitoring station F1, and another red circle highlights station S3. The map also shows the IWMF site boundary and land formation footprint.</p>		
<p>Parameter</p>	<p>Suspended Solid (SS)</p>		
<p>Action & Limit Levels</p>	<p>Action Level</p>		<p>Limit Level</p>
	<p>≥ 15.4 mg/L (120% of C2)</p>		<p>≥ 16.7 mg/L (130% of C2)</p>
<p>Measurement Level</p>	<p>Impact Station(s) of Exceedance</p>	<p>Control Stations</p>	<p>Impact Station(s) without Exceedance</p>
	<p>16.7 mg/L (F1) 16.7 mg/L (S3)</p>	<p>10.0 mg/L (C1) 12.8 mg/L (C2)</p>	<p>7.8 mg/L (B1) 10.0 mg/L (B2) 14.0 mg/L (B3) 15.0 mg/L (B4) 15.0 mg/L (H1) 13.5 mg/L (M1) 8.3 mg/L (CR1) 6.8 mg/L (CR2) 12.5 mg/L (S1) 14.7 mg/L (S2)</p>

<p>Dominating sea current direction was found to be from Southeast to Northwest at waters around Shek Kwu Chau.</p> <p>F1 is located at unrelated stream direction (neither upstream nor downstream, far away) to the works location, exceedance of this monitoring station is deemed to be unrelated to the Project.</p> <p>From MMO monitoring records on 02/01, MMO teams were arranged to one DCM barges (ESC-61) and two derrick barges (Shun Tat D12 & FTB 19) on that day while no deficiency of silt curtain was found before the start of construction activity.</p> <p>S3 is located close to the works location within the Project site while silt curtain checking on ESC-61 (09:45 & 16:45) & Shun Tat D12 (09:00) were implemented by the Contractor and checking results showed that no deficiency of silt curtain was found on that day. The DCM installation works scheduled in ESC-61 were suspended due to high swell and deteriorating weather condition on site. It might suggest that the high SS exceedance at S3 is deemed to be unrelated to the Project.</p> <p>Site tidiness in the present barges in the Project site were checked during weekly site inspection on 02/01, where was no improper site practice that might contribute to the increase in SS level was observed during the inspection.</p>

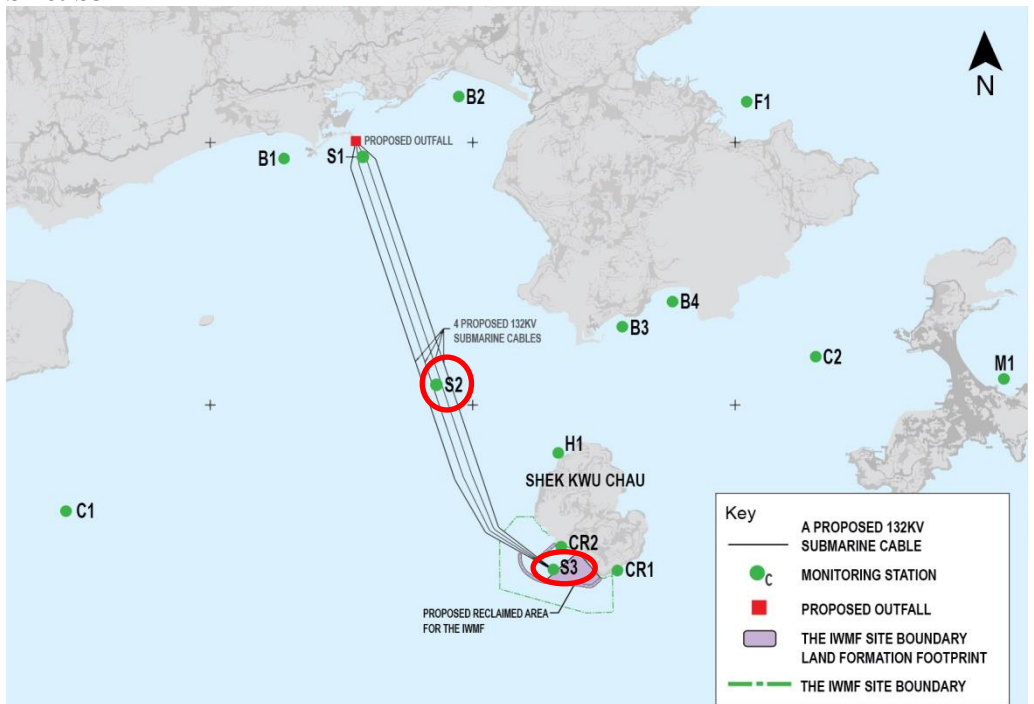
<p>Mid-Flood</p>			
<p>Monitoring Location</p>	<p>S2 & S3</p>

<p>Parameter</p>	<p>Suspended Solid (SS)</p>		
<p>Action & Limit Levels</p>	<p>Action Level</p>		<p>Limit Level</p>
	<p>≥ 8.0 mg/L</p>		<p>≥ 10.0 mg/L</p>
<p>Measurement Level</p>	<p>Impact Station(s) of Exceedance</p>	<p>Control Stations</p>	<p>Impact Station(s) without Exceedance</p>
	<p>9.8 mg/L (S2) 12.2 mg/L (S3)</p>	<p>6.0 mg/L (C1) 6.3 mg/L (C2)</p>	<p>6.5 mg/L (B1) 6.0 mg/L (B2) 3.8 mg/L (B3) 6.3 mg/L (B4) 7.0 mg/L (F1) 5.2 mg/L (H1) 6.0 mg/L (M1) 6.7 mg/L (CR1) 6.7 mg/L (CR2) 7.3 mg/L (S1)</p>

<p>Possible reason for Action or Limit Level Non-compliance</p>	<p>Works scheduled on site on 04/01 include ground investigation (GI) work of borehole drilling, DCM main works and sand blanket laying at caisson seawall area.</p> <p>Dominating sea current direction was found to be from Southeast to Northwest at waters around Shek Kwu Chau.</p> <p>S2 is located at unrelated stream direction (neither upstream nor downstream, far away) to the works location, exceedance of this monitoring station is deemed to be unrelated to the Project.</p> <p>From MMO monitoring records on 02/01, MMO teams were arranged to one DCM barge (ESC-61) on that day while no deficiency of silt curtain was found before the start of construction activity.</p> <p>S3 is located close to the works location within the Project site while silt curtain checking on ESC-61 (15:45) was implemented by the Contractor and checking results showed that no deficiency of silt curtain was found on that day. The DCM main works scheduled in ESC-61 & ESC-62 were suspended due to high swell and deteriorating weather condition. The sand blanket laying at caisson seawall area scheduled in Shun Tat D12 was suspended due to maintenance works for the derrick barge D12. The absence of works and above rationales might suggest that the high SS exceedance at S3 is deemed to be unrelated to the Project.</p> <p>Site tidiness in the present barges in the Project site were checked during weekly site inspection on 02/01, where was no improper site practice that might contribute to the increase in SS level was observed during the inspection.</p>

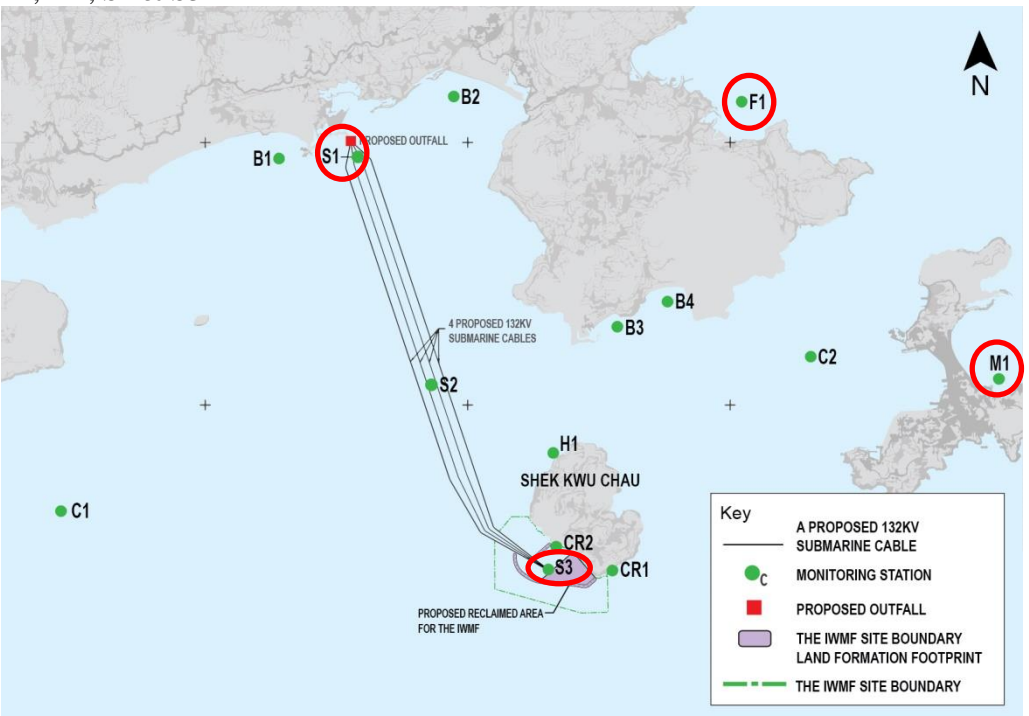
<p>Mid-Ebb</p>			
<p>Monitoring Location</p>	<p>F1, M1, S1 & S3</p>

<p>Parameter</p>	<p>Suspended Solid (SS)</p>		
<p>Action & Limit Levels</p>	<p>Action Level</p>		<p>Limit Level</p>
	<p>≥ 9.2 mg/L (120% of C1)</p>		<p>≥ 10.0 mg/L</p>
<p>Measurement Level</p>	<p>Impact Station(s) of Exceedance</p>	<p>Control Stations</p>	<p>Impact Station(s) without Exceedance</p>
	<p>9.5 mg/L (F1) 10.5 mg/L (M1) 10.8 mg/L (S1) 10.8 mg/L (S3)</p>	<p>7.7 mg/L (C1) 7.3 mg/L (C2)</p>	<p>5.8 mg/L (B1) 5.8 mg/L (B2) 8.0 mg/L (B3) 6.0 mg/L (B4) 8.2 mg/L (H1) 7.8 mg/L (CR1) 8.3 mg/L (CR2) 7.3 mg/L (S2)</p>
<p>Possible reason for Action or Limit Level Non-compliance</p>	<p>Works scheduled on site on 14/01 include ground investigation (GI) work of borehole drilling, Cone Penetration Test work, sand blanket and geotextile laying at caisson</p>

<p>seawall area and DCM main works.</p> <p>Dominating sea current direction was found to be from Northwest to Southeast at waters around Shek Kwu Chau.</p> <p>F1, M1 & S1 are located at unrelated stream direction (neither upstream nor downstream, far away) to the works location, exceedance of these monitoring stations are deemed to be unrelated to the Project.</p> <p>From MMO monitoring records on 14/01, MMO teams were arranged to one DCM barges (ESC-61) and two derrick barges (Shun Tat D12 & FTB-19) on that day while no deficiency of silt curtain was found before the start of construction activity.</p> <p>S3 is located close to the works location within the Project site while silt curtain checking was implemented on ESC-61 (07:00), FTB-19 (07:00) and Shun Tat D12 (09:30) by the Contractor and checking results showed that no deficiency of silt curtain was found on that day. The DCM main works scheduled in ESC-62 was suspended due to adverse wave condition. No sand blanket laying scheduled in Shun Tat D12 was carried out on that day. It might suggest that the high SS exceedance at S3 is deemed to be unrelated to the Project.</p> <p>Site tidiness in the present barges in the Project site were checked during weekly site inspection on 15/01, where was no major observation of improper site practice that might contribute to the increase in SS level was observed during the inspection.</p>

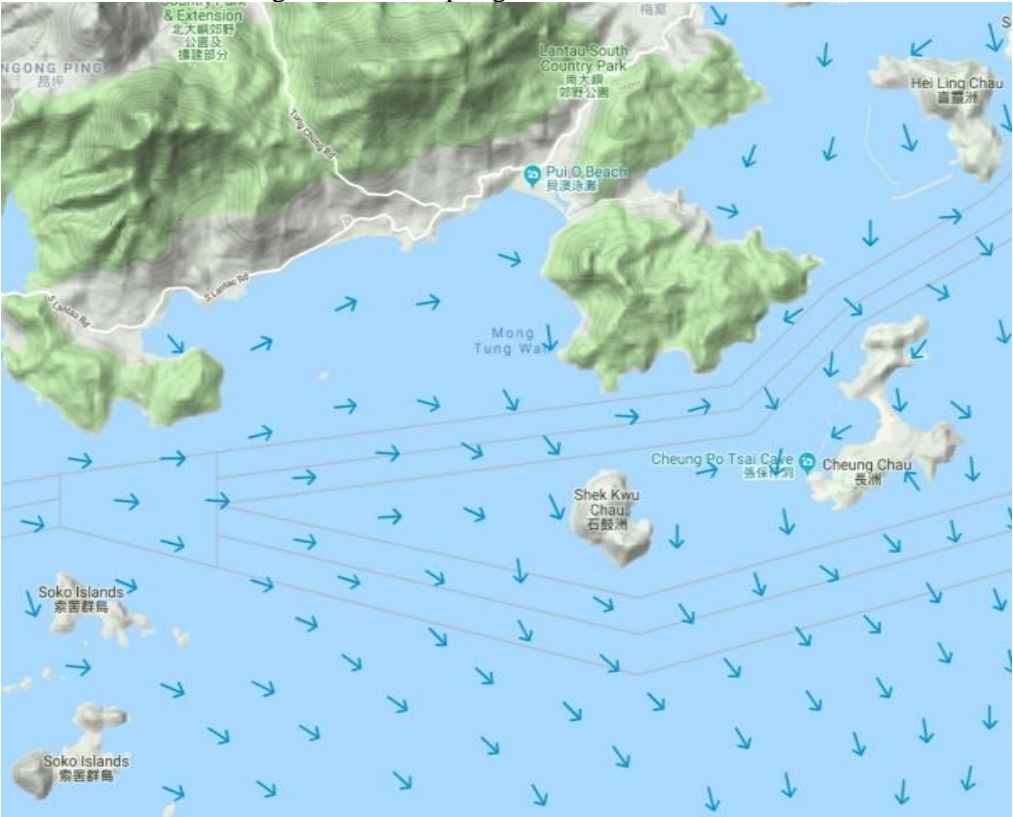
<p>Actions taken / to be taken</p>	<p>Examination of environmental performance of the Project will be continued during the weekly inspection, and the Contractor is remained to implement all applicable mitigation measures as per the Updated EM&A Manual.</p>
<p>Remarks</p>	<p>Current direction during mid-ebb sampling on 14/01:</p>

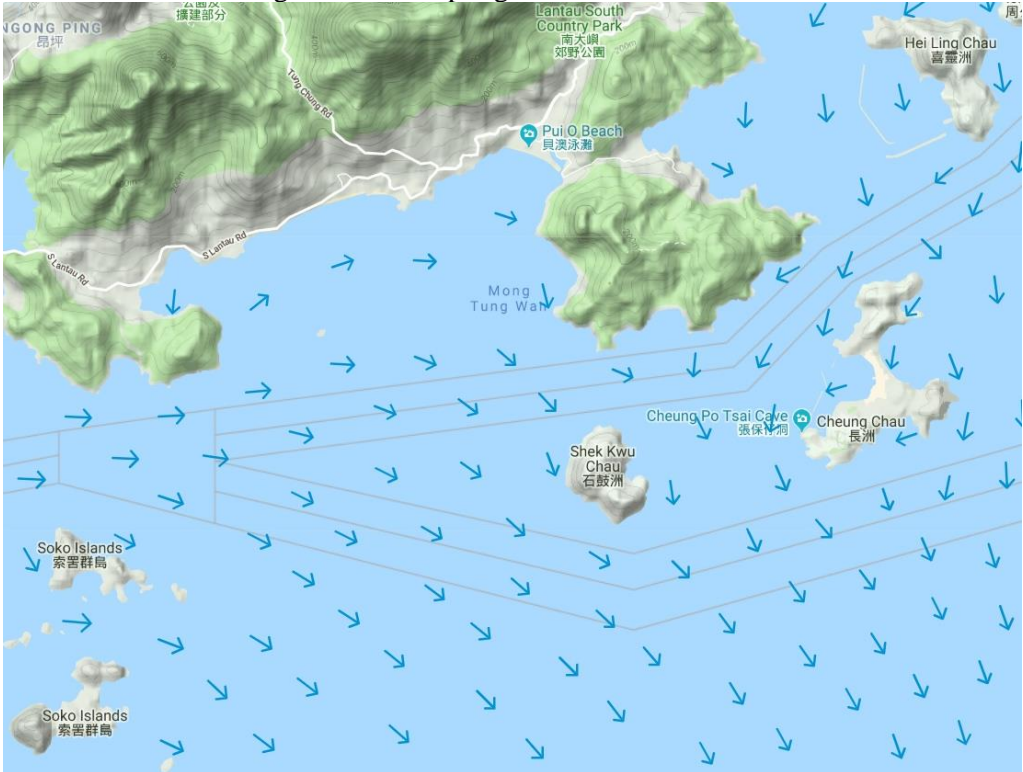
<p>Remarks</p>	<p>Current direction during mid-ebb sampling on 16/01:</p>

<p>(Sourced from http://current.hydro.gov.hk/en/map.html)</p>
<p>Prepared by</p>	<p>Polar Chan</p>
<p>Date</p>	<p>24 January 2019</p>

<p>CR1 is located at downstream monitoring station, CR2 & S3 are located close to the works location within the Project site while silt curtain checking was implemented on FTB-19 (07:30), Shun Tat D12 (09:00) & ESC-61 (12:55) by the Contractor and checking results showed that no deficiency of silt curtain was found on that day. The DCM main works scheduled in ESC-62 was suspended due to adverse wave condition. It might suggest that the high SS exceedances at CR1, CR2 & S3 are deemed to be unrelated to the Project.</p> <p>Site tidiness in the present barges in the Project site were checked during weekly site inspection on 15/01, where was no major observation of improper site practice that might contribute to the increase in SS level was observed during the inspection.</p>
<p>Actions taken / to be taken</p>	<p>Examination of environmental performance of the Project will be continued during the weekly inspection, and the Contractor is remained to implement all applicable mitigation measures as per the Updated EM&A Manual.</p>

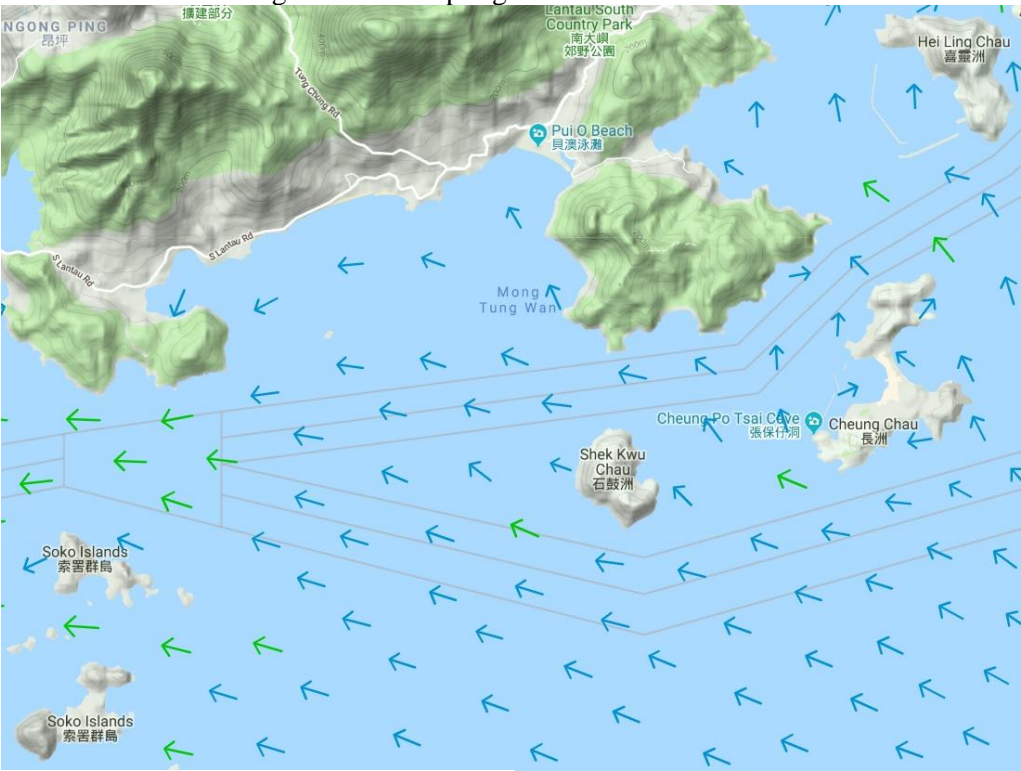
<p>Actions taken / to be taken</p>	<p>Examination of environmental performance of the Project will be continued during the weekly inspection, and the Contractor is remained to implement all applicable mitigation measures as per the Updated EM&A Manual.</p>
<p>Remarks</p>	<p>Current direction during mid-ebb sampling on 18/01:</p>

<p>(Sourced from http://current.hydro.gov.hk/en/map.html)</p>
<p>Prepared by</p>	<p>Polar Chan</p>
<p>Date</p>	<p>29 January 2019</p>

<p>From MMO monitoring records on 18/01, MMO teams were arranged to two DCM barges (ESC-61 & ESC-62) and two derrick barges (Shun Tat D12 & FTB-19) on that day while no deficiency of silt curtain was found before the start of construction activity.</p> <p>Silt curtain checking was implemented on FTB-19 (07:30), Shun Tat D12 (09:30) & ESC-61 (07:10) by the Contractor and checking results showed that no deficiency of silt curtain was found on that day. The DCM main works scheduled in ESC-62 was suspended due to adverse wave condition. No sand blanket laying at reclamation area scheduled in Shun Tat D12 was carried out on that day due to high swell and adverse wave condition.</p> <p>Site tidiness in the present barges in the Project site were checked during weekly site inspection on 15/01, where was no major observation of improper site practice that might contribute to the increase in SS level was observed during the inspection.</p>

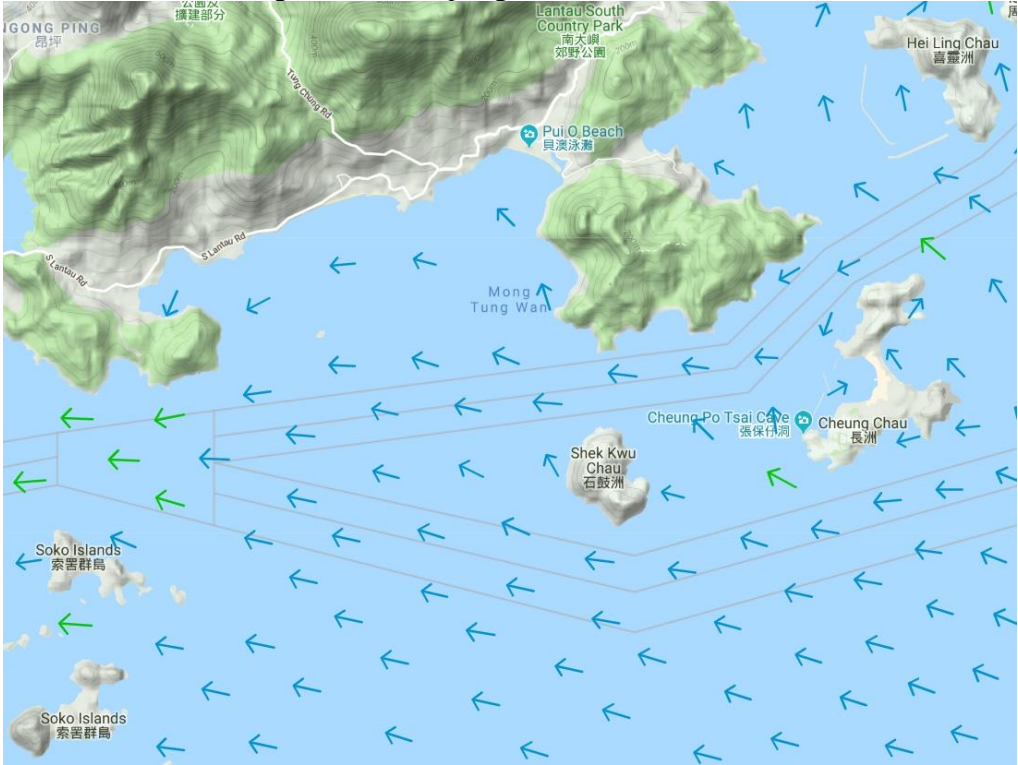
<p>Remarks</p>	<p>Current direction during mid-ebb sampling on 23/01:</p>

<p>(Sourced from http://current.hydro.gov.hk/en/map.html)</p>

<p>H1 is located at downstream location to the works location while silt curtain checking was implemented on FTB-19 (07:00), Shun Tat D12 (10:30), Shun Tat D32 (11:30), ESC-61 (07:08) & ESC-62 (07:10) by the Contractor and checking results showed that no deficiency of silt curtain was found on that day. It might suggest that the high SS exceedance at H1 is deemed to unrelated to the Project.</p> <p>Site tidiness in the present barges in the Project site were checked during weekly site inspection on 24/01, where was no major observation of improper site practice that might contribute to the increase in SS level was observed during the inspection.</p>
<p>Actions taken / to be taken</p>	<p>Examination of environmental performance of the Project will be continued during the weekly inspection, and the Contractor is remained to implement all applicable mitigation measures as per the Updated EM&A Manual.</p>

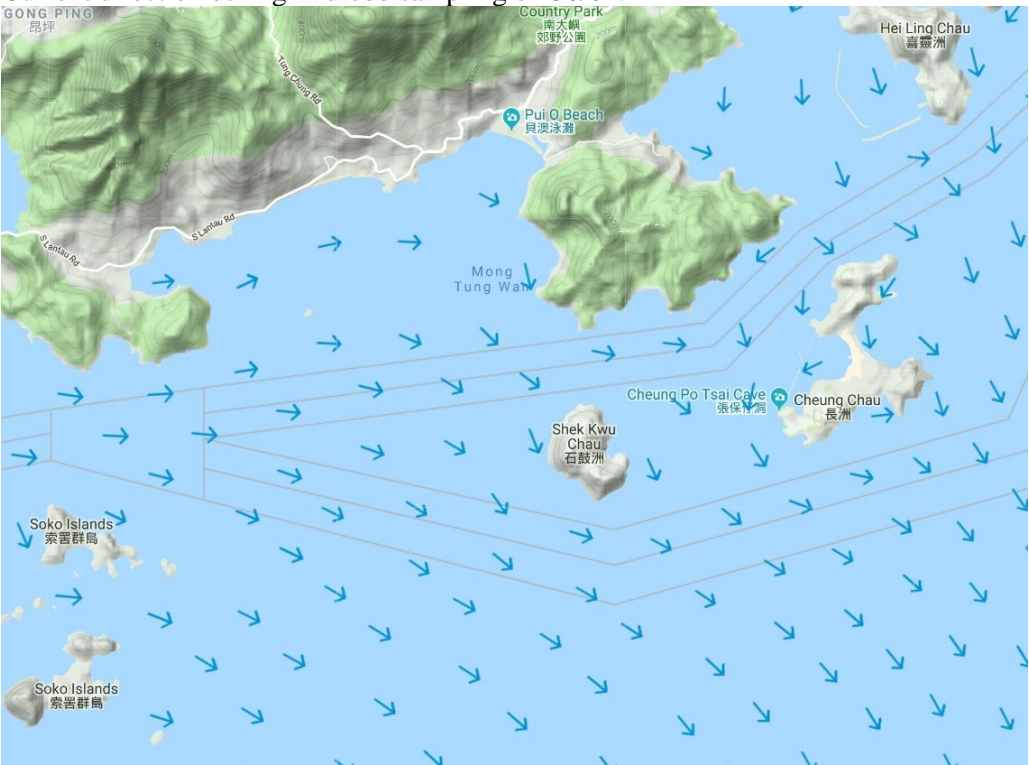
<p>Remarks</p>	<p>Current direction during mid-ebb sampling on 30/01:</p>

<p>(Sourced from http://current.hydro.gov.hk/en/map.html)</p>
<p>Prepared by</p>	<p>Polar Chan</p>
<p>Date</p>	<p>13 February 2019</p>

<p> barges (ESC-61 & ESC-62) and two derrick barges (Shun Tat D12 & FTB-19) on that day while no deficiency of silt curtain was found before the start of construction activity.</p> <p>Silt curtain checking was implemented on Shun Tat D12 (09:31), FTB-19 (10:00), ESC-61 (07:10) & ESC-62 (07:10) by the Contractor and checking results showed that no deficiency of silt curtain was found on that day.</p> <p>Site tidiness in the present barges in the Project site were checked during weekly site inspection on 29/01, where was no major observation of improper site practice that might contribute to the increase in SS level was observed during the inspection.</p>
<p>Actions taken / to be taken</p>	<p>Examination of environmental performance of the Project will be continued during the weekly inspection, and the Contractor is remained to implement all applicable mitigation measures as per the Updated EM&A Manual.</p>
