Appendix N Exceedance Report

Statistical Summary of Exceedances in the Reporting Period

Incident Report on Action Level or Limit Level Non-compliance

Project	Integrated Waste Management Facilities, Phase 1		
Date	1 February 2019 (Lab result received on 15 February 2019)		
Time	13:55 – 17:25 (Mid-Flood)		
Monitoring Location	Mid-Flood		
Monitoring Location	<p>M1</p> <p>The map shows the Shek Kwu Chau area with various monitoring stations (B1-F1, C1-C2, H1, CR1-CR2, S1-S3) and a proposed outfall (S1). It also indicates the location of 4 proposed 132KV submarine cables and a proposed reclaimed area for the IWMF. Station M1 is highlighted with a red circle.</p>		
Parameter	Suspended Solid (SS)		
Action & Limit Levels	Action Level		Limit Level
	≥ 8.0 mg/L		≥ 10.0 mg/L
Measurement Level	Impact Station(s) of Exceedance	Control Stations	Impact Station(s) without Exceedance

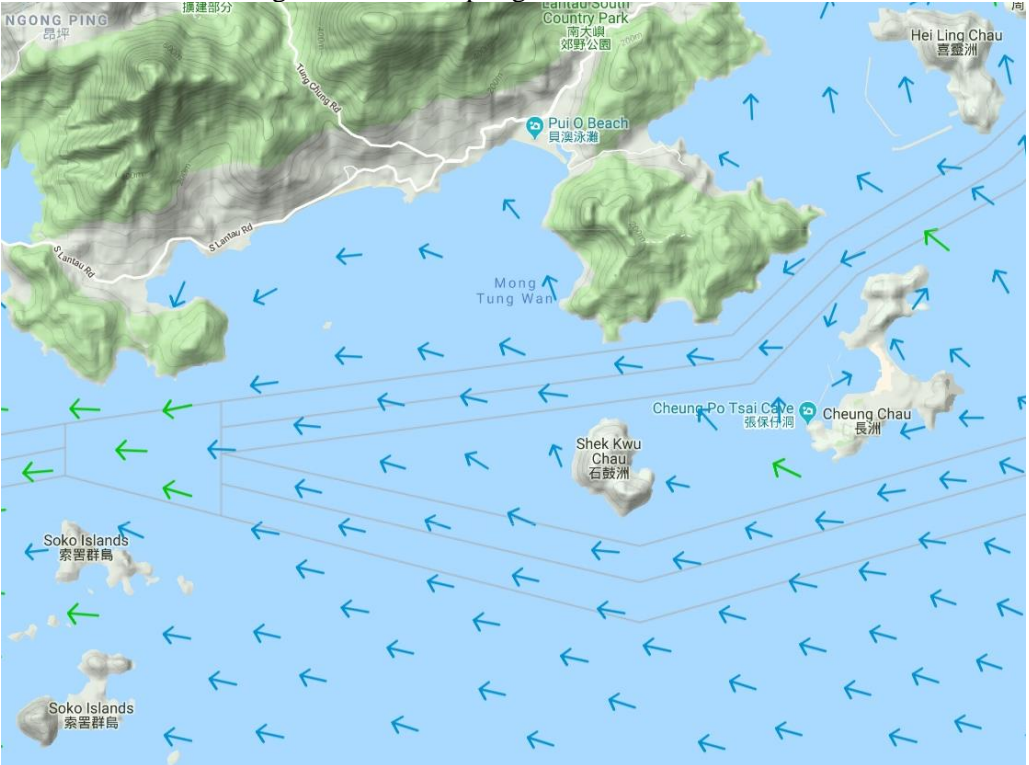
<p>Remarks</p>	<p>Current direction during mid-flood sampling on 01/02:</p>

<p>(Sourced from http://current.hydro.gov.hk/en/map.html)</p>

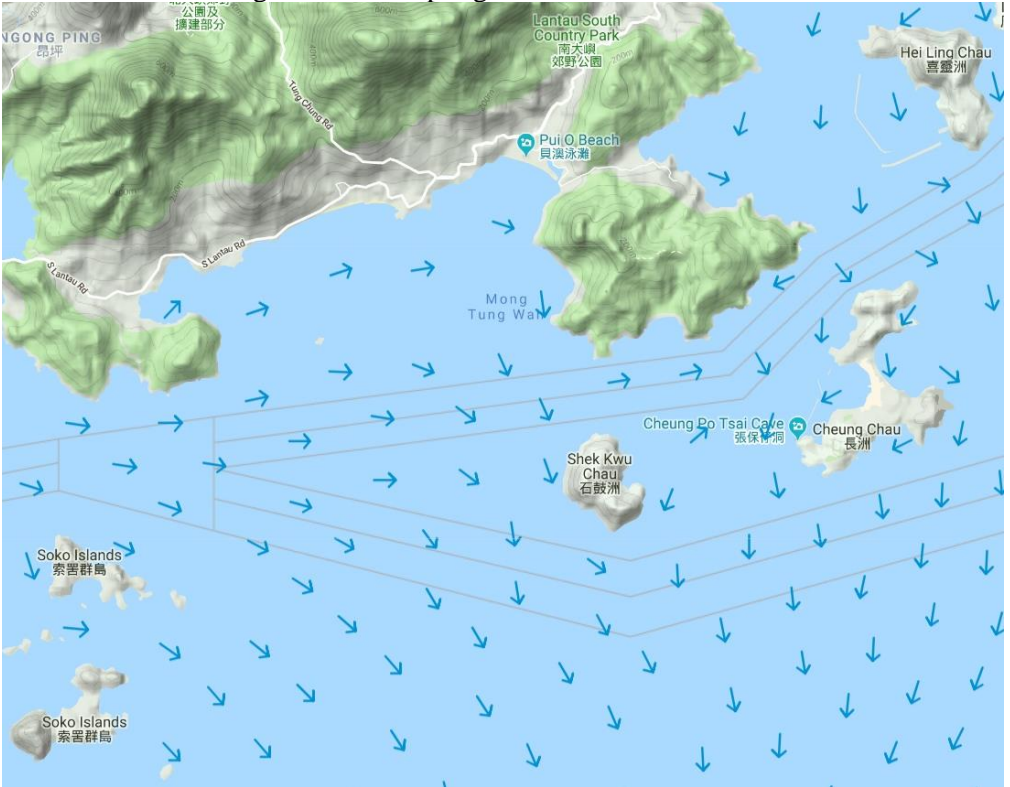
<p>Remarks</p>	<p>Current direction during mid-ebb sampling on 04/02:</p>

<p>(Sourced from http://current.hydro.gov.hk/en/map.html)</p>
<p>Prepared by</p>	<p>Polar Chan</p>
<p>Date</p>	<p>18 February 2019</p>

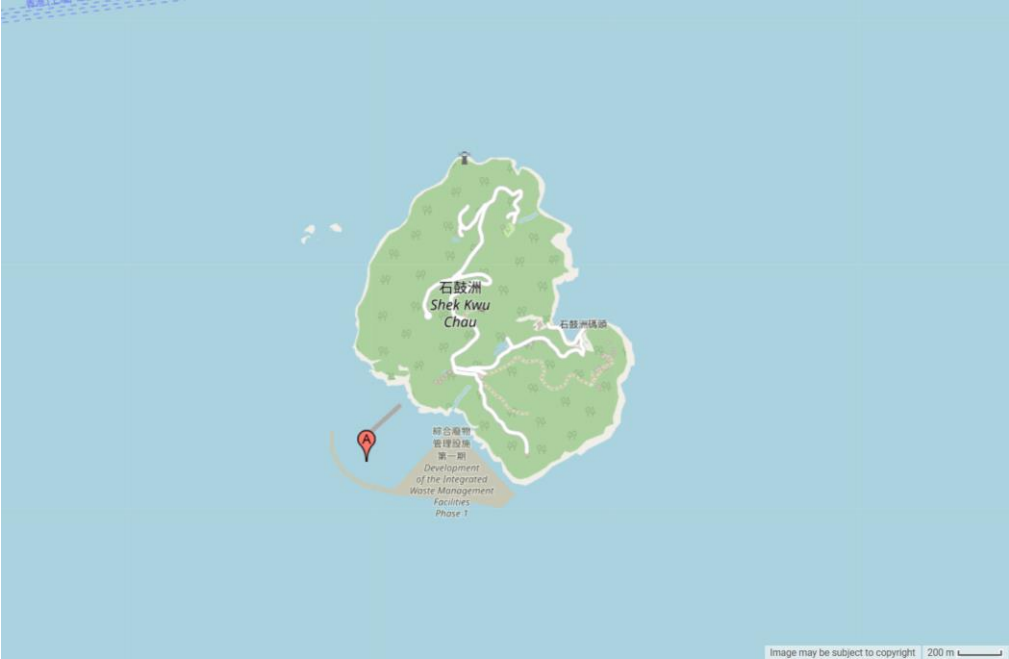
Project	Integrated Waste Management Facilities, Phase 1
Date	11 February 2019 (Lab result received on 18 February 2019)
Time	08:38 – 12:08 (Mid-Flood) 14:52 – 18:22 (Mid-Ebb)
Mid-Flood	
Monitoring Location	<p>II : A (N22°11.406 E113° 59.968)</p>

<p>Note: Drawing is not to scale</p>
Parameter	Suspended Solid (SS)

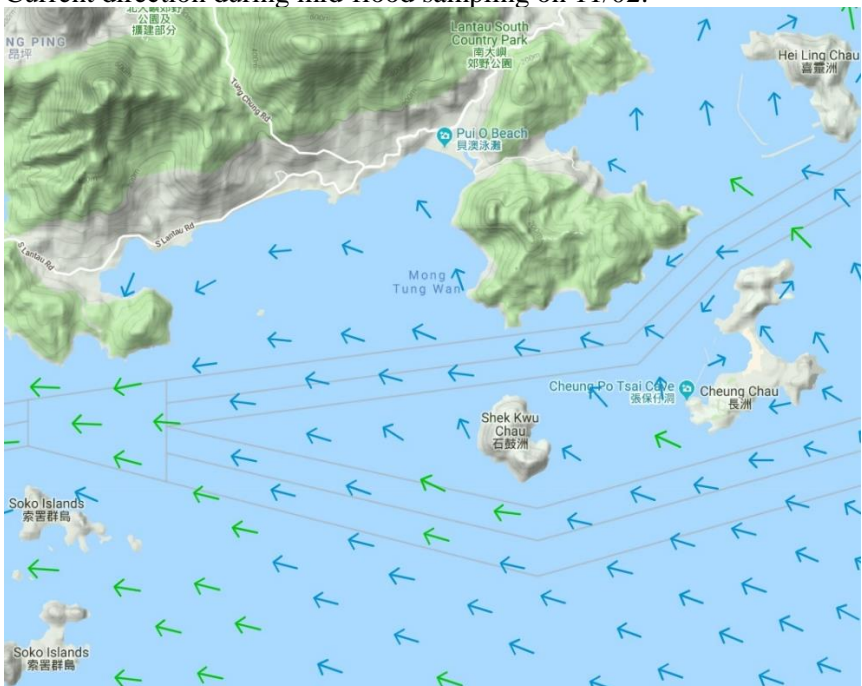
Actions taken / to be taken	Examination of environmental performance of the Project will be continued during the weekly inspection, and the Contractor is remained to implement all applicable mitigation measures as per the Updated EM&A Manual.		
Remarks	<p>Note: N/A – cancelled due to the monitoring station positioning on land.</p> <p>Current direction during mid-flood sampling on 11/02:</p>

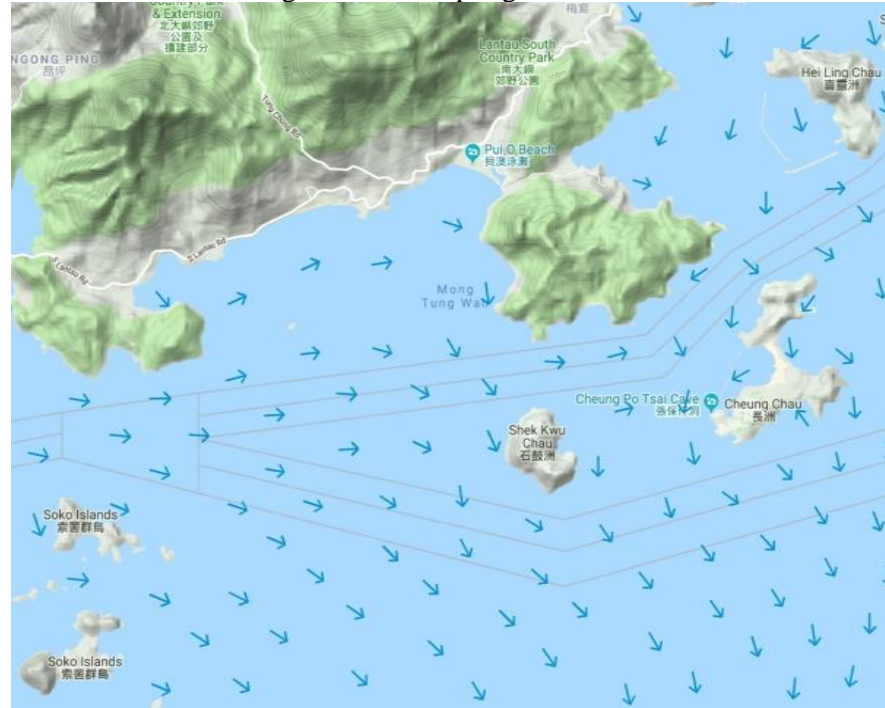
Current direction during mid-ebb sampling on 11/02:

Legend	
Speed (knot)	Speed (knot)
0-0.5	1.5-2.0
0.5-1.0	2.0-2.5
1.0-1.5	2.5 and above

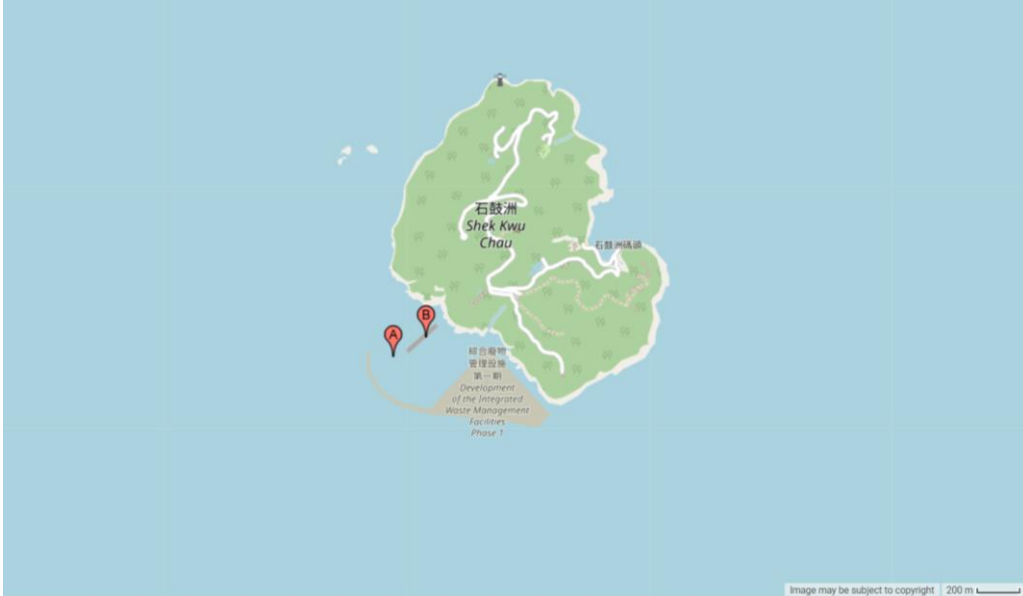
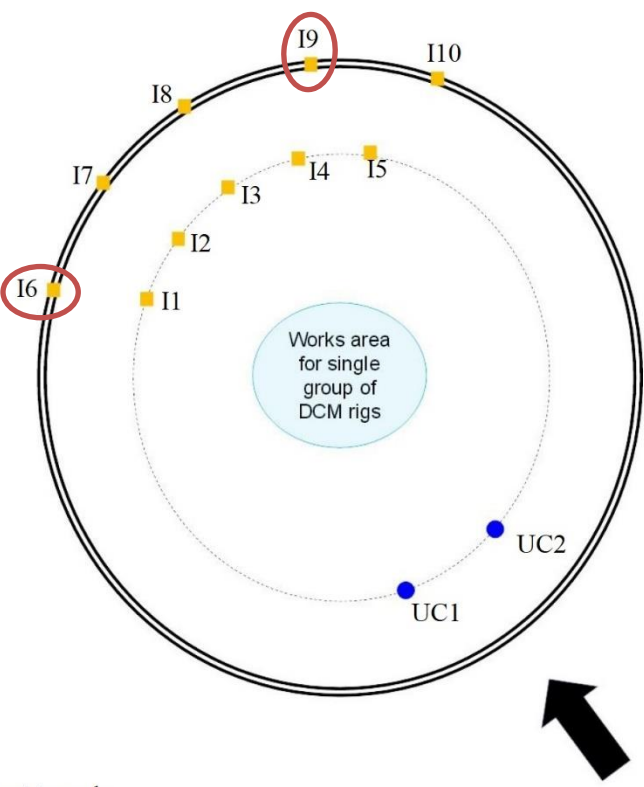
Project	Integrated Waste Management Facilities, Phase 1	
Date	12 February 2019 (Lab result received on 19 February 2019)	
Time	09:22 – 12:52 (Mid-Flood) 15:07 – 19:00 (Mid-Ebb)	
Mid-Flood		
Monitoring Location	<p>I6 : A (N22°11.406 E113° 59.968) I9 : B (N22°11.415 E113° 59.032)</p>

<p>Note: Drawing is not to scale</p>	
Parameter	Suspended Solid (SS)	
Action & Limit Levels	Action Level	Limit Level

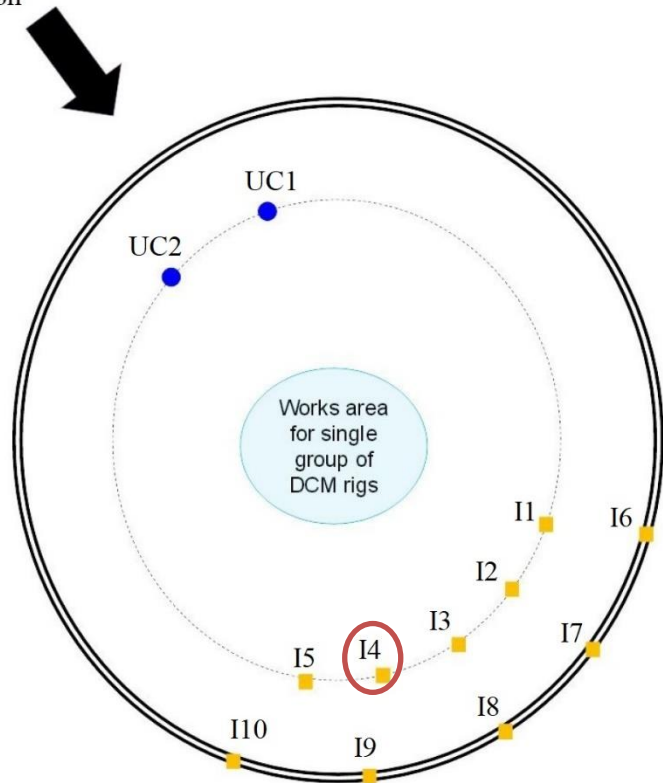
Actions taken / to be taken	Examination of environmental performance of the Project will be continued during the weekly inspection, and the Contractor is remained to implement all applicable mitigation measures as per the Updated EM&A Manual.		
Mid-Ebb			
Monitoring Location	I4 : A (N22°11.312 E113°59.230)

Tide Direction

Note: Drawing is not to scale

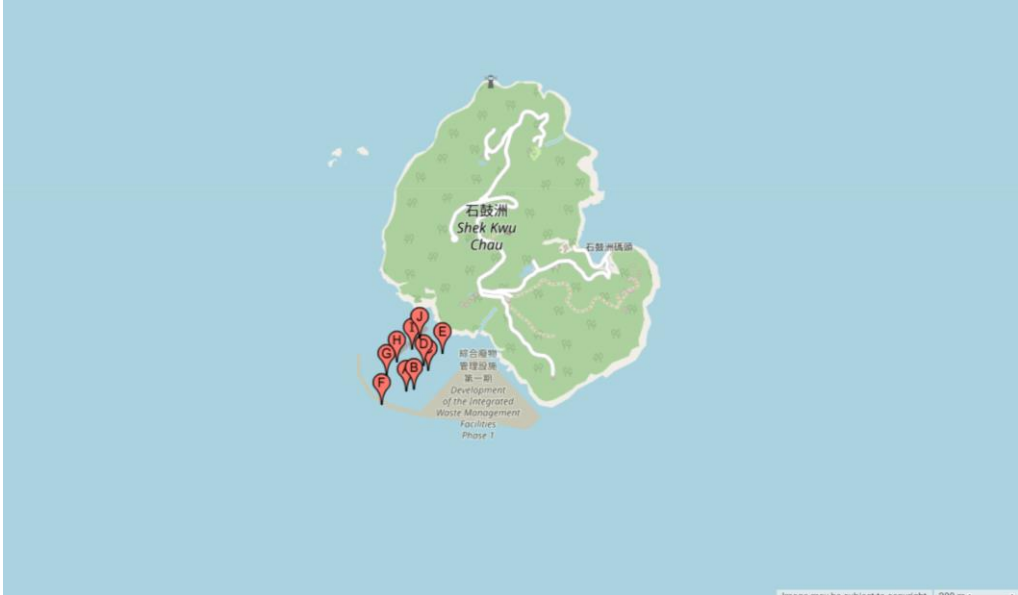
Project	Integrated Waste Management Facilities, Phase 1
Date	13 February 2019 (Lab result received on 19 February 2019)
Time	10:05 – 13:35 (Mid-Flood)
Mid-Flood	
Monitoring Location	<p> I1 : A (N22°11.342 E113° 59.010) I2 : B (N22°11.348 E113° 59.030) I3 : C (N22°11.395 E113° 59.069) I4 : D (N22°11.406 E113° 59.055) I5 : E (N22°11.438 E113° 59.107) I6 : F (N22°11.308 E113° 58.944) I7 : G (N22°11.383 E113° 58.956) I8 : H (N22°11.415 E113° 58.983) I9 : I (N22°11.447 E113° 59.026) I10 : J (N22°11.475 E113° 59.045) </p>

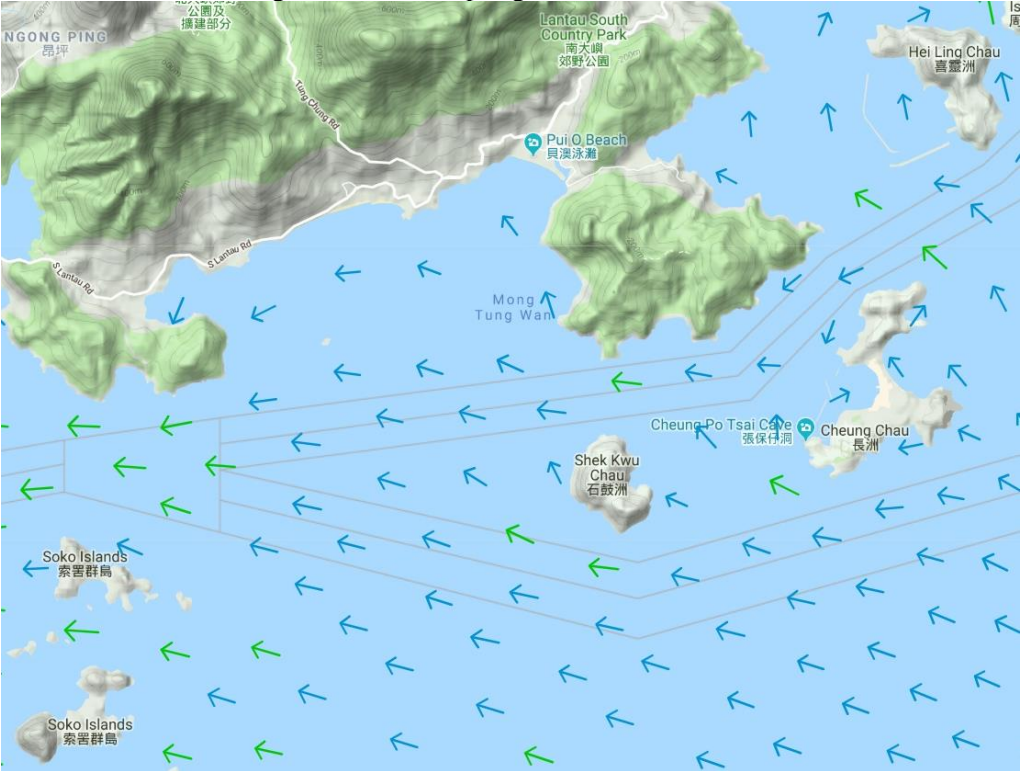
<p>Remarks</p>	<p>Current direction during mid-flood sampling on 13/02:</p>

<p>(Sourced from http://current.hydro.gov.hk/en/map.html)</p>
<p>Prepared by</p>	<p>Polar Chan</p>
<p>Date</p>	<p>20 February 2019</p>

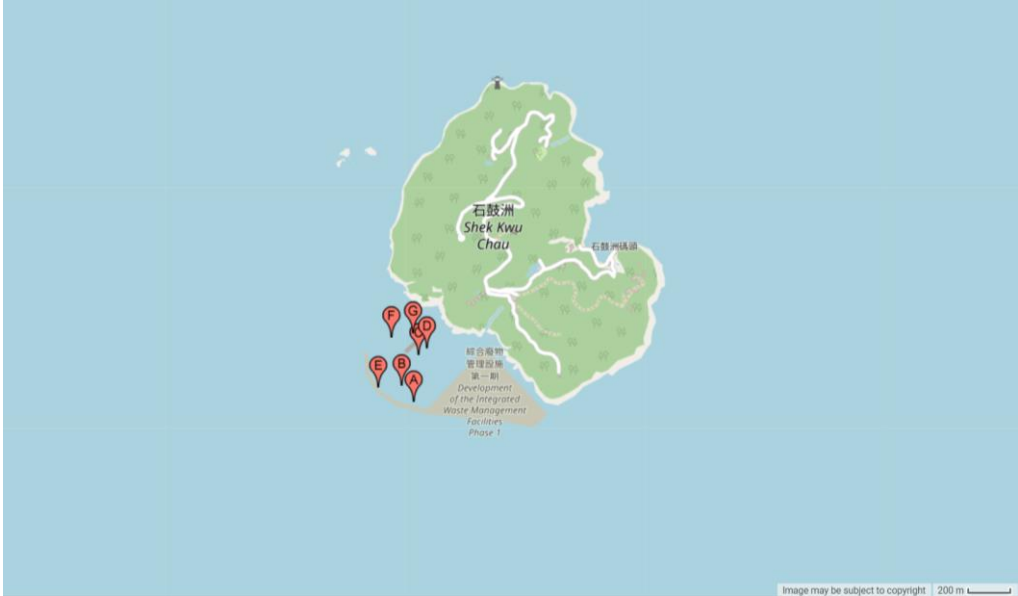
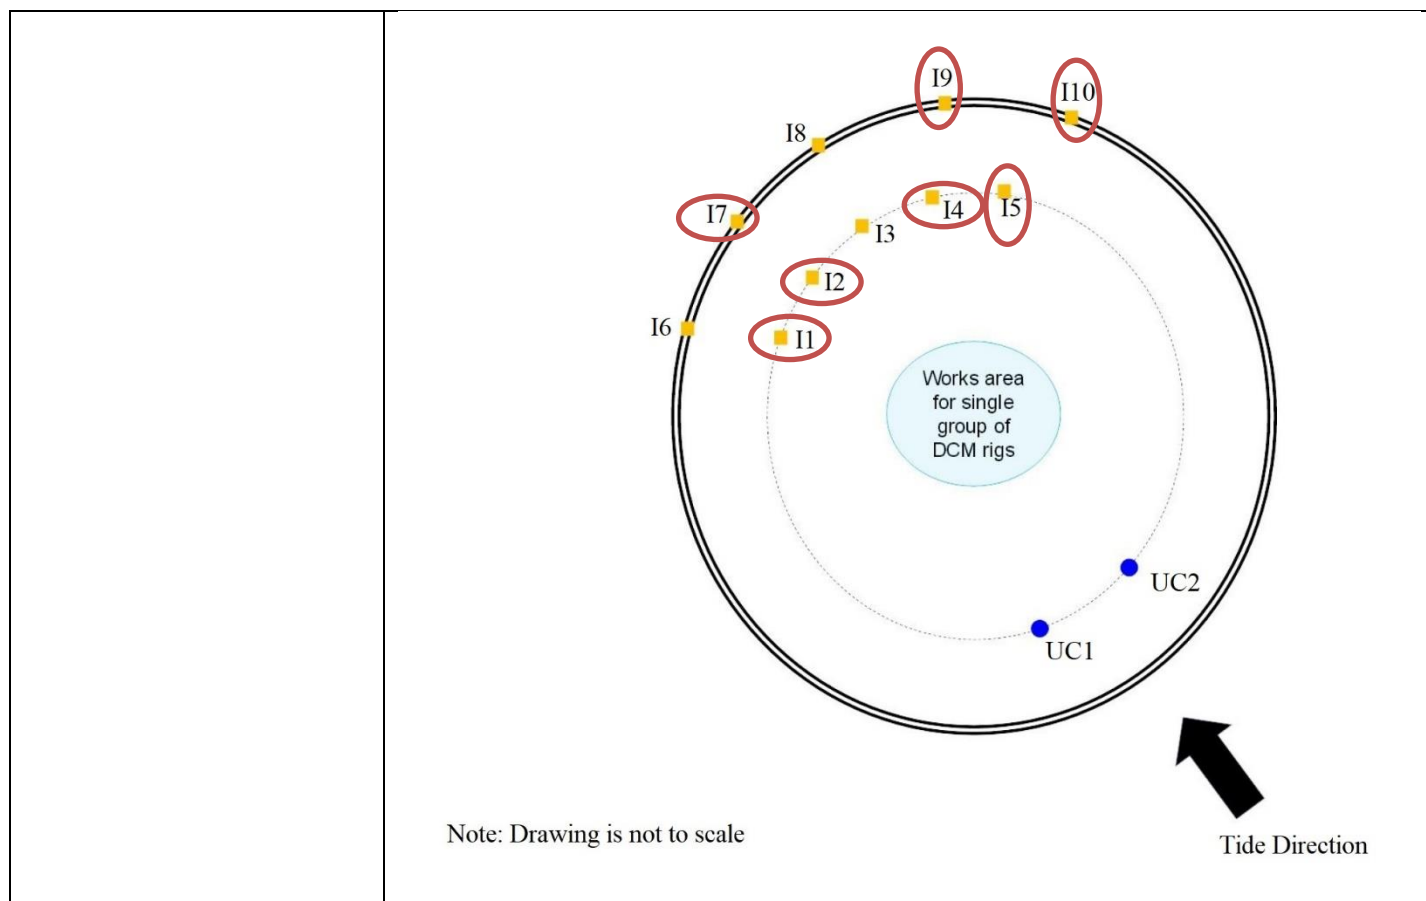
Project	Integrated Waste Management Facilities, Phase 1
Date	14 February 2019 (Lab result received on 20 February 2019)
Time	10:47 – 14:17 (Mid-Flood) 16:55 – 19:00 (Mid-Ebb)
Mid-Flood	
Monitoring Location	<p> I1 : A (N22°11.312 E113° 59.909) I2 : B (N22°11.351 E113° 58.976) I4 : C (N22°11.420 E113° 59.024) I5 : D (N22°11.448 E113° 59.046) I7 : E (N22°11.348 E113° 58.912) I9 : F (N22°11.474 E113° 58.947) I10 : G (N22°11.485 E113° 59.008) </p>

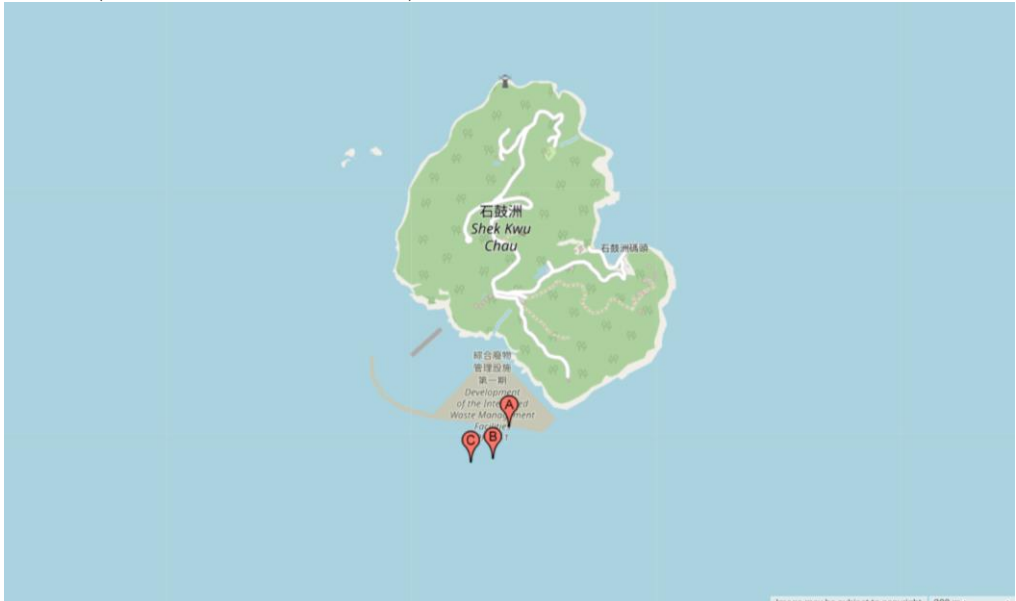
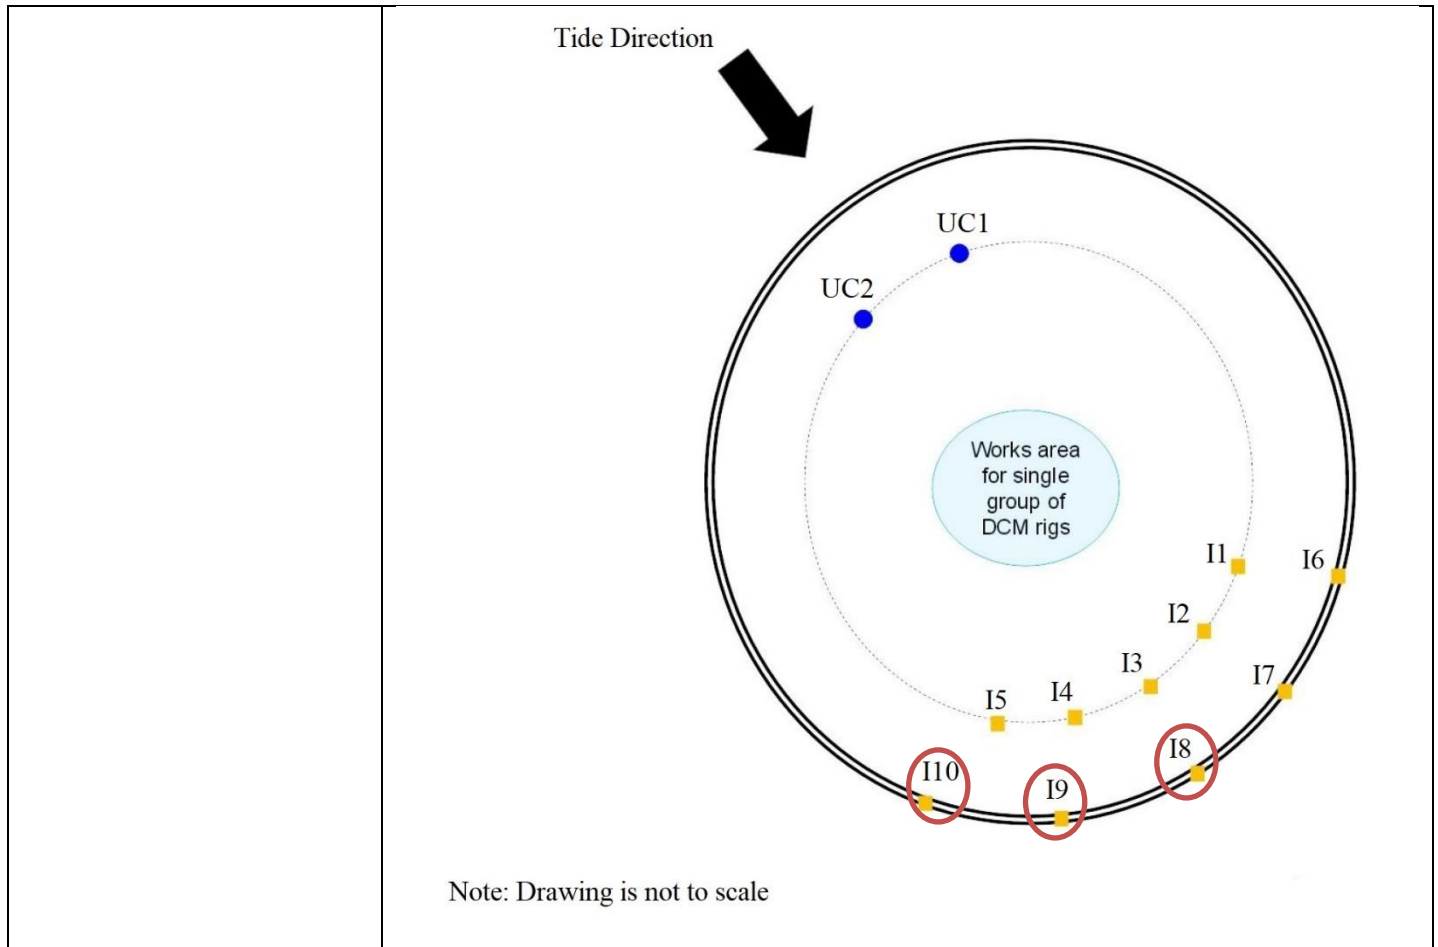
<p>day. It might suggest that SS exceedances are deemed to be unrelated to the Project.</p> <p>Site tidiness in the present barges in the Project site were checked during weekly site inspection on 13/02, where was no major observation of improper site practice that might contribute to the increase in SS level was observed during the inspection.</p>
<p>Actions taken / to be taken</p>	<p>Examination of environmental performance of the Project will be continued during the weekly inspection, and the Contractor is remained to implement all applicable mitigation measures as per the Updated EM&A Manual.</p>
<p>Mid-Ebb</p>	
<p>Monitoring Location</p>	<p>I8 : A (N22°11.259 E113° 59.248) I9 : B (N22°11.180 E113° 59.207) I10 : C (N22°11.170 E113° 59.147)</p>

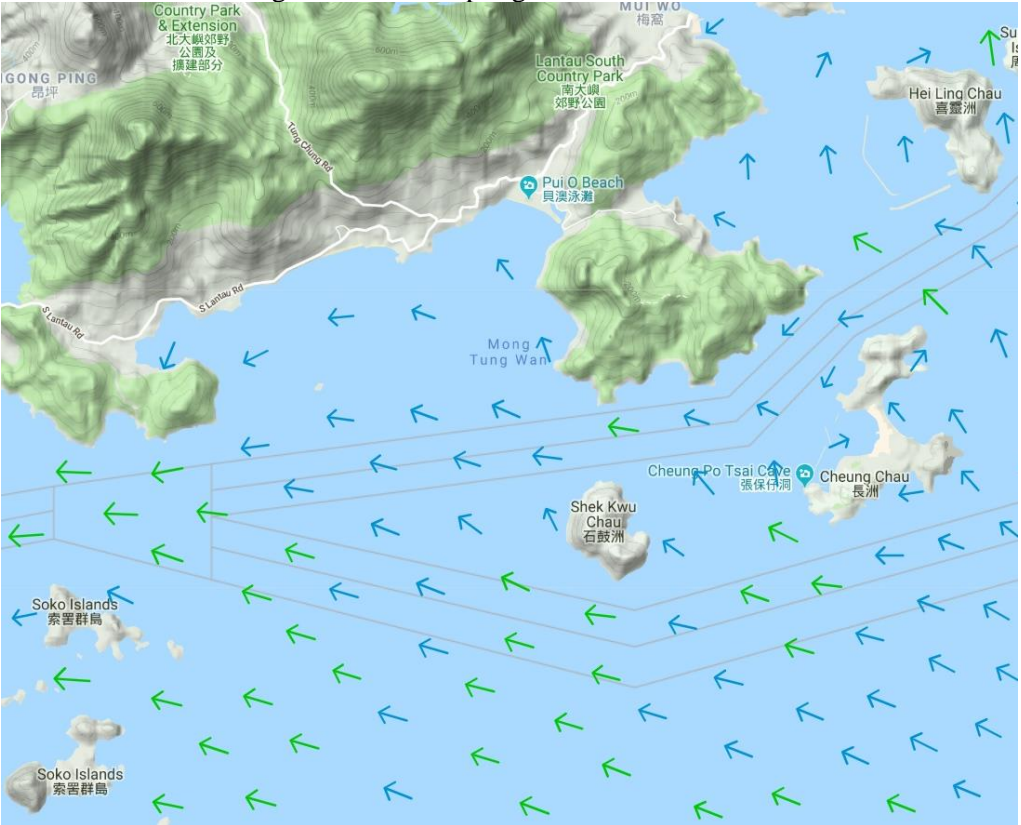
<p>Cheung Kee No.7 and Kam Ying No.8 with referring to the site diary on that day. It might suggest that SS exceedances are deemed to be unrelated to the Project.</p> <p>Site tidiness in the present barges in the Project site were checked during weekly site inspection on 13/02, where was no major observation of improper site practice that might contribute to the increase in SS level was observed during the inspection.</p>
<p>Actions taken / to be taken</p>	<p>Examination of environmental performance of the Project will be continued during the weekly inspection, and the Contractor is remained to implement all applicable mitigation measures as per the Updated EM&A Manual.</p>
<p>Remarks</p>	<p>Current direction during mid-flood sampling on 14/02:</p>

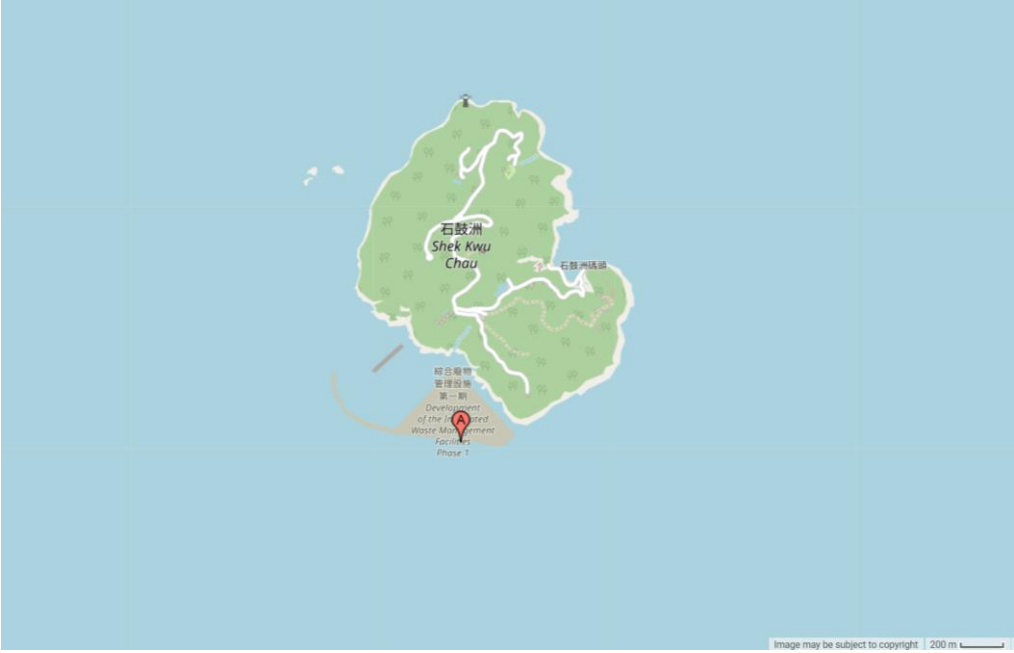
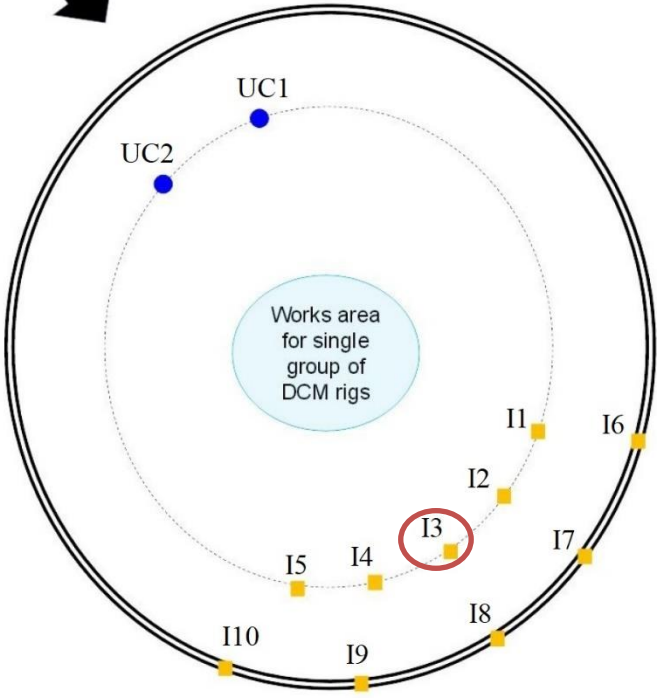
Project	Integrated Waste Management Facilities, Phase 1
Date	15 February 2019 (Lab result received on 20 February 2019)
Time	08:00 – 09:17 (Mid-Ebb) 11:39 – 15:09 (Mid-Flood)
Mid-Ebb	
Monitoring Location	<p>I3 : A (N22°11.258 E113° 59.226)</p>

<p style="text-align: right; font-size: small;">Image may be subject to copyright 200 m</p> <p style="text-align: center;">Tide Direction

<p>Note: Drawing is not to scale</p>

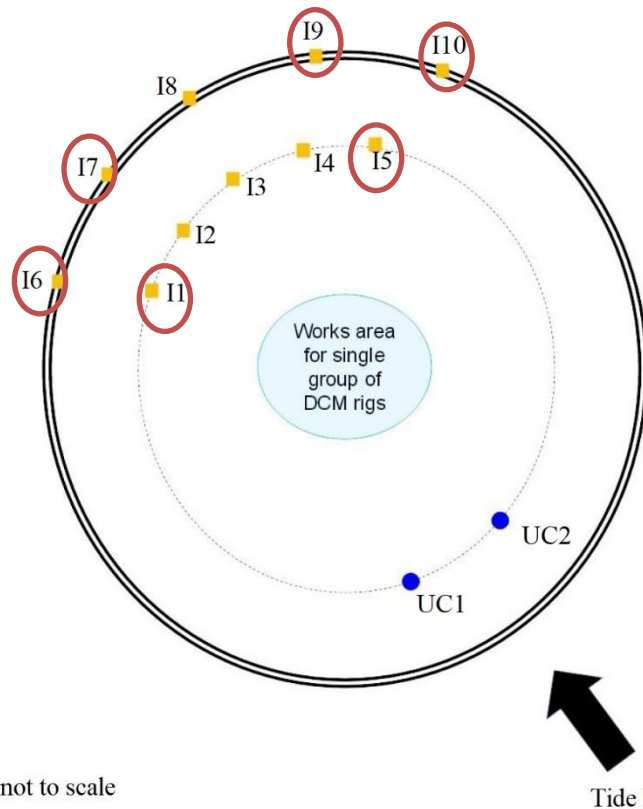
Actions taken / to be taken	Examination of environmental performance of the Project will be continued during the weekly inspection, and the Contractor is remained to implement all applicable mitigation measures as per the Updated EM&A Manual.		
Mid-Flood			
Monitoring Location	I1: A (N22°11.322 E113° 58.997) I5 : B (N22°11.423 E113° 59.057) I6 : C (N22°11.283 E113° 58.941) I7 : D (N22°11.341 E113° 58.918) I9 : E (N22°11.448 E113° 58.965) I10 : F (N22°11.483 E113° 59.014)

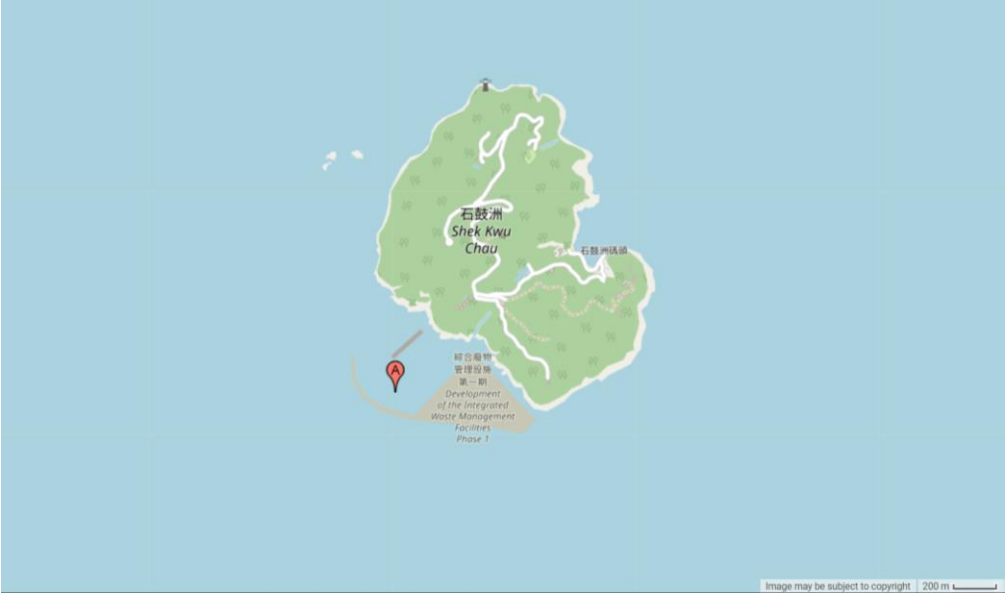
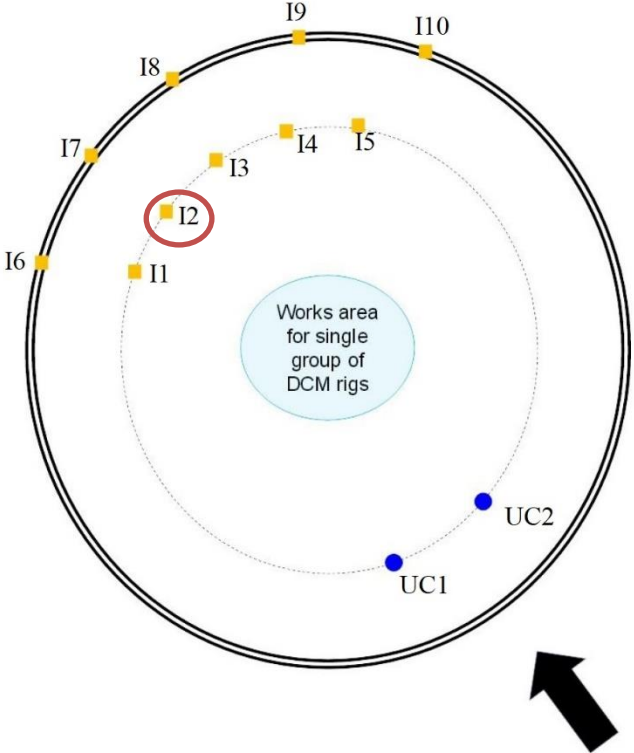
Project	Integrated Waste Management Facilities, Phase 1	
Date	16 February 2019 (Lab result received on 20 February 2019)	
Time	12:51 – 16:21 (Mid-Flood)	
Monitoring Location	Mid-Flood	
	I2 : A (N22°11.350 E113° 58.994)

<p data-bbox="520 1861 820 1890">Note: Drawing is not to scale</p> <p data-bbox="1294 1872 1449 1901">Tide Direction</p>	
Parameter	Suspended Solid (SS)	
Action & Limit Levels	Action Level	Limit Level
	≥ 4.6 mg/L (120% of average of UC1 & UC2)	≥ 5.0 mg/L (130% of average of UC1 & UC2)

Measurement Level	Impact Station(s) of Exceedance	Control Stations	Impact Station(s) without Exceedance
	4.8 mg/L (I2)	3.2 mg/L (UC1) 4.5 mg/L (UC2)	4.2 mg/L (I1) 2.2 mg/L (I3) 2.0 mg/L (I4) 2.0 mg/L (I5) 4.3 mg/L (I6) 4.0 mg/L (I7) 3.0 mg/L (I8) 3.8 mg/L (I9) 2.0 mg/L (I10)
Possible reason for Action or Limit Level Non-compliance	<p>Works scheduled on site on 16/02 include laying of sand blanket at caisson seawall area, cone penetration test plant trial, post cone penetration test for DCM main works, DCM sample coring for DCM main works and DCM main works.</p> <p>Dominating sea current direction was found to be from Southeast to Northwest at waters around Shek Kwu Chau.</p> <p>From MMO monitoring records on 16/02, MMO teams were arranged to two DCM barges (ESC-61 & ESC-62) and two derrick barges (Shun Tat D12 & FTB-19) on that day while no deficiency of silt curtain was found before the start of construction activity.</p> <p>I2 is located close to the work location within the Project site while silt curtain checking was implemented on ESC-61 (08:15), ESC-62 (07:20), Shun Tat D12 (11:00) and FTB-19 (12:30) by the Contractor and checking results showed that no deficiency of silt curtain was found on that day. No sand blanket laying work scheduled in Kam Ying No.8 was carried out with referring to site diary on that day. When compared to the baseline data of dry season (Action Level: 8mg/L & Limit Level: 10mg/L), most of the monitoring stations (including upstream control station UC1 and UC2) were relatively low, it might suggest that the SS exceedance at I2 is deemed to be unrelated to the Project.</p>

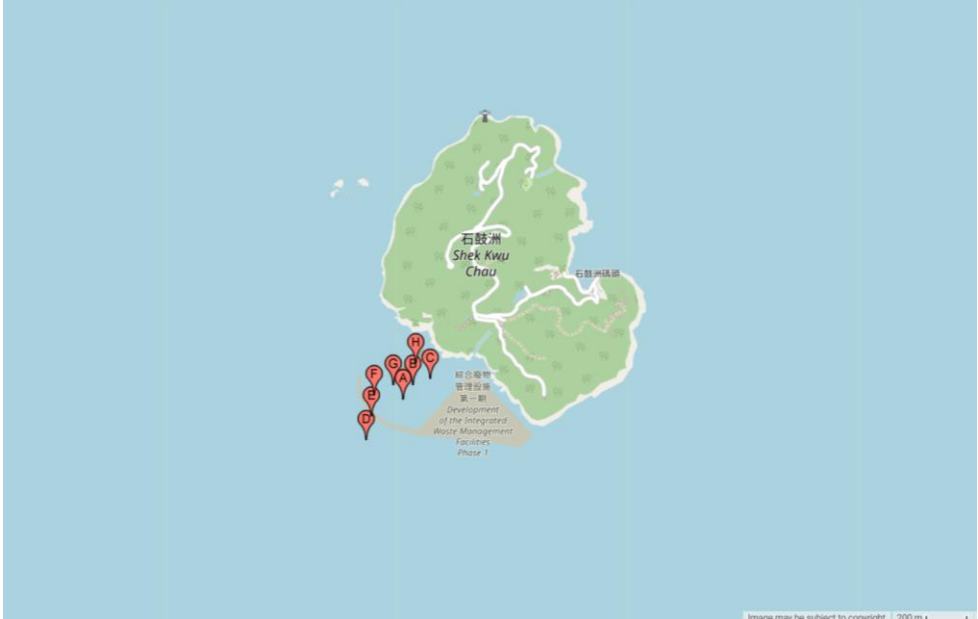
Project	Integrated Waste Management Facilities, Phase 1
Date	17 February 2019 (Lab result received on 21 February 2019)
Time	14:04 – 17:34 (Mid-Flood)
Mid-Flood	
Monitoring Location	<p>I3 : A (N22°11.374 E113° 59.005) I4 : B (N22°11.412 E113° 59.034) I5 : C (N22°11.429 E113° 59.082) I6 : D (N22°11.265 E113° 58.899) I7 : E (N22°11.327 E113° 58.916) I8 : F (N22°11.385 E113° 58.923) I9 : G (N22°11.421 E113° 58.975) I10 : H (N22°11.469 E113° 59.040)</p>

3.2 mg/L (I3) 2.7 mg/L (I4) 3.5 mg/L (I5) 3.2 mg/L (I6) 3.0 mg/L (I7) 2.8 mg/L (I8) 3.2 mg/L (I9) 2.5 mg/L (I10)	2.0 mg/L (UC1) 2.0 mg/L (UC2)	2.0 mg/L (I1) 2.0 mg/L (I2)
Possible reason for Action or Limit Level Non-compliance	<p>Works scheduled on site on 17/02 include laying of sand blanket at caisson seawall area, DCM sample coring for DCM main works and DCM main works.</p> <p>Dominating sea current direction was found to be from Southeast to Northwest at waters around Shek Kwu Chau.</p> <p>From MMO monitoring records on 17/02, MMO teams were arranged to two DCM barges (ESC-61 & ESC-62) and three derrick barges (DENSON3, Shun Tat D12 & FTB-19) on that day while no deficiency of silt curtain was found before the start of construction activity.</p> <p>I3, I4, I5, I6, I7, I8, I9 & I10 are located close to the work location within the Project site while silt curtain checking was implemented on Shun Tat D12 (09:00) by the Contractor and checking results showed that no deficiency of silt curtain was found on that day. No sand blanket laying works scheduled in FTB-19 & Kam Ying No.8 were</p>

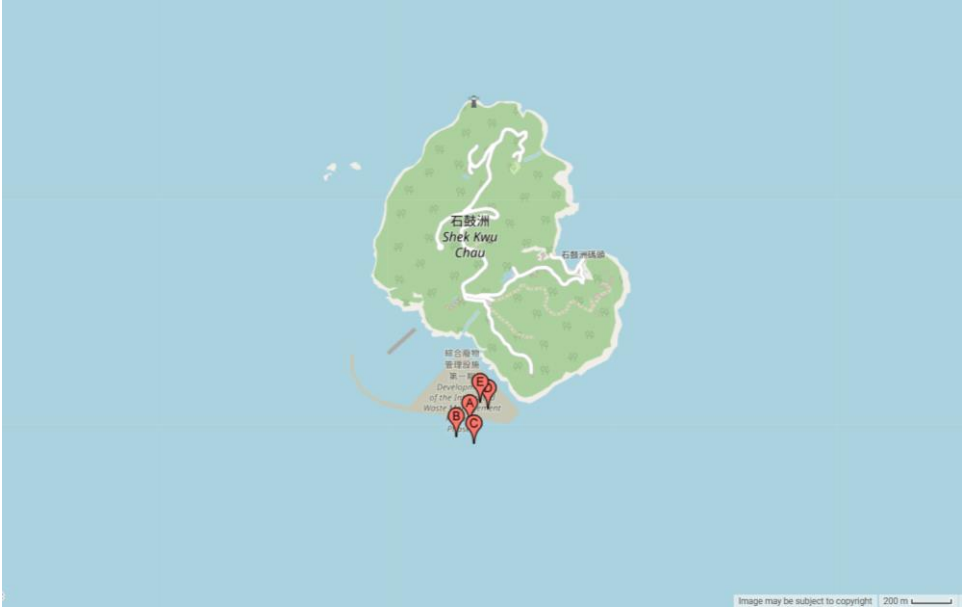
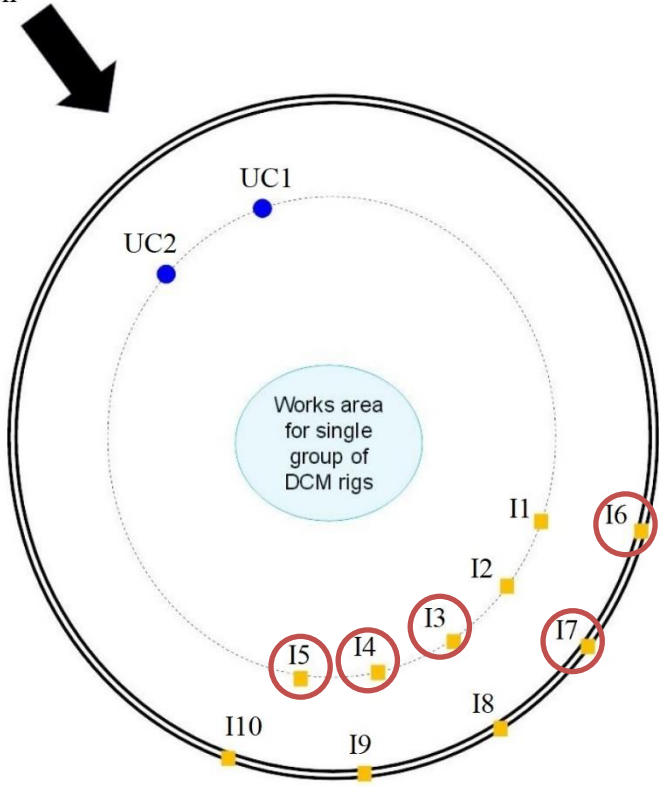
Project	Integrated Waste Management Facilities, Phase 1
Date	18 February 2019 (Lab result received on 21 February 2019)
Time	09:55 – 13:25 (Mid-Ebb)
Mid-Ebb	
Monitoring Location	<p>I3 : A (N22°11.247 E113° 59.227) I4 : B (N22°11.211 E113° 59.188) I5 : C (N22°11.192 E113° 59.238) I6 : D (N22°11.288 E113° 59.281) I7 : E (N22°11.303 E113° 59.258)</p>

<p style="text-align: right; font-size: small;">Image may be subject to copyright 200 m</p> <p style="text-align: center;">Tide Direction</p>

<p style="text-align: center;">Note: Drawing is not to scale</p>

5.0 mg/L (I3) 6.5 mg/L (I4) 7.3 mg/L (I5) 5.5 mg/L (I6) 5.3 mg/L (I7)	3.8 mg/L (UC1) 3.7 mg/L (UC2)	3.8 mg/L (I1) 3.0 mg/L (I2) 3.5 mg/L (I8) 4.0 mg/L (I9) 3.7 mg/L (I10)
Possible reason for Action or Limit Level Non-compliance	<p>Works scheduled on site on 18/02 include laying of sand blanket at caisson seawall area, cone penetration test plant trial, post cone penetration test, DCM sample coring for DCM main works and DCM main works.</p> <p>Dominating sea current direction was found to be from Southeast to Northwest at waters around Shek Kwu Chau.</p> <p>From MMO monitoring records on 18/02, MMO teams were arranged to two DCM barges (ESC-61 & ESC-62) and two derrick barges (Shun Tat D12 & FTB-19) on that day while no deficiency of silt curtain was found before the start of construction activity.</p> <p>I3, I4, I5, I6 & I7 are located close to the work location within the Project site while no sand blanket laying works scheduled in FTB-19, Shun Tat D12, Cheung Kee No.7 & Kam Ying No.8 were carried out with referring to site diary on that day. No DCM main works scheduled in ESC-61 & ESC-62 were carried out due to adverse wave condition on that day. It might suggest that the SS exceedance at I3, I4, I5, I6 & I7 are deemed to be unrelated to the Project.</p>

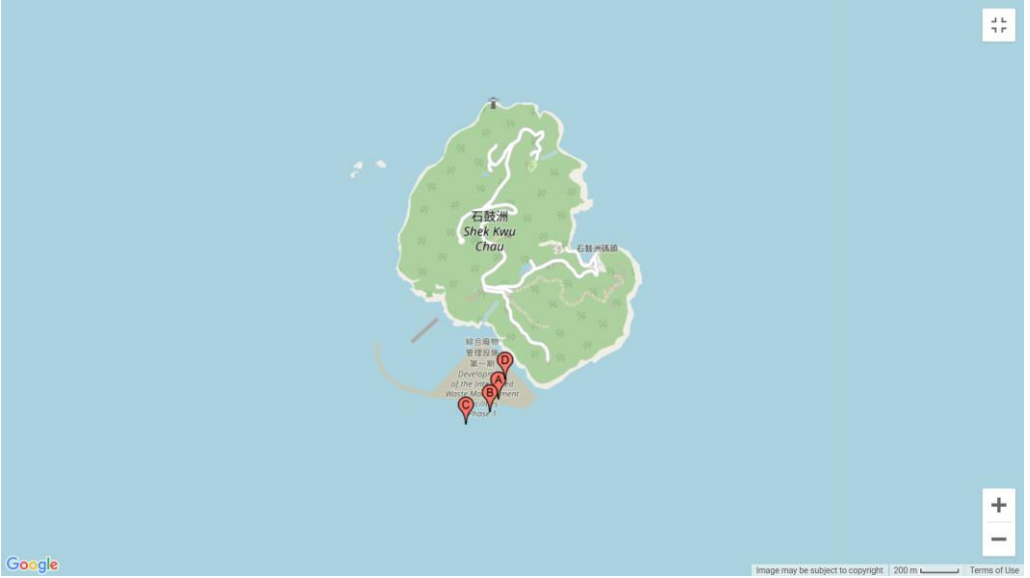
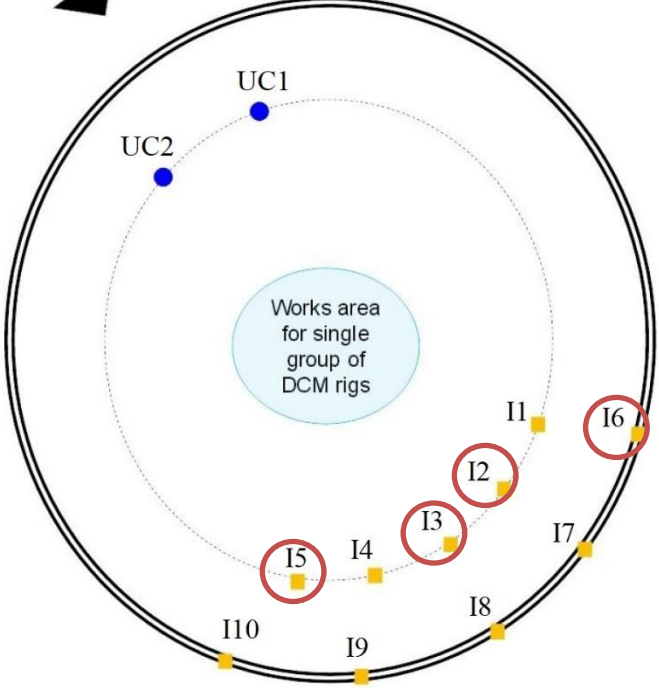
Project	Integrated Waste Management Facilities, Phase 1
Date	19 February 2019 (Lab result received on 21 February 2019)
Time	10:43 – 14:13 (Mid-Ebb) 14:54 – 19:00 (Mid-Flood)
Mid-Ebb	
Monitoring Location	<p>I2 : A (N22°11.274 E113° 59.254) I3 : B (N22°11.238 E113° 59.228) I5 : C (N22°11.202 E113° 59.155) I6 : D (N22°11.329 E113° 59.274)</p>

<p style="text-align: center;">Tide Direction

<p>Note: Drawing is not to scale</p>

9.5 mg/L (I2) 9.3 mg/L (I3) 9.3 mg/L (I5) 9.2 mg/L (I6)	6.7 mg/L (UC1) 7.8 mg/L (UC2)	6.8 mg/L (I1) 7.3 mg/L (I4) 8.7 mg/L (I7) 8.2 mg/L (I8) 7.3 mg/L (I9) 8.7 mg/L (I10)
Possible reason for Action or Limit Level Non-compliance	<p>Works scheduled on site on 19/02 include sand blanket laying at caisson seawall area, post cone penetration test work, DCM sample coring, DCM main works and DCM plant trial.</p> <p>Dominating sea current direction was found to be from Northwest to Southeast at waters around Shek Kwu Chau.</p> <p>From MMO monitoring records on 19/02, MMO teams were arranged to two DCM barges (ESC-61 & ESC-62) and two derrick barge (FTB-19 & Kam Ying No.8) on that day while no deficiency of silt curtain was found before the start of construction activity.</p> <p>I2, I3, I5 & I6 are located close to the works location within the Project site while silt curtain checking was implemented on FTB-19 (07:00), Kam Ying (18:00), ESC-61 (10:30) and ESC-62 (00:00) by the Contractor and checking results showed that no deficiency of silt curtain was found on that day. No sand blanket laying work was carried out on Cheung Kee No.7 with referring to the site diary on that day. It might suggest that SS exceedances are deemed to be unrelated to the Project.</p>

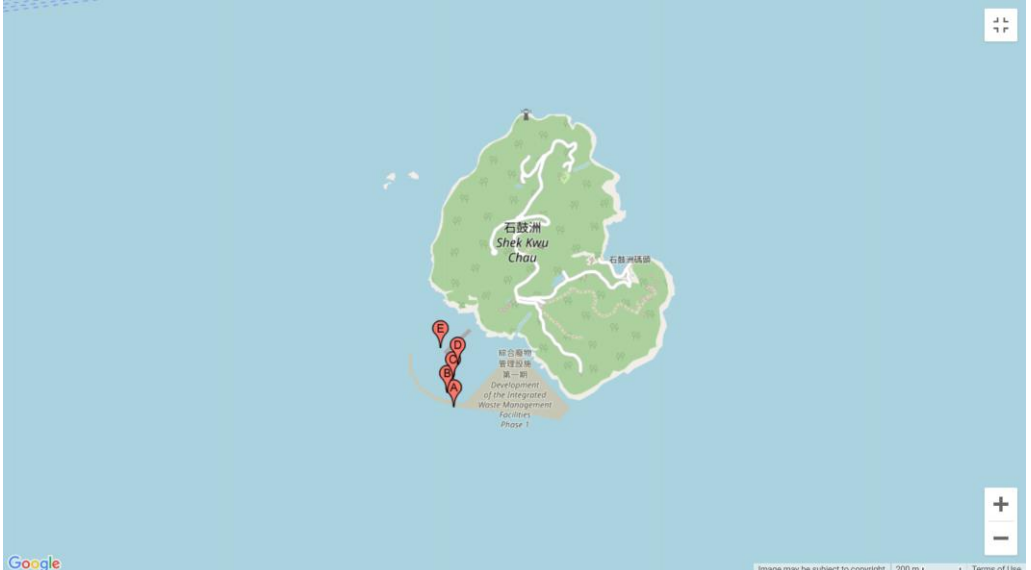
Actions taken / to be taken	Examination of environmental performance of the Project will be continued during the weekly inspection, and the Contractor is remained to implement all applicable mitigation measures as per the Updated EM&A Manual.		
Mid-Flood			
Monitoring Location	<p>I1 : A (N22°11.283 E113° 59.016) I2 : B (N22°11.324 E113° 58.994) I3 : C (N22°11.363 E113° 59.011) I4 : D (N22°11.405 E113° 59.028) I9 : E (N22°11.453 E113° 58.974)</p>

9.2 mg/L (I1) 8.2 mg/L (I2) 9.0 mg/L (I3) 8.7 mg/L (I4) 8.0 mg/L (I9)	5.2 mg/L (UC1) 6.7 mg/L (UC2)	6.5 mg/L (I5) 5.5 mg/L (I6) 5.7 mg/L (I7) 5.7 mg/L (I8) 6.7 mg/L (I10)
Possible reason for Action or Limit Level Non-compliance	<p>Works scheduled on site on 19/02 include sand blanket laying at caisson seawall area, post cone penetration test work, DCM sample coring, DCM main works and DCM plant trial.</p> <p>Dominating sea current direction was found to be from Southeast to Northwest at waters around Shek Kwu Chau.</p> <p>From MMO monitoring records on 19/02, MMO teams were arranged to two DCM barges (ESC-61 & ESC-62) and two derrick barge (FTB-19 & Kam Ying No.8) on that day while no deficiency of silt curtain was found before the start of construction activity.</p> <p>I1, I2, I3, I4 & I9 are located close to the works location within the Project site while silt curtain checking was implemented on FTB-19 (07:00), Kam Ying (18:00), ESC-61 (10:30) and ESC-62 (00:00) by the Contractor and checking results showed that no deficiency of silt curtain was found on that day. No sand blanket laying work was carried out on Cheung Kee No.7 with referring to the site diary on that day. It might suggest that SS exceedances are deemed to be unrelated to the Project.</p>

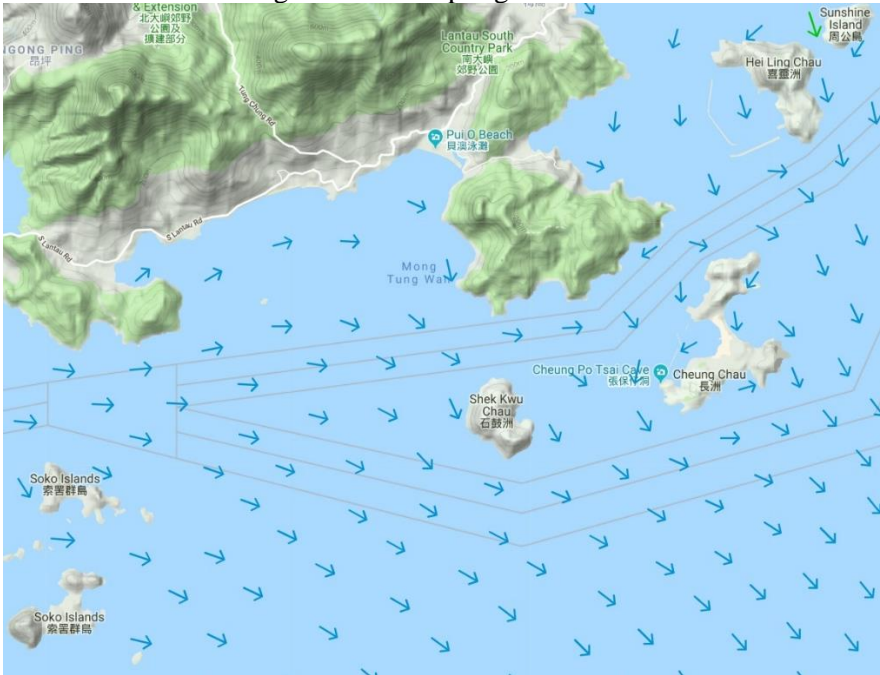
Current direction during mid-ebb sampling on 19/02:

Legend			
Speed (knot)	→	Speed (knot)	→
0-0.5	→	1.5-2.0	→
0.5-1.0	→	2.0-2.5	→
1.0-1.5	→	2.5 and above	→
