Appendix N Exceedance Report

Statistical Summary of Exceedances in the Reporting Period

Incident Report on Action Level or Limit Level Non-compliance

Project	Integrated Waste Management Facilities, Phase 1		
Date	1 February 2019 (Lab result received on 15 February 2019)		
Time	13:55 – 17:25 (Mid-Flood)		
Monitoring Location	Mid-Flood		
Monitoring Location	<p>M1</p> <p>The map shows the Shek Kwu Chau area with various monitoring stations (B1-F1, C1-C2, H1, CR1-CR2, S1-S3) and a proposed outfall (S1). It also indicates the location of 4 proposed 132KV submarine cables and a proposed reclaimed area for the IWMF. Station M1 is highlighted with a red circle.</p>		
Parameter	Suspended Solid (SS)		
Action & Limit Levels	Action Level		Limit Level
	≥ 8.0 mg/L		≥ 10.0 mg/L
Measurement Level	Impact Station(s) of Exceedance	Control Stations	Impact Station(s) without Exceedance

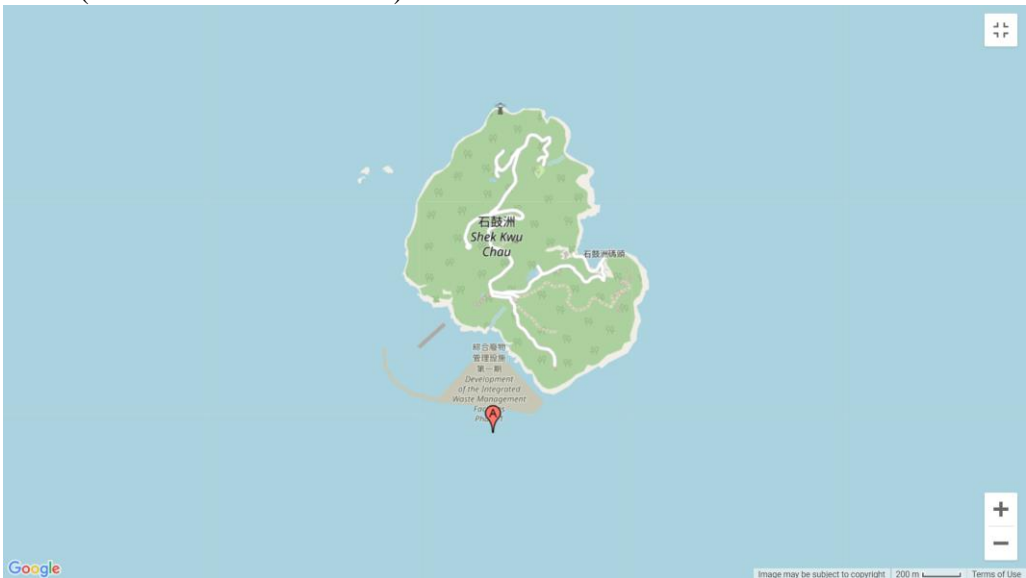
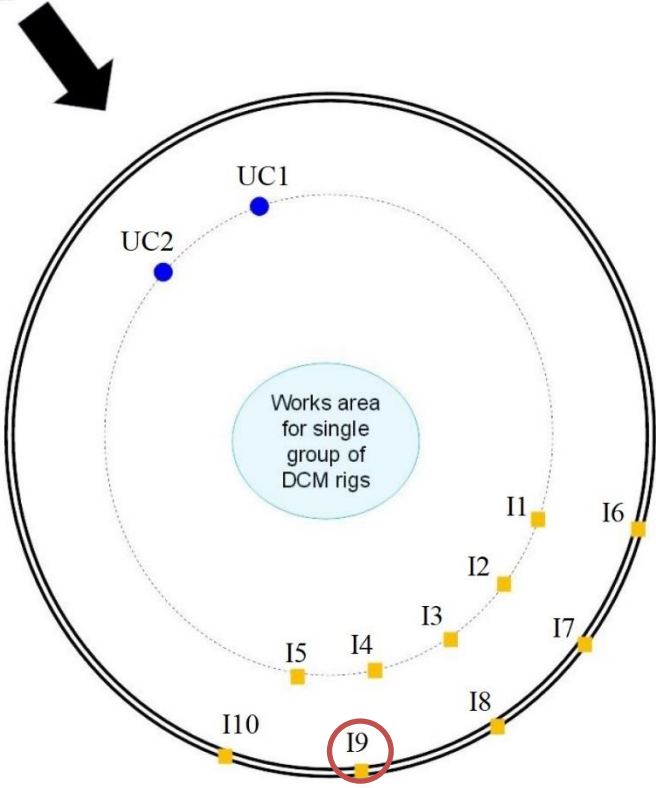
Project	Integrated Waste Management Facilities, Phase 1	
Date	20 February 2019 (Lab result received on 22 February 2019)	
Time	11:25 – 14:55 (Mid-Ebb) 15:46 – 19:00 (Mid-Flood)	
Mid-Ebb		
Monitoring Location	I9 : A (N22°11.192 E113° 59.216)

<p style="text-align: center;">Tide Direction</p>

<p style="text-align: center;">Note: Drawing is not to scale</p>	
Parameter	Suspended Solid (SS)	
Action & Limit Levels	Action Level	Limit Level
	≥ 8.2 mg/L (120% of average of UC1 & UC2)	≥ 8.9 mg/L (130% of average of UC1 & UC2)

UC2)		UC2)
Measurement Level	Impact Station(s) of Exceedance	Control Stations	Impact Station(s) without Exceedance
	9.5 mg/L (I9)	7.0 mg/L (UC1) 6.7 mg/L (UC2)	7.5 mg/L (I1) 7.7 mg/L (I2) 6.3 mg/L (I3) 4.8 mg/L (I4) 6.3 mg/L (I5) 6.2 mg/L (I6) 7.5 mg/L (I7) 7.8 mg/L (I8) 7.7 mg/L (I10)
Possible reason for Action or Limit Level Non-compliance	<p>Works scheduled on site on 20/02 include laying of geotextile at reclamation area, laying of sand blanket at caisson seawall area, post cone penetration test works, DCM sample coring, DCM main works and DCM plant trial.</p> <p>Dominating sea current direction was found to be from Northwest to Southeast at waters around Shek Kwu Chau.</p> <p>From MMO monitoring records on 20/02, MMO teams were arranged to two DCM barges (ESC-61 & ESC-62) and two derrick barge (FTB-19 & Kam Ying No.8) on that day while no deficiency of silt curtain was found before the start of construction activity.</p> <p>I9 is located close to the works location within the Project site while silt curtain checking was implemented on FTB-19 (08:00), Kam Ying No.8 (09:00), ESC-61 (16:00) and ESC-62 (07:00) by the Contractor and checking results showed that no deficiency of silt curtain was found on that day. It might suggest that SS exceedance is deemed to be unrelated to the Project.</p>

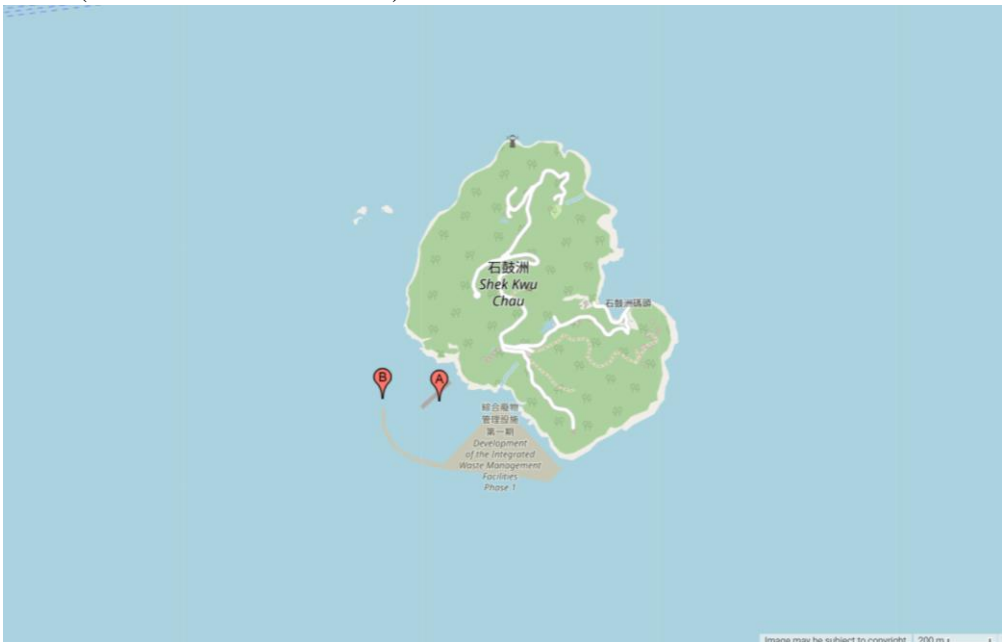
Actions taken / to be taken	<p>Examination of environmental performance of the Project will be continued during the weekly inspection, and the Contractor is remained to implement all applicable mitigation measures as per the Updated EM&A Manual.</p>		
Mid-Flood			
Monitoring Location	<p>I1 : A (N22°11.454 E113° 59.035) I2 : B (N22°11.459 E113° 58.879)</p>

7.7 mg/L (I4) 7.3 mg/L (I7)	5.8 mg/L (UC1) 5.8 mg/L (UC2)	5.8 mg/L (I1) 5.7 mg/L (I2) 6.2 mg/L (I3) 6.7 mg/L (I5) 4.8 mg/L (I6) 6.0 mg/L (I8) 5.7 mg/L (I9) 5.3 mg/L (I10)
Possible reason for Action or Limit Level Non-compliance	<p>Works scheduled on site on 20/02 include laying of geotextile at reclamation area, laying of sand blanket at caisson seawall area, post cone penetration test works, DCM sample coring, DCM main works and DCM plant trial.</p> <p>Dominating sea current direction was found to be from Southeast to Northwest at waters around Shek Kwu Chau.</p> <p>From MMO monitoring records on 20/02, MMO teams were arranged to two DCM barges (ESC-61 & ESC-62) and two derrick barge (FTB-19 & Kam Ying No.8) on that day while no deficiency of silt curtain was found before the start of construction activity.</p> <p>I4 & I7 are located close to the works location within the Project site while silt curtain checking was implemented on FTB-19 (08:00), Kam Ying No.8 (09:00), ESC-61 (16:00) and ESC-62 (07:00) by the Contractor and checking results showed that no</p>

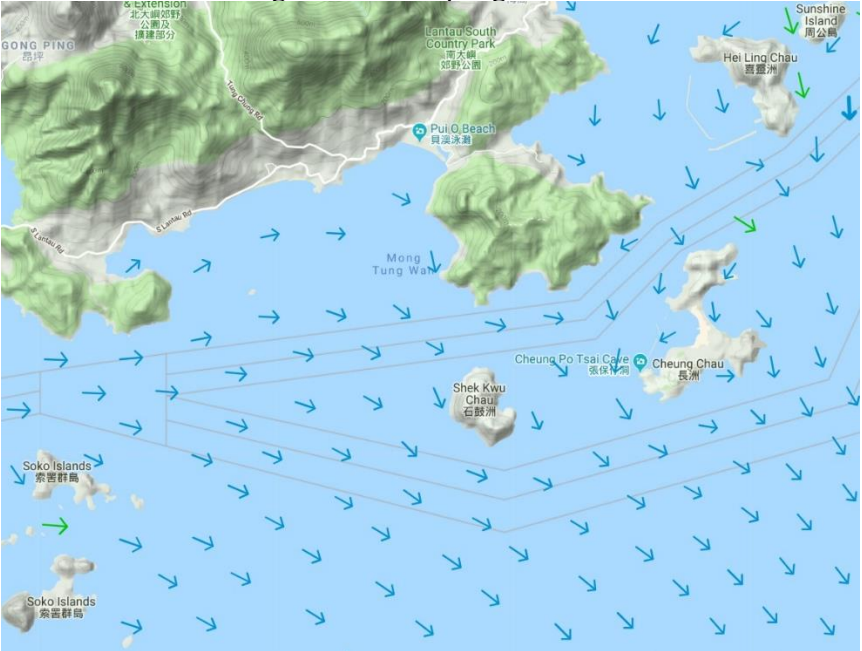
<table><tr> <th colspan="4">Legend</th> </tr><tr> <th>Speed (knot)</th> <th>Color</th> <th>Speed (knot)</th> <th>Color</th> </tr><tr> <td>0-0.5</td> <td>Blue arrow</td> <td>1.5-2.0</td> <td>Orange arrow</td> </tr><tr> <td>0.5-1.0</td> <td>Green arrow</td> <td>2.0-2.5</td> <td>Purple arrow</td> </tr><tr> <td>1.0-1.5</td> <td>Yellow arrow</td> <td>2.5 and above</td> <td>Red arrow</td> </tr></table>

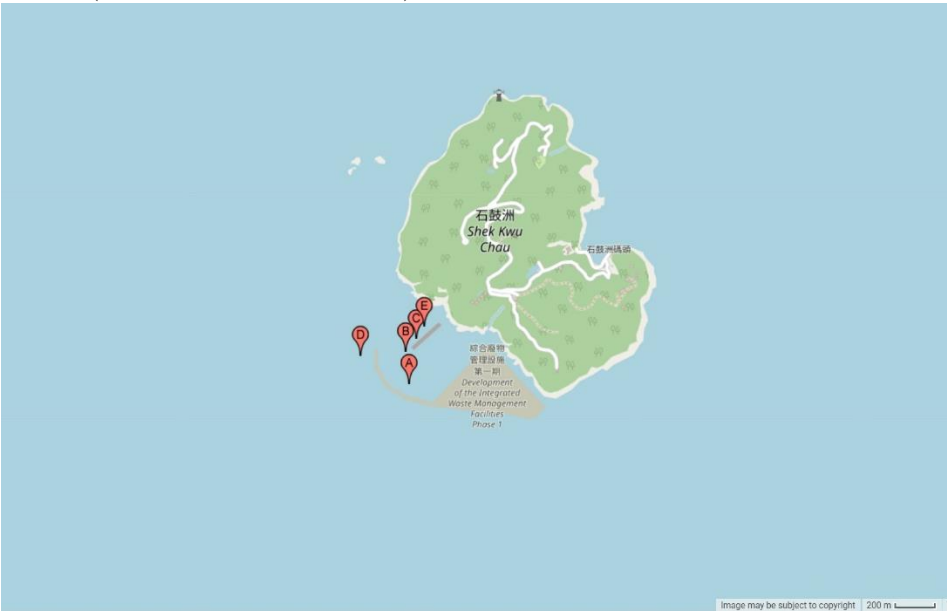
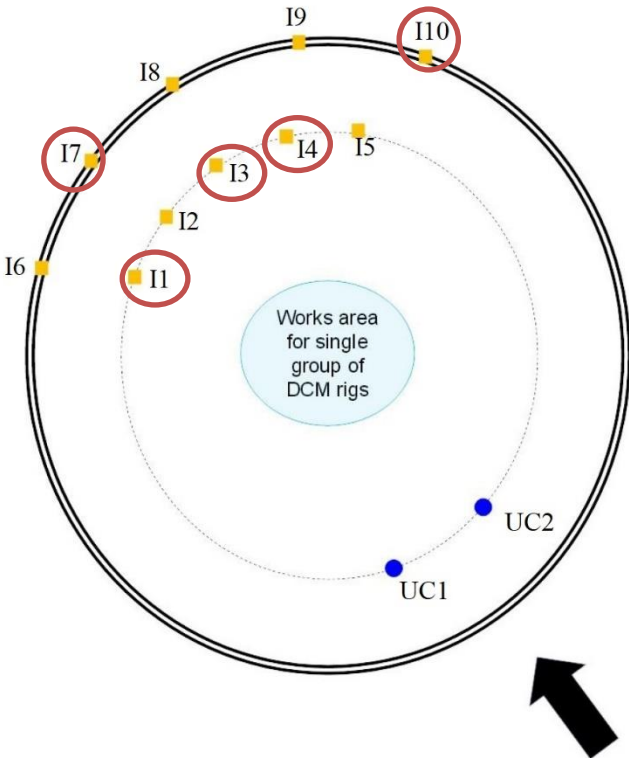
Project	Integrated Waste Management Facilities, Phase 1
Date	21 February 2019 (Lab result received on 26 February 2019)
Time	08:00 - 09:50 (Mid-Flood)
Mid-Flood	
Monitoring Location	<p> I1 : A (N22°11.343 E113° 59.976) I3 : B (N22°11.429 E113° 58.967) I4 : C (N22°11.465 E113° 58.996) I7 : D (N22°11.419 E113° 58.835) I10 : E (N22°11.496 E113° 59.019) </p>

<p>Note: Drawing is not to scale</p> <p style="text-align: right;">Tide Direction</p>

6.5 mg/L (I1) 5.5 mg/L (I3) 6.2 mg/L (I4) 5.7 mg/L (I7) 5.7 mg/L (I10)	2.5 mg/L (UC1) 6.5 mg/L (UC2)	2.0 mg/L (I2) 3.7 mg/L (I5) 3.2 mg/L (I6) 5.2 mg/L (I8) 4.0 mg/L (I9)
Possible reason for Action or Limit Level Non-compliance	<p>Works scheduled on site on 21/02 include laying of geotextile at caisson seawall area, laying of sand blanket at caisson seawall area, removal of surface rock at vertical blockwork seawall area, post cone penetration test work, post cone penetration test for Pre-construction Site Trial, DCM sample coring for DCM main works and DCM main works.</p> <p>Dominating sea current direction was found to be from Southeast to Northwest at waters around Shek Kwu Chau.</p> <p>From MMO monitoring records on 21/02, MMO teams were arranged to two DCM barges (ESC-61 & ESC-62) and three derrick barges (DL-5, Kam Ying No.8 & FTB-19) on that day while no deficiency of silt curtain was found before the start of construction activity.</p> <p>I1, I3, I4, I7 & I10 are located close to the work location within the Project site while silt curtain checking was implemented on DL5 (08:00), FTB19 (15:00), ESC-62 (07:00), ESC-61 (14:30) and Kam Ying No.8 (16:30) by the Contractor and checking results showed that no deficiency of silt curtain was found on that day. When compared to the baseline data of dry season (Action Level: 8mg/L & Limit Level: 10mg/L), most of the monitoring stations (including upstream control station UC1 and UC2) were relatively low, it might suggest that the SS exceedance at I1, I3, I4, I7 & I10 are deemed to be unrelated to the Project.</p>

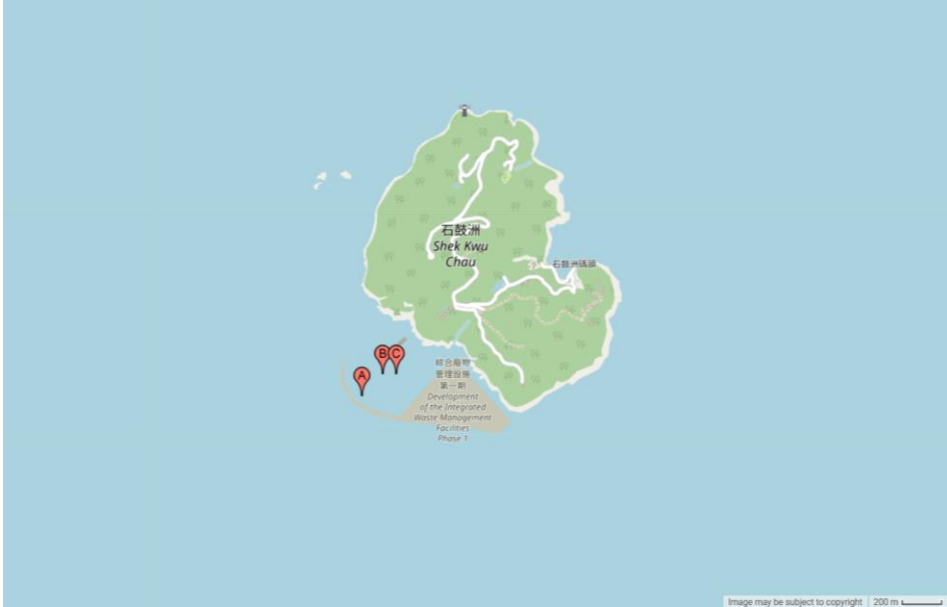
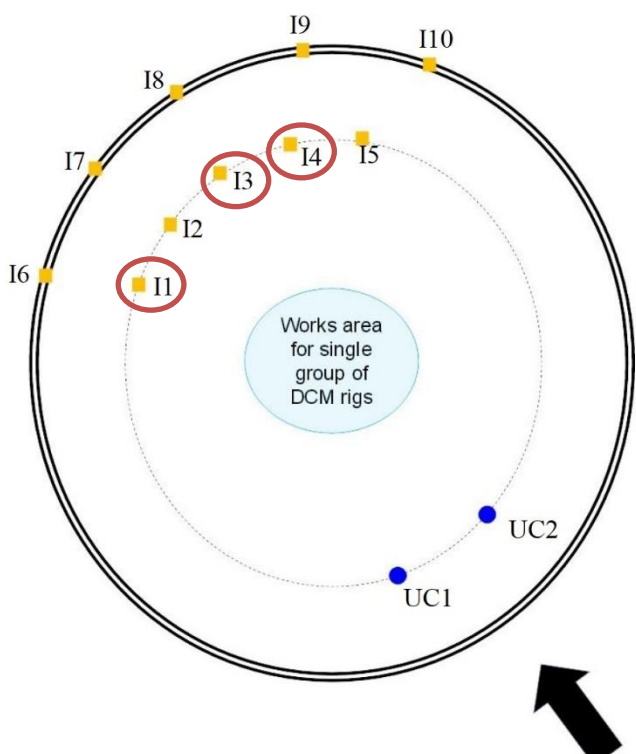
Project	Integrated Waste Management Facilities, Phase 1	
Date	22 February 2019 (Lab result received on 27 February 2019)	
Time	08:00 - 10:22 (Mid-Flood)	
Monitoring Location	Mid-Flood	
	I1 : A (N22°11.348 E113° 58.937) I3 : B (N22°11.407 E113° 59.000) I4 : C (N22°11.407 E113° 59.038)

<p data-bbox="518 1915 821 1948">Note: Drawing is not to scale</p>	
Parameter	Suspended Solid (SS)	
Action & Limit Levels	Action Level	Limit Level

2.7 mg/L (I1) 4.2 mg/L (I3) 3.0 mg/L (I4)	2.3 mg/L (UC1) 2.0mg/L (UC2)	2.0 mg/L (I2) 2.3 mg/L (I5) 2.5 mg/L (I6) 2.5 mg/L (I7) 2.5 mg/L (I8) 2.2 mg/L (I9) 2.0 mg/L (I10)
Possible reason for Action or Limit Level Non-compliance	<p>Works scheduled on site on 22/02 include laying of geotextile at caisson seawall area, laying of sand blanket at caisson seawall area, post cone penetration test work, DCM sample coring for DCM main works and DCM main works.</p> <p>Dominating sea current direction was found to be from Southeast to Northwest at waters around Shek Kwu Chau.</p> <p>From MMO monitoring records on 22/02, MMO teams were arranged to two DCM barges (ESC-61 & ESC-62) and two derrick barges (Kam Ying No,8 & FTB-19) on that day while no deficiency of silt curtain was found before the start of construction activity.</p> <p>I1, I3 & I4 are located close to the work location within the Project site while silt curtain checking was implemented on FTB19 (08:00), ESC-62 (07:00), ESC-61 (08:30) and Kam Ying No.8 (16:00) by the Contractor and checking results showed that no deficiency of silt curtain was found on that day. When compared to the baseline data of dry season (Action Level: 8mg/L & Limit Level: 10mg/L), most of the monitoring stations (including upstream control station UC1 and UC2) were relatively low, it might suggest that the SS exceedance at I1, I3 & I4 are deemed to be unrelated to the Project.</p> <p>Site tidiness in the present barges in the Project site were checked during weekly site inspection on 26/02, where was no major observation of improper site practice that might contribute to the increase in SS level was observed during the inspection.</p>

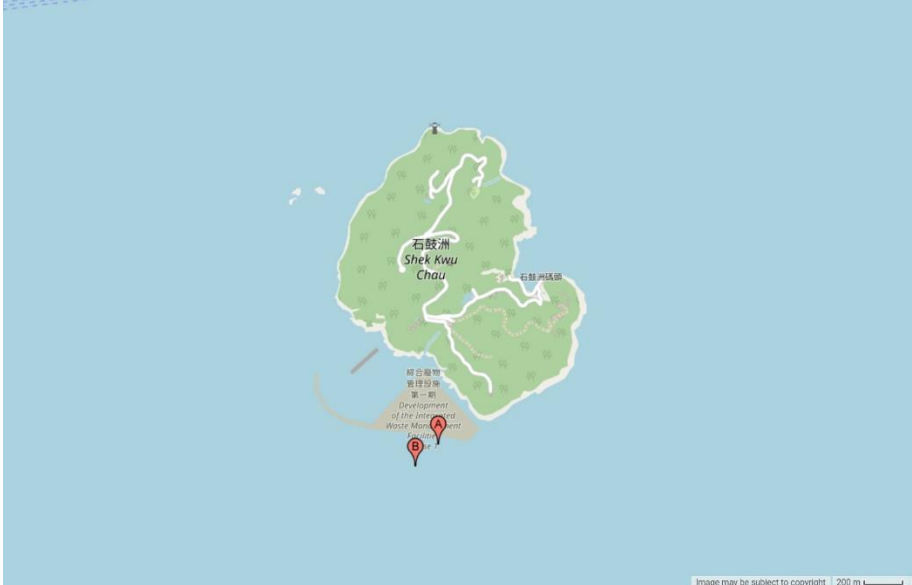
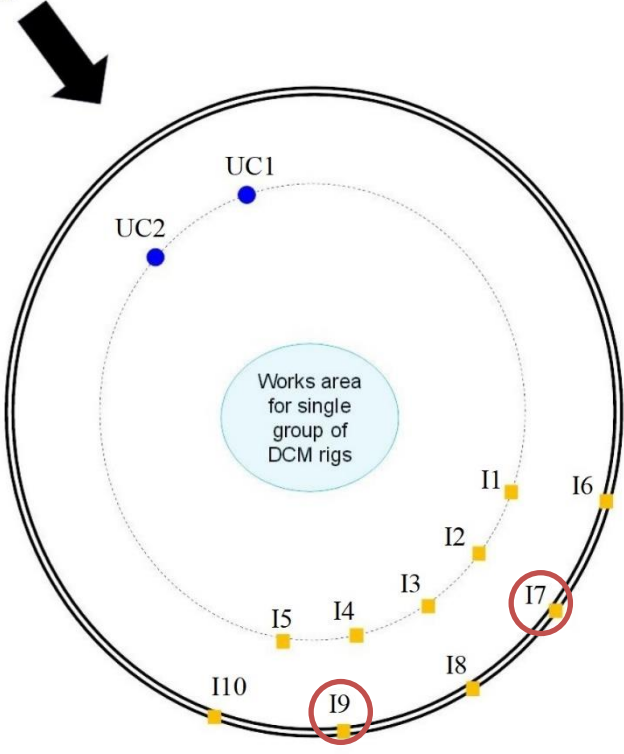
Project	Integrated Waste Management Facilities, Phase 1	
Date	23 February 2019 (Lab result received on 26 February 2019)	
Time	13:21 - 16:51 (Mid-Ebb)	
Monitoring Location	<p style="text-align: center;">Mid-Ebb</p> <p>I7 : A (N22°11.236 E113° 59.249) I9 : B (N22°11.236 E113° 59.179)</p>

<p style="text-align: center;">Tide Direction</p>

<p style="text-align: center;">Note: Drawing is not to scale</p>	
Parameter	Suspended Solid (SS)	
Action & Limit Levels	Action Level	Limit Level
	≥ 4.3 mg/L (120% of average of UC1 &	≥ 4.7 mg/L (130% of average of UC1 &

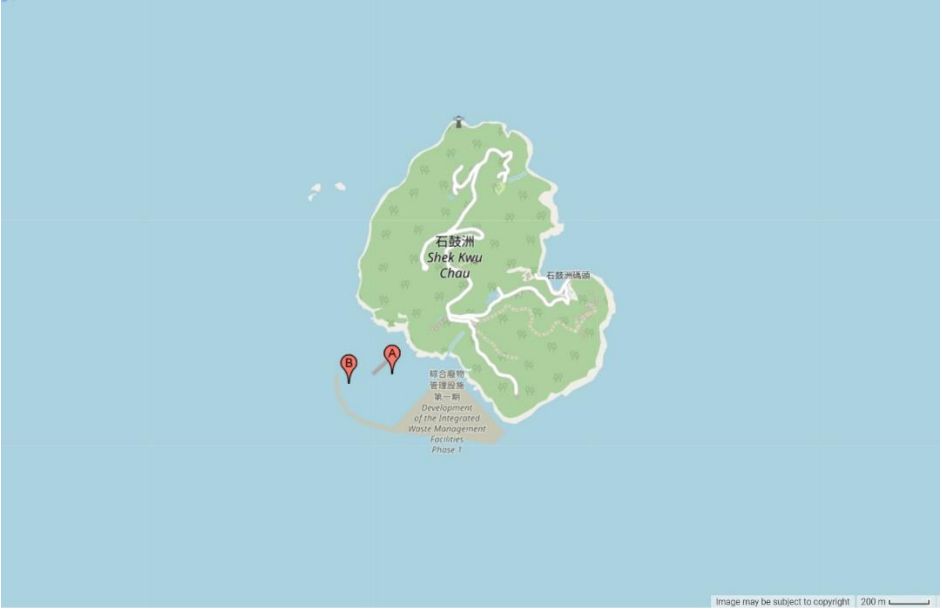
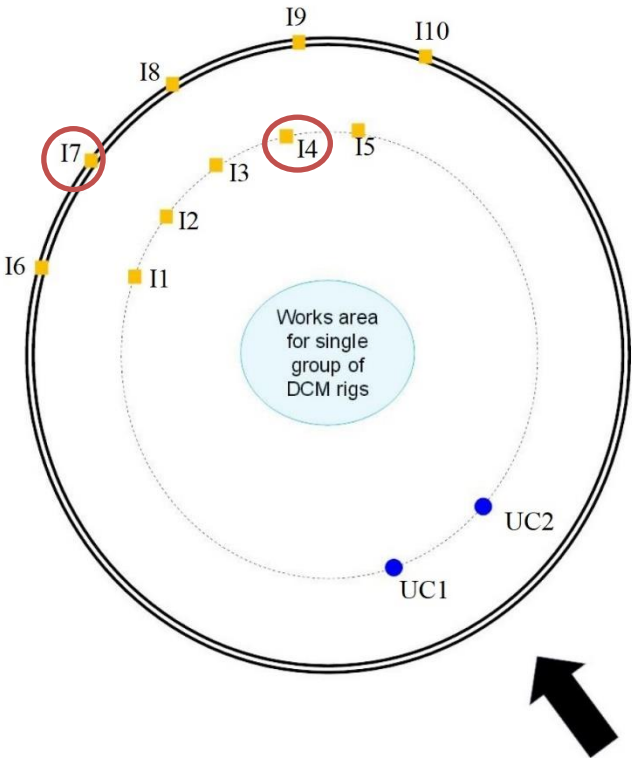
Project	Integrated Waste Management Facilities, Phase 1	
Date	24 February 2019 (Lab result received on 27 February 2019)	
Time	08:00 - 11:27 (Mid-Flood) 14:03 - 17:33 (Mid-Ebb)	
Mid-Flood		
Monitoring Location	<p>I4 : A (N22°11.437 E113° 59.043) I7 : B (N22°11.412 E113° 58.918)</p>

<p>Note: Drawing is not to scale</p>	
Parameter	Suspended Solid (SS)	
Action & Limit Levels	Action Level	Limit Level

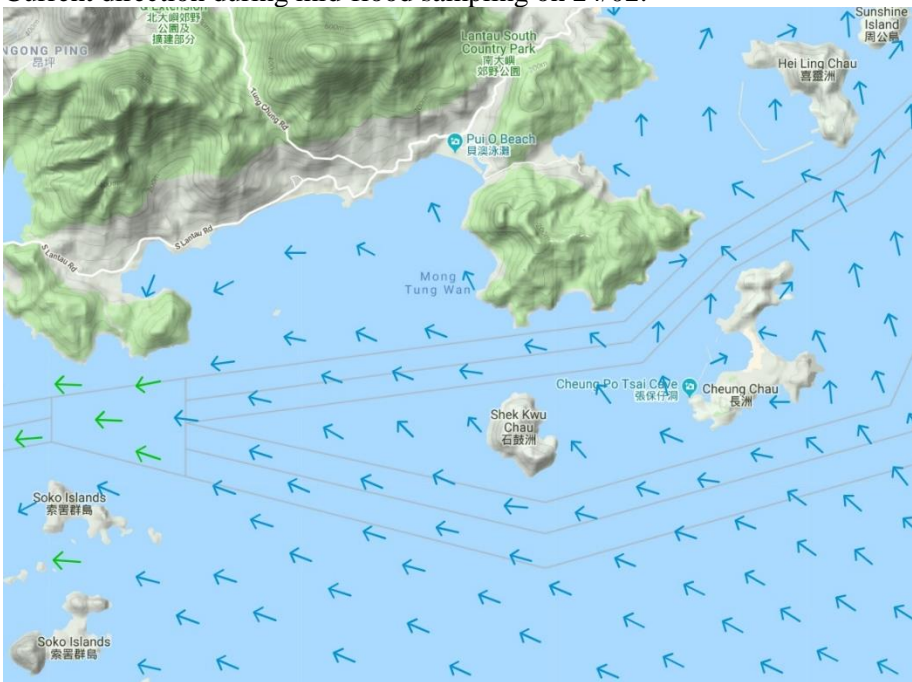
Actions taken / to be taken	Examination of environmental performance of the Project will be continued during the weekly inspection, and the Contractor is remained to implement all applicable mitigation measures as per the Updated EM&A Manual.
Remarks	<p>Current direction during mid-flood sampling on 24/02:</p>

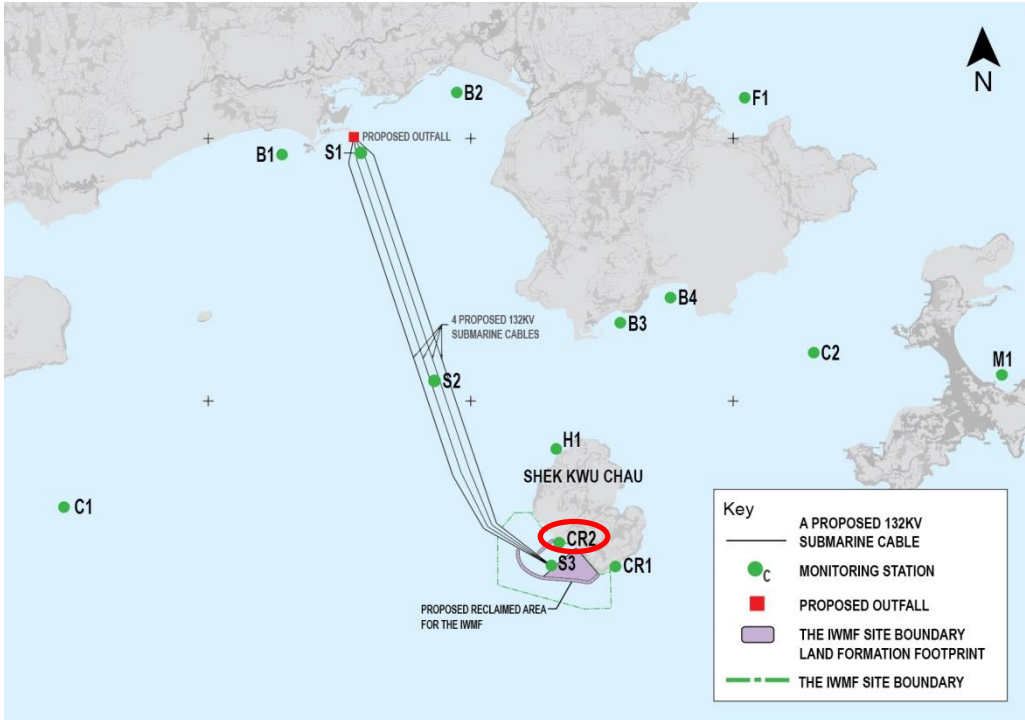
Project	Integrated Waste Management Facilities, Phase 1		
Date	25 February 2019 (Lab result received on 5 March 2019)		
Time	14:56 – 18:26 (Mid-Ebb)		
Mid-Ebb			
Monitoring Location	CR2

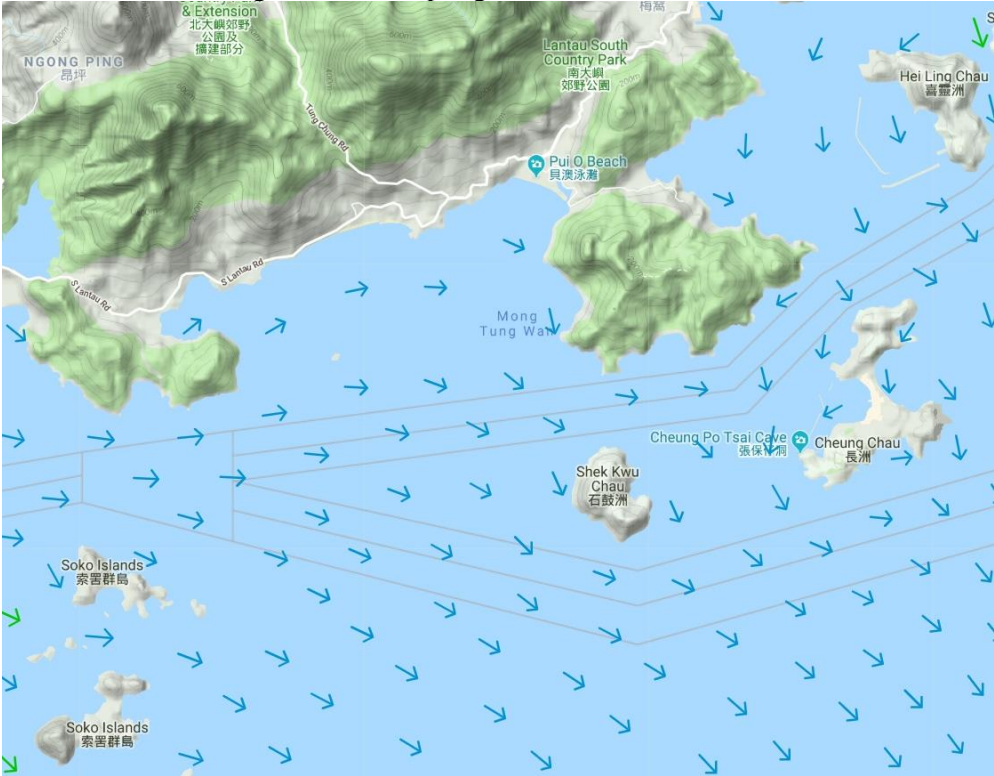
<p>19 (07:00) & ESC-61 (08:30) by the Contractor and checking results showed that no deficiency of silt curtain was found on that day. No sand blanket laying work scheduled in Cheung Kee No.7 was carried out with referring to the site diary on that day. It might suggest that the SS exceedance at CR2 is deemed to be unrelated to the Project.</p> <p>Site tidiness in the present barges in the Project site were checked during weekly site inspection on 26/02, where was no major observation of improper site practice that might contribute to the increase in SS level was observed during the inspection.</p>
<p>Actions taken / to be taken</p>	<p>Examination of environmental performance of the Project will be continued during the weekly inspection, and the Contractor is remained to implement all applicable mitigation measures as per the Updated EM&A Manual.</p>
<p>Remarks</p>	<p>Current direction during mid-ebb sampling on 25/02:</p>

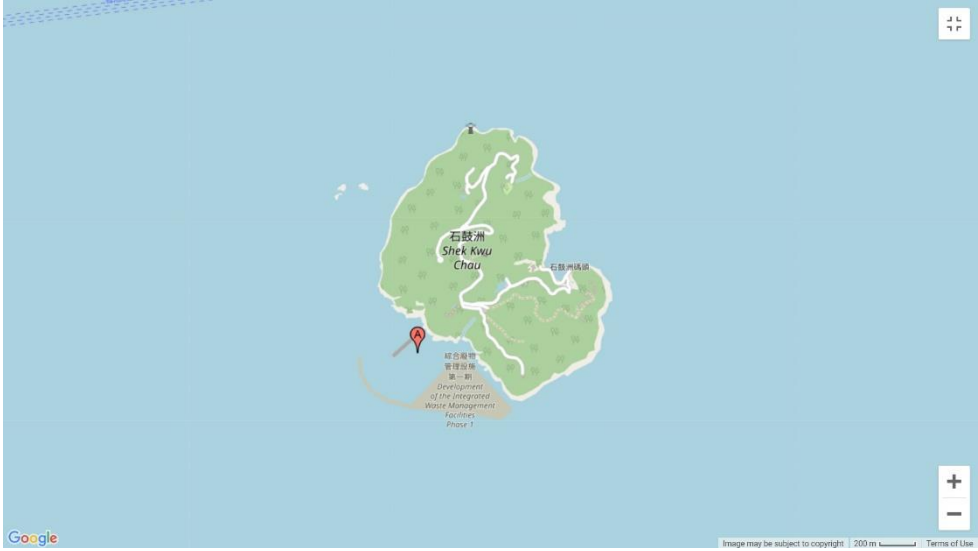
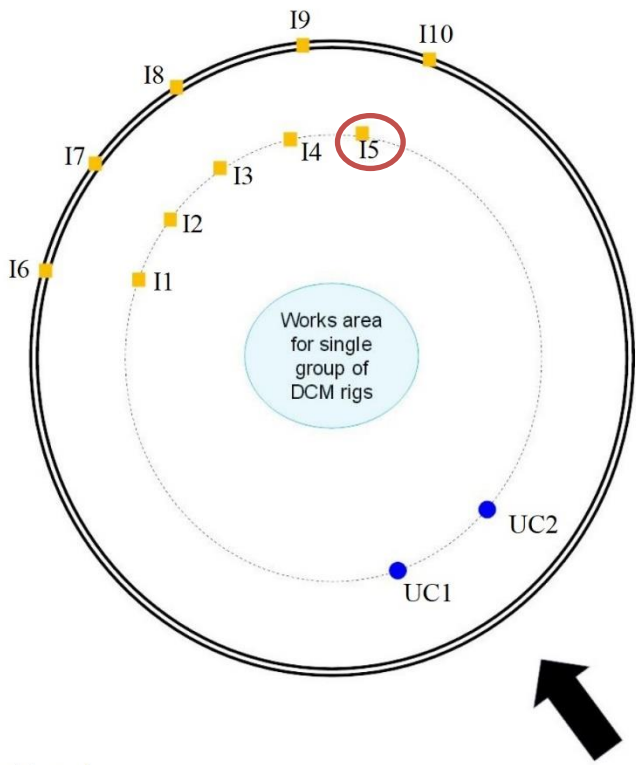
Project	Integrated Waste Management Facilities, Phase 1		
Date	26 February 2019 (Lab result received on 6 March 2019)		
Time	09:13 - 12:43 (Mid-Flood) 16:13 - 19:00 (Mid-Ebb)		
Mid-Flood			
Monitoring Location	I5 : A (N22°11.449 E113° 59.067)

<p style="text-align: center;">Note: Drawing is not to scale</p> <p style="text-align: right;">Tide Direction</p>		
Parameter	Suspended Solid (SS)		
Action & Limit Levels	Action Level	Limit Level	
	≥ 6.9 mg/L (120% of average of UC1 & UC2)	≥ 7.5 mg/L (130% of average of UC1 & UC2)	
Measurement Level	Impact Station(s) of	Control Stations	Impact Station(s) without

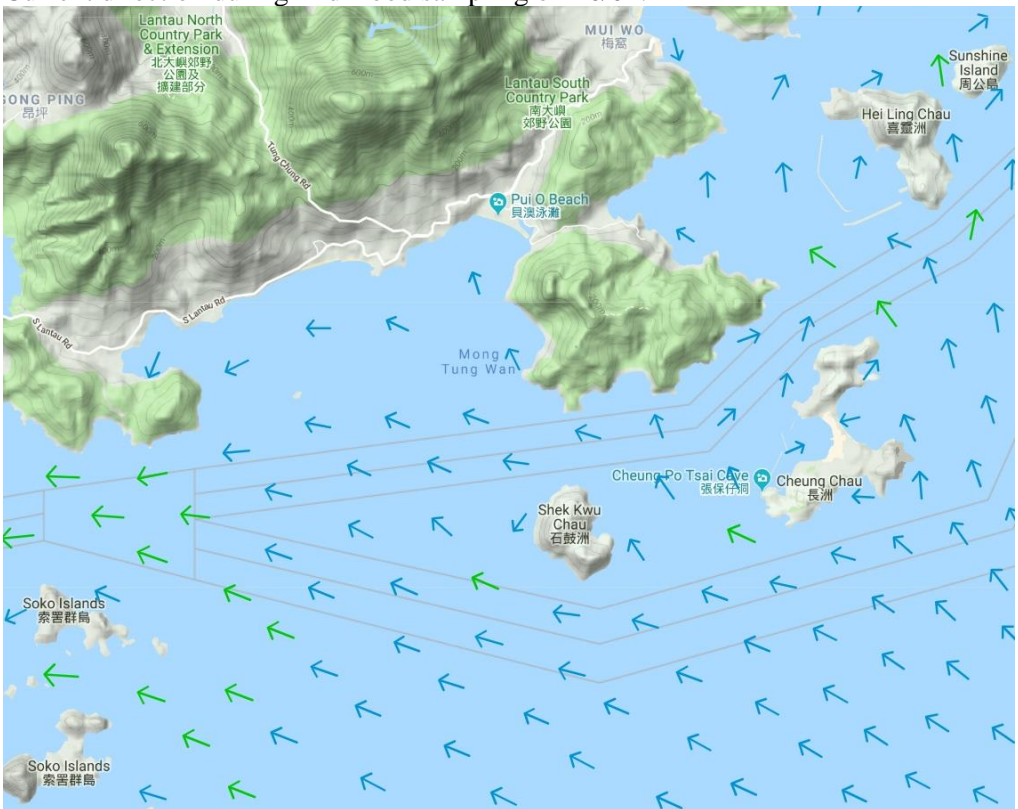
Actions taken / to be taken	Examination of environmental performance of the Project will be continued during the weekly inspection, and the Contractor is remained to implement all applicable mitigation measures as per the Updated EM&A Manual.	
Remarks	<p>Current direction during mid-flood sampling on 26/02:</p>

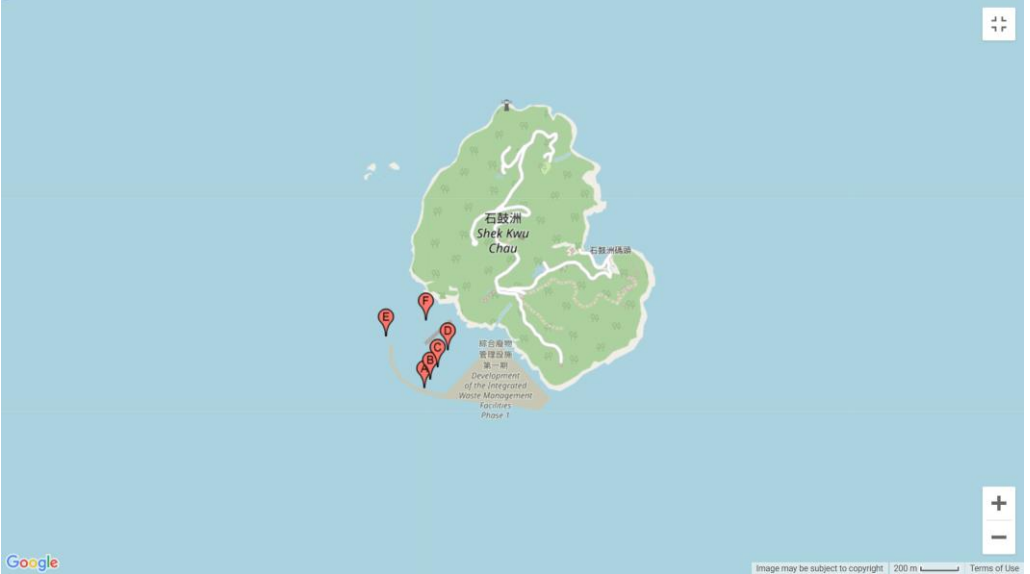
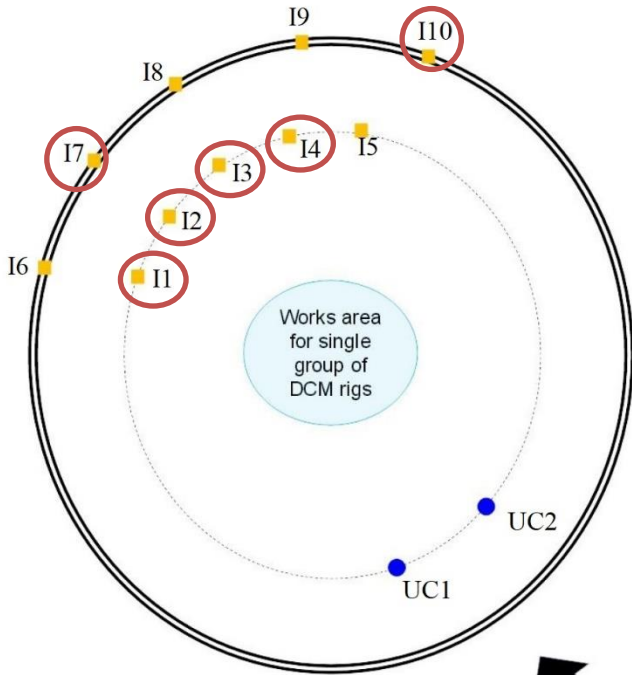
Project	Integrated Waste Management Facilities, Phase 1
Date	28 February 2019 (Lab result received on 7 March 2019)
Time	11:11 - 14:41 (Mid-Flood) 17:10 - 19:00 (Mid-Ebb)
Mid-Flood	
Monitoring Location	<p> I1 : A (N22°11.310 E113° 58.985) I2 : B (N22°11.334 E113° 59.001) I3 : C (N22°11.371 E113° 59.026) I4 : D (N22°11.419 E113° 59.057) I7 : E (N22°11.460 E113° 58.865) I10 : F (N22°11.505 E113° 58.990) </p>

<p>Note: Drawing is not to scale</p> <p style="text-align: right;">Tide Direction</p>

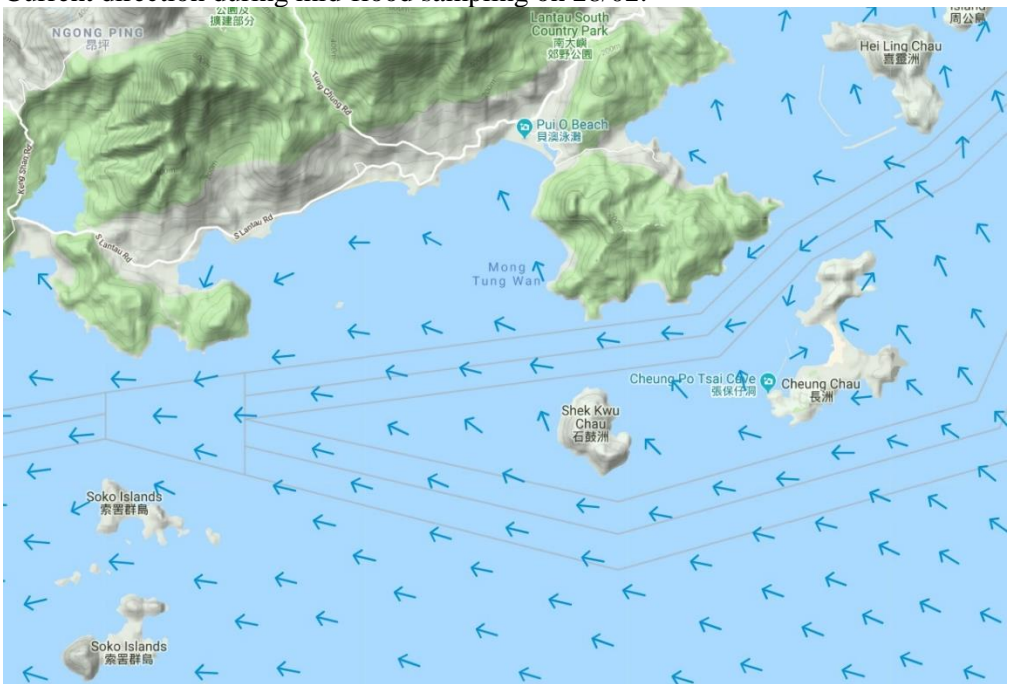
Actions taken / to be taken	Examination of environmental performance of the Project will be continued during the weekly inspection, and the Contractor is remained to implement all applicable mitigation measures as per the Updated EM&A Manual.	
Remarks	<p>Current direction during mid-flood sampling on 28/02:</p>
