Appendix N Exceedance Report

Incident Report on Action Level or Limit Level Non-compliance

Project	Integrated Waste Management Facilities, Phase 1
Date	2 March 2019 (Lab result received on 6 March 2019)
Time	09:16 – 11:40 (Mid-Ebb)
Monitoring Location	Mid-Ebb
	I5 : A (N22°11.241 E113° 59.154) I6 : B (N22°11.318 E113° 59.264) I7 : C (N22°11.252 E113° 59.287) I9 : D (N22°11.213 E113° 59.292) I10 : E (N22°11.16 E113° 59.235)

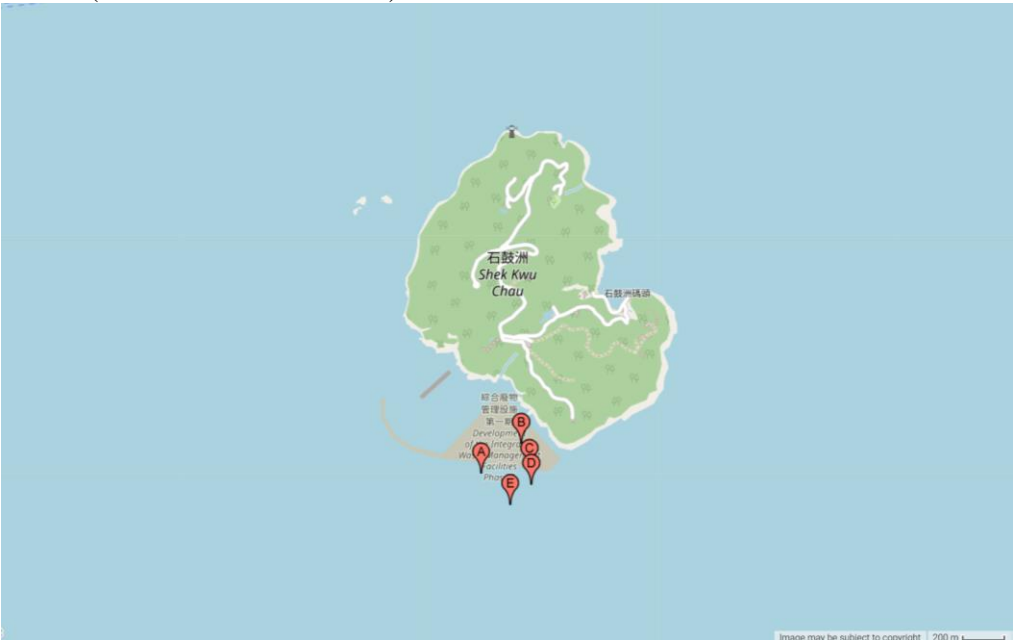
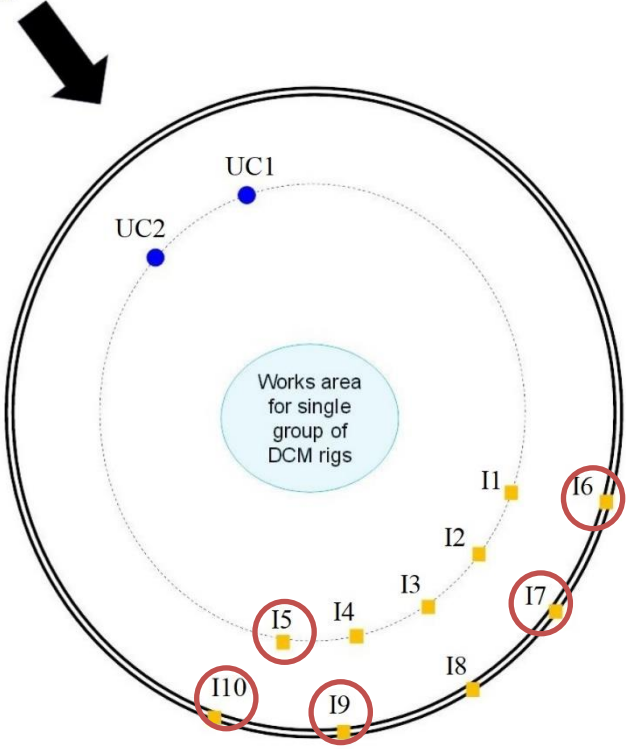
<p style="text-align: center;">Note: Drawing is not to scale</p>

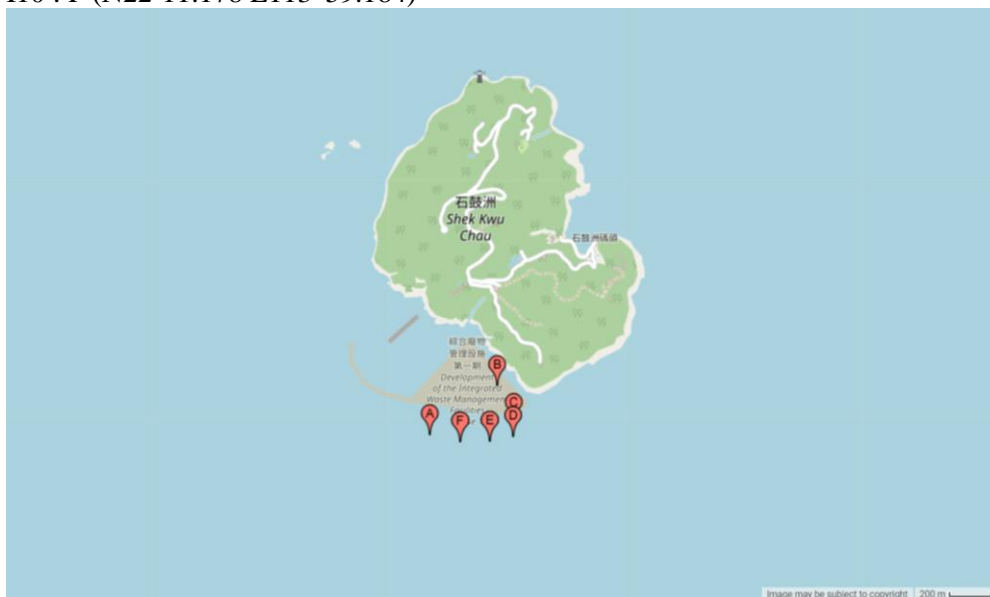
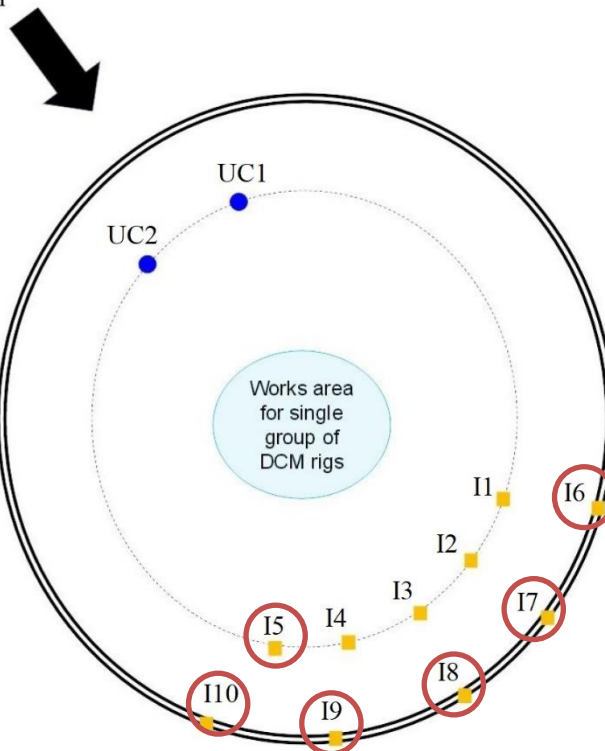
- I5 : A (N22°11.197 E113° 59.101)
- I6 : B (N22°11.324 E113° 59.288)
- I7 : C (N22°11.225 E113° 59.334)
- I8 : D (N22°11.191 E113° 59.332)
- I9 : E (N22°11.180 E113° 59.266)
- I10 : F (N22°11.178 E113° 59.184)

Note: Drawing is not to scale

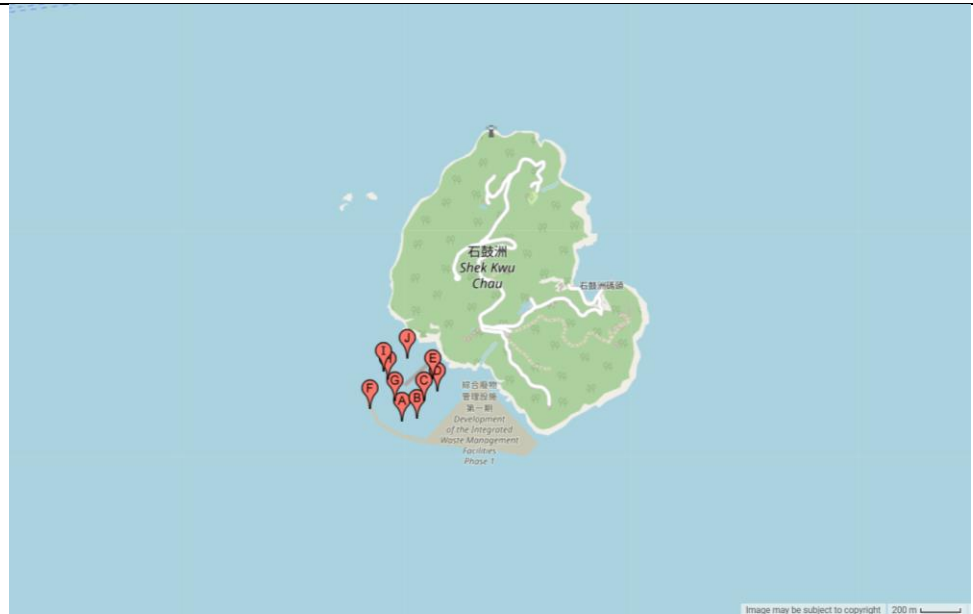
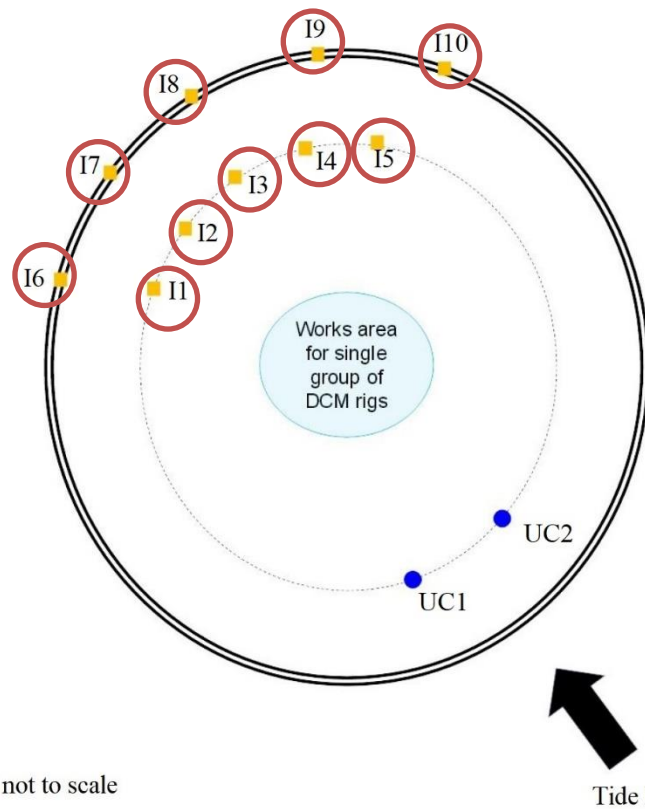
Actions taken / to be taken	Examination of environmental performance of the Project will be continued during the weekly inspection, and the Contractor is remained to implement all applicable mitigation measures as per the Updated EM&A Manual.
Mid-Flood	
Monitoring Location	<p>I1 : A (N22°11.340 E113° 58.979)</p> <p>I2 : B (N22°11.348 E113° 59.024)</p> <p>I3 : C (N22°11.394 E113° 59.043)</p> <p>I4 : D (N22°11.420 E113° 59.082)</p> <p>I5 : E (N22°11.454 E113° 59.068)</p> <p>I6 : F (N22°11.373 E113° 58.886)</p> <p>I7 : G (N22°11.394 E113° 58.958)</p> <p>I8 : H (N22°11.452 E113° 58.938)</p> <p>I9 : I (N22°11.472 E113° 58.926)</p> <p>I10 : J (N22°11.508 E113° 58.995)</p>

Note: Drawing is not to scale

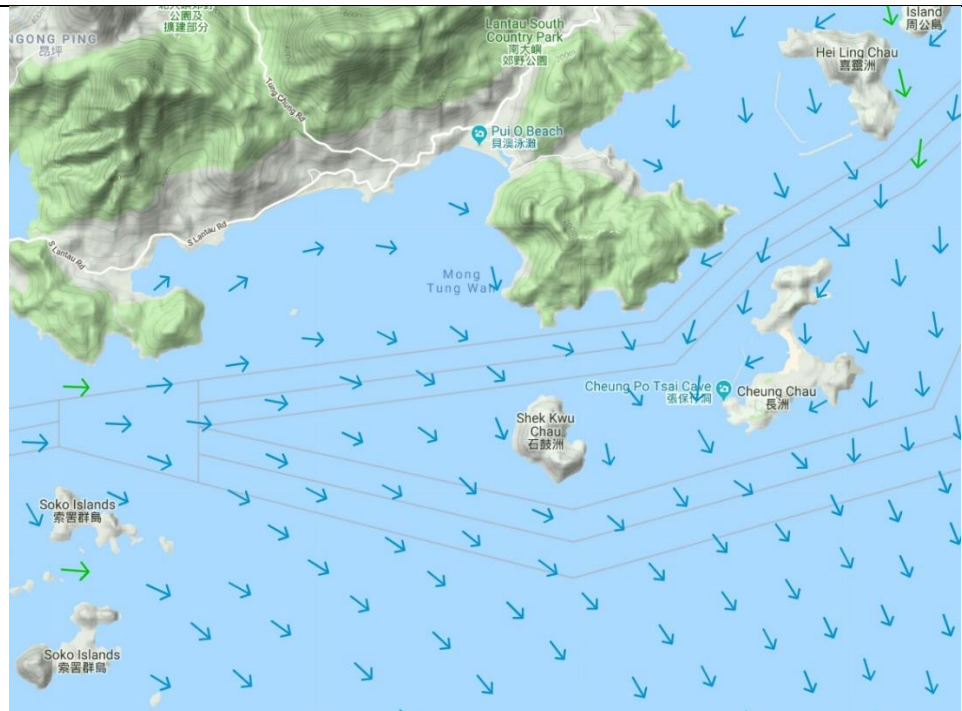
Actions taken / to be taken	<p>Examination of environmental performance of the Project will be continued during the weekly inspection, and the Contractor is remained to implement all applicable mitigation measures as per the Updated EM&A Manual.</p>		
Remarks	<p>Current direction during mid-ebb sampling on 04/03:</p>

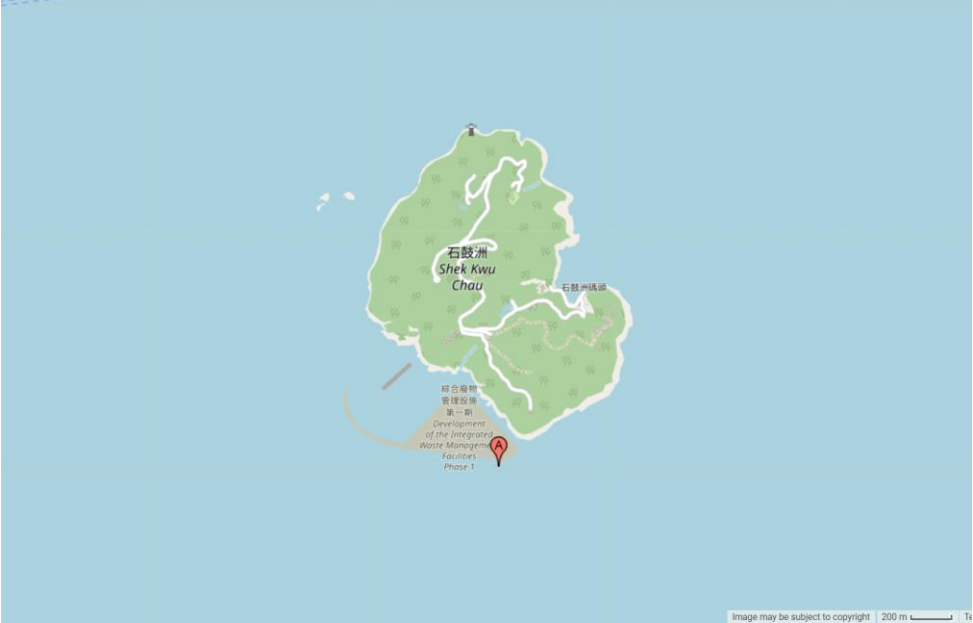
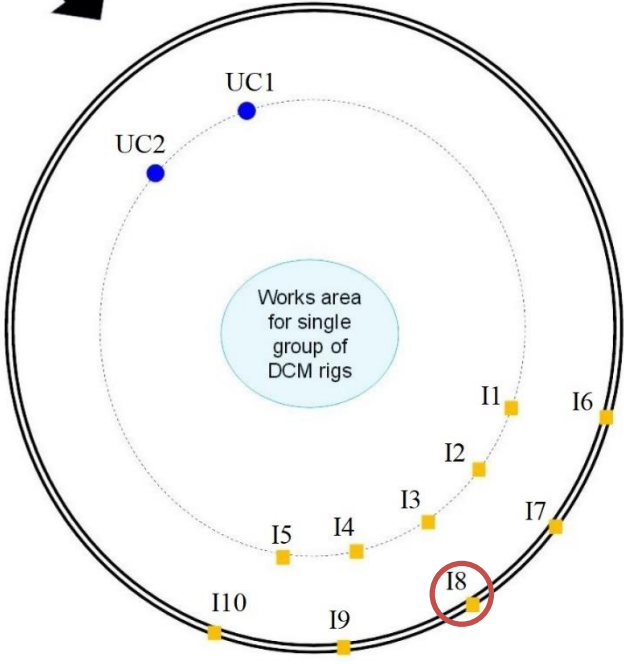
Project	Integrated Waste Management Facilities, Phase 1	
Date	6 March 2019 (Lab result received on 11 March 2019)	
Time	11:02 – 14:32 (Mid-Ebb) 16:37 – 19:00 (Mid-Flood)	
Mid-Ebb		
Monitoring Location	<p>I8 : A (N22°11.232 E113°59.137)</p>

<p style="text-align: center;">Note: Drawing is not to scale</p>	
Parameter	Suspended Solid (SS)	
Action & Limit Levels	Action Level	Limit Level

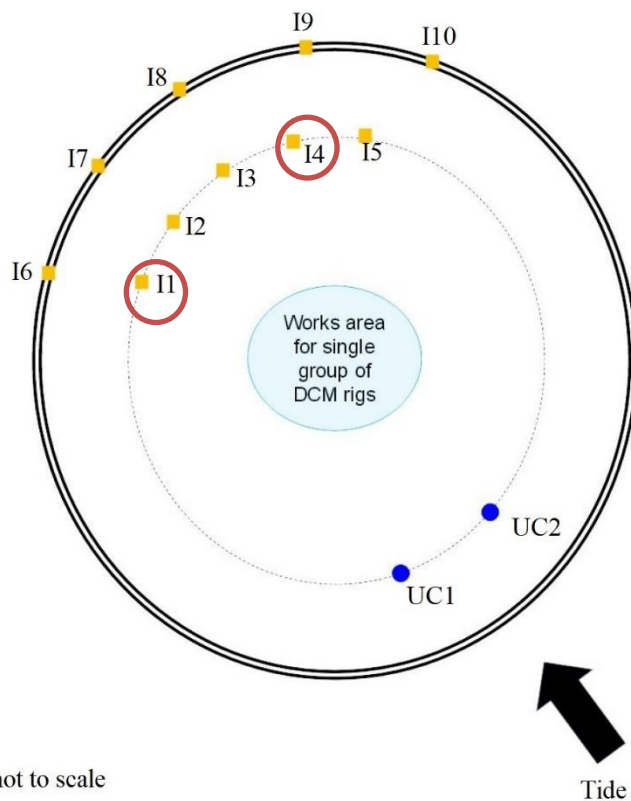
Actions taken / to be taken	Examination of environmental performance of the Project will be continued during the weekly inspection, and the Contractor is remained to implement all applicable mitigation measures as per the Updated EM&A Manual.		
Mid-Flood			
Monitoring Location	I1 : A (N22°11.302 E113° 58.979) I4 : B (N22°11.402 E113° 59.093)

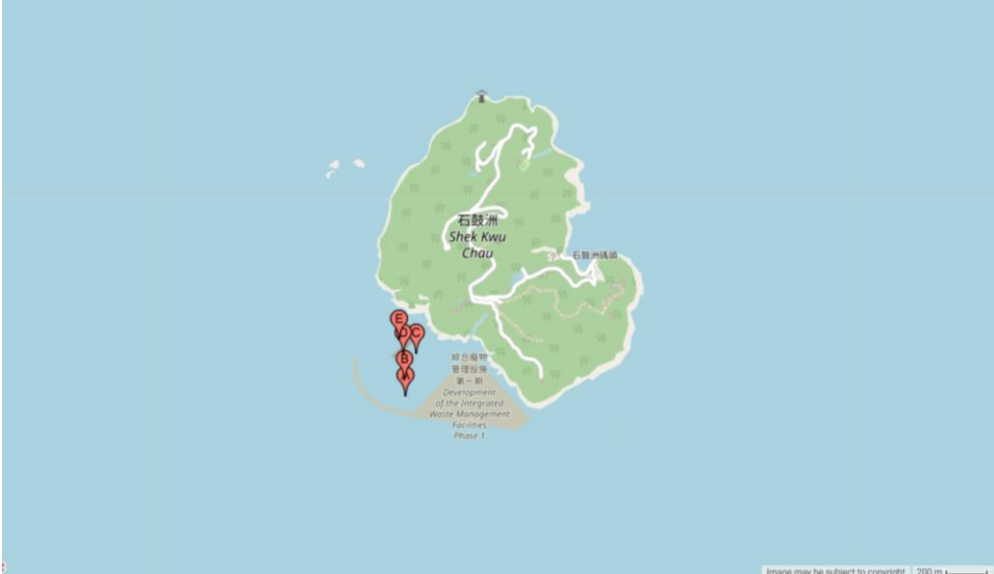
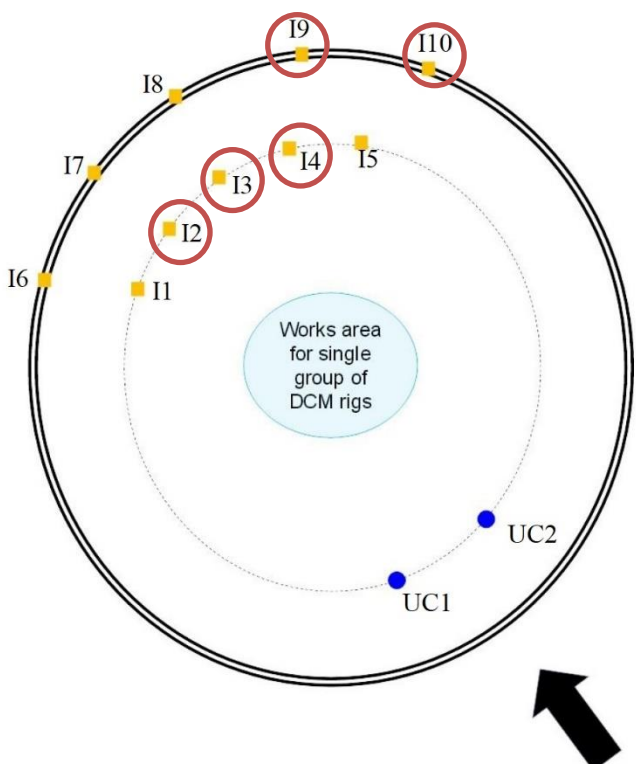
Project	Integrated Waste Management Facilities, Phase 1
Date	8 March 2019 (Lab result received on 13 March 2019)
Time	16:37 – 19:00 (Mid-Flood)
Monitoring Location	Mid-Flood
	<p>I2 : A (N22°11.335 E113° 59.023) I3 : B (N22°11.379 E113° 59.020) I4 : C (N22°11.446 E113° 59.054) I9 : D (N22°11.446 E113° 59.018) I10 : E (N22°11.482 E113° 59.004)</p>

<p style="text-align: center;">Note: Drawing is not to scale</p> <p style="text-align: right;">Tide Direction

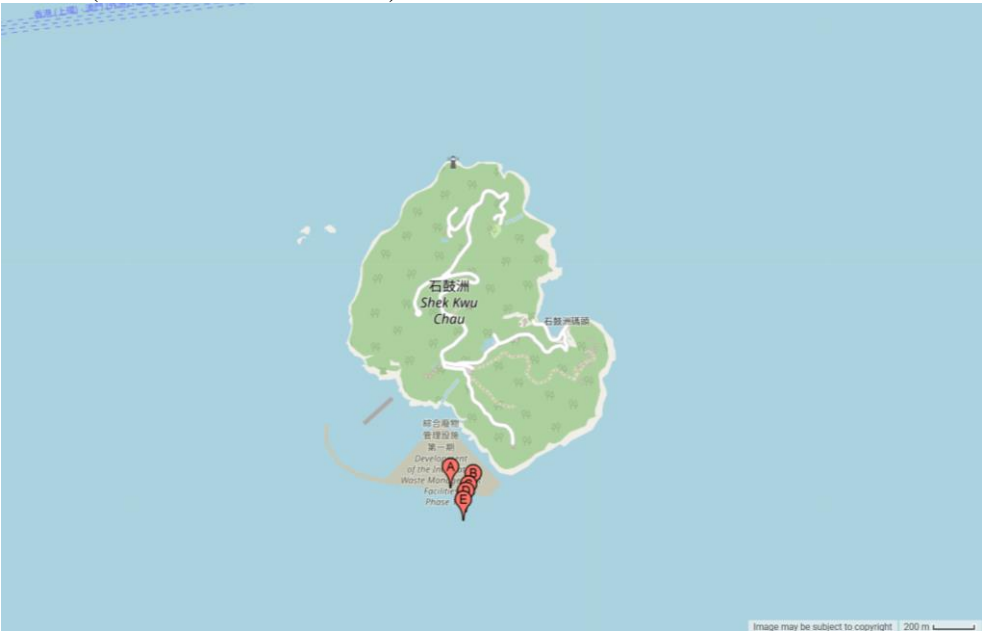
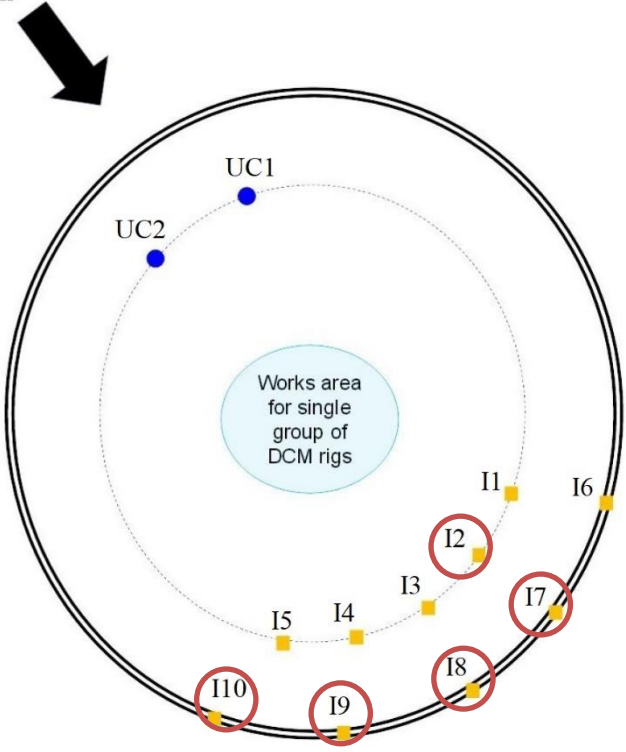
Project	Integrated Waste Management Facilities, Phase 1
Date	10 March 2019 (Lab result received on 13 March 2019)
Time	12:51 – 16:21 (Mid-Ebb)
Monitoring Location	<p style="text-align: center;">Mid-Ebb</p> <p>I2 : A (N22°11.241 E113° 59.154) I7 : B (N22°11.318 E113° 59.264) I8 : C (N22°11.252 E113° 59.287) I9 : D (N22°11.213 E113° 59.292) I10 : E (N22°11.16 E113° 59.235)</p>

<p>Note: Drawing is not to scale</p>

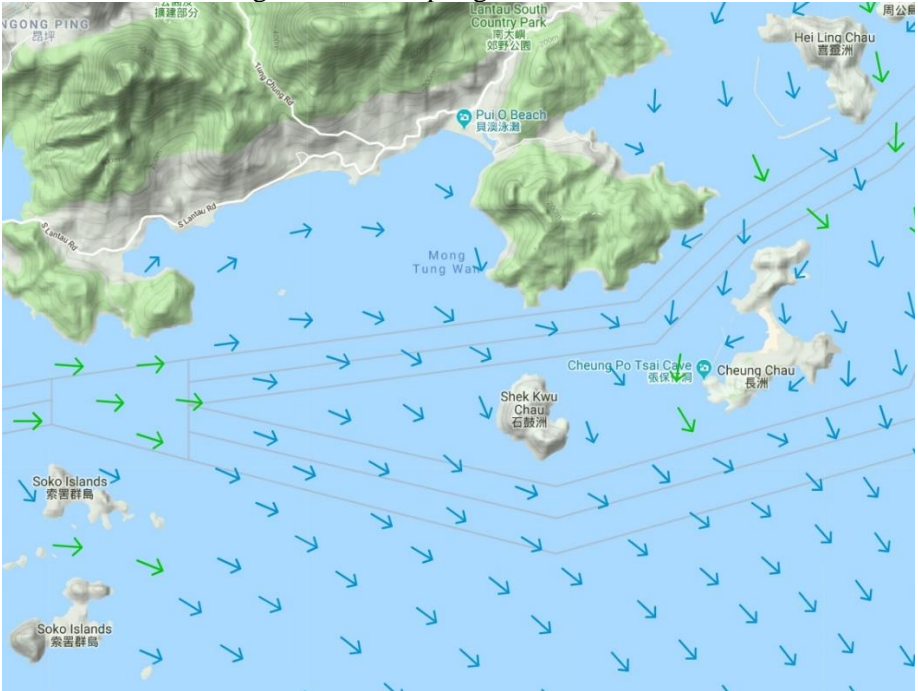
<p>Actions taken / to be taken</p>	<p>Part of the silt curtain at the back location of the barge was maintained on 12/03. The Contractor was reminded to keep tracking on the status of the deployed silt curtain during construction works.</p> <p>Examination of environmental performance of the Project will be continued during the weekly inspection, and the Contractor is remained to implement all applicable mitigation measures as per the Updated EM&A Manual.</p>
<p>Remarks</p>	<p>Current direction during mid-ebb sampling on 13/03:</p>

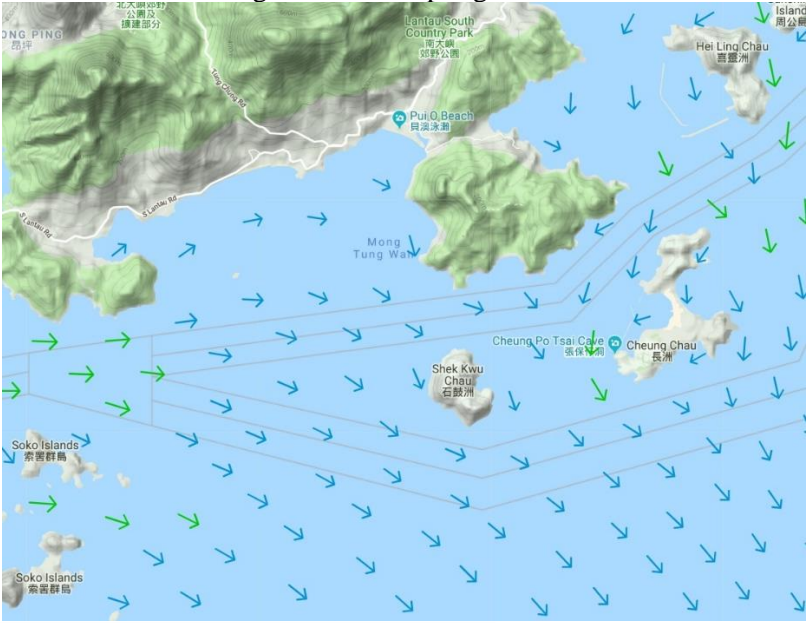
<p>Actions taken / to be taken</p>	<p>Part of the silt curtain at the back location of the barge was maintained on 12/03. The Contractor was reminded to keep tracking on the status of the deployed silt curtain during construction works.</p> <p>Examination of environmental performance of the Project will be continued during the weekly inspection, and the Contractor is remained to implement all applicable mitigation measures as per the Updated EM&A Manual.</p>
<p>Remarks</p>	<p>Current direction during mid-ebb sampling on 15/03:</p>

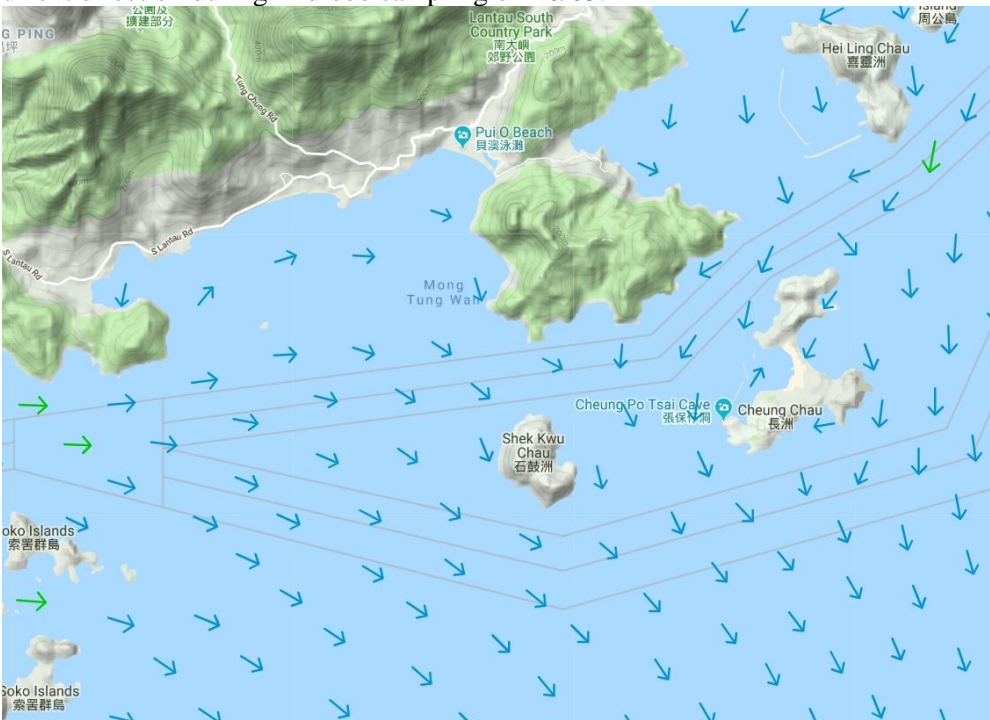
<p>Actions taken / to be taken</p>	<p>Examination of environmental performance of the Project will be continued during the weekly inspection, and the Contractor is remained to implement all applicable mitigation measures as per the Updated EM&A Manual.</p>
<p>Remarks</p>	<p>Current direction during mid-ebb sampling on 20/03:</p>

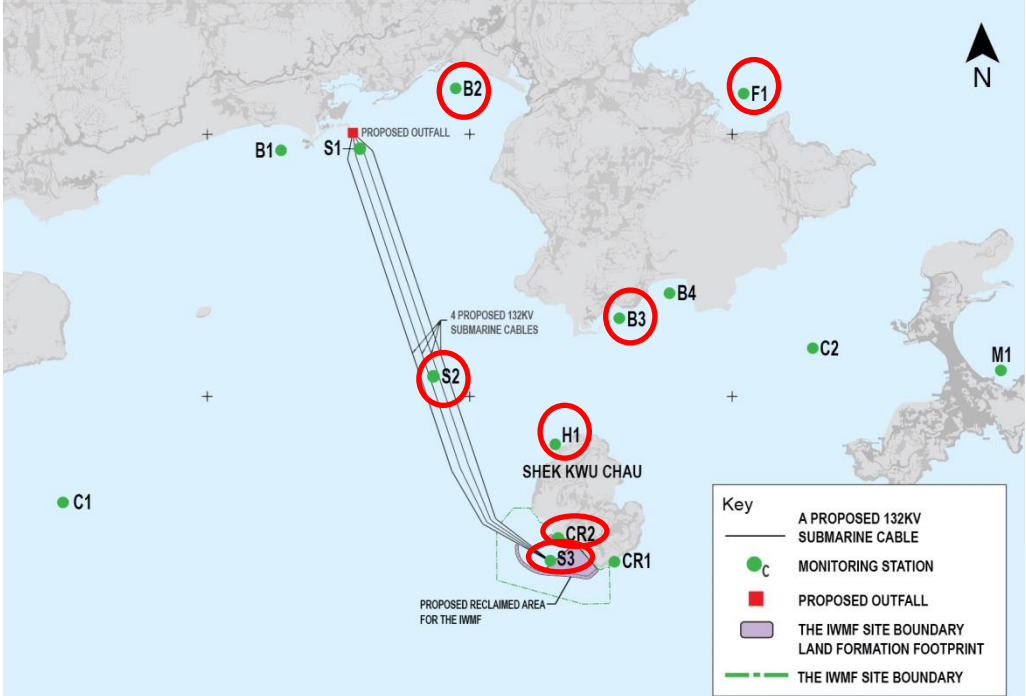
<p>Actions taken / to be taken</p>	<p>The damage of silt curtain at the stern near the anchor ESC-61 was maintained on 01/04. The Contractor was reminded to keep tracking on the status of the deployed silt curtain during construction works.</p> <p>Examination of environmental performance of the Project will be continued during the weekly inspection, and the Contractor is remained to implement all applicable mitigation measures as per the Updated EM&A Manual.</p>		
<p>Mid-Ebb</p>			
<p>Monitoring Location</p>	<p>B2, B3, F1, H1, CR2, S2 & S3</p>

<p>Parameter</p>	<p>Suspended Solid (SS)</p>		
<p>Action & Limit Levels</p>	<p>Action Level</p>		<p>Limit Level</p>
	<p>≥ 8.4 mg/L (120% of C1)</p>		<p>≥ 10.0 mg/L</p>
<p>Measurement Level</p>	<p>Impact Station(s) of Exceedance</p>	<p>Control Stations</p>	<p>Impact Station(s) without Exceedance</p>

8.5 mg/L (B2) 9.8 mg/L (B3) 9.2 mg/L (F1) 9.8 mg/L (H1) 9.8 mg/L (CR2) 8.5 mg/L (S2) 8.5 mg/L (S3)	7.0 mg/L (C1) 8.5 mg/L (C2)	7.8 mg/L (B1) 7.0 mg/L (B4) 7.7 mg/L (M1) 7.5 mg/L (CR1) 8.3 mg/L (S1)
Possible reason for Action or Limit Level Non-compliance	<p>Works scheduled on site on 25/03 include laying of geotextile at caisson breakwater area, laying of sand blanket at both caisson breakwater area and caisson seawall area, post cone penetration test works, DCM sample coring for DCM main works, DCM main works, removal of surface rock at vertical blockwork seawall area and dredging at vertical blockwork seawall area.</p> <p>Dominating sea current direction was found to be from Northwest to Southeast at waters around Shek Kwu Chau.</p> <p>B2, B3, F1 & S2 are located at unrelated stream direction (neither upstream nor downstream, far away) to the works location, exceedance of these monitoring stations are deemed to be unrelated to the Project.</p> <p>From MMO monitoring records on 25/03, MMO teams were arranged to two DCM barges (ESC-61 & ESC-62) and five derrick barges (Shun Tat D12, GD-851, FTB-19, DL-5 & Cheung Kee No.10) on that day while no deficiency of silt curtain was found before the start of construction activity.</p> <p>H1 is located upstream location, CR2 & S3 are located close to the works location within the Project site while silt curtain checking was implemented by the Contractor on DL-5 (08:30), FTB-19 (20:45), ESC-62 (16:30), ESC-61 (09:15) & Shun Tat D12 (09:30) and checking results showed that no deficiency of silt curtain was found on that day. No construction works scheduled on Cheung Kee No.10 was carried out with referring to the site diary on that day. No surface rock removal work scheduled on GD-851 was carried out with referring to the site diary on that day. It might suggest that the SS exceedance at H1, CR2 & S3 are deemed to be unrelated to the Project.</p> <p>Site tidiness in the present barges in the Project site was checked during weekly site inspection on 26/03, where damage was observed on the silt curtain at the stern near the anchor on ESC-61. However, according to the investigation in the previous paragraphs, this observation was not considered as the source of SS exceedance.</p>

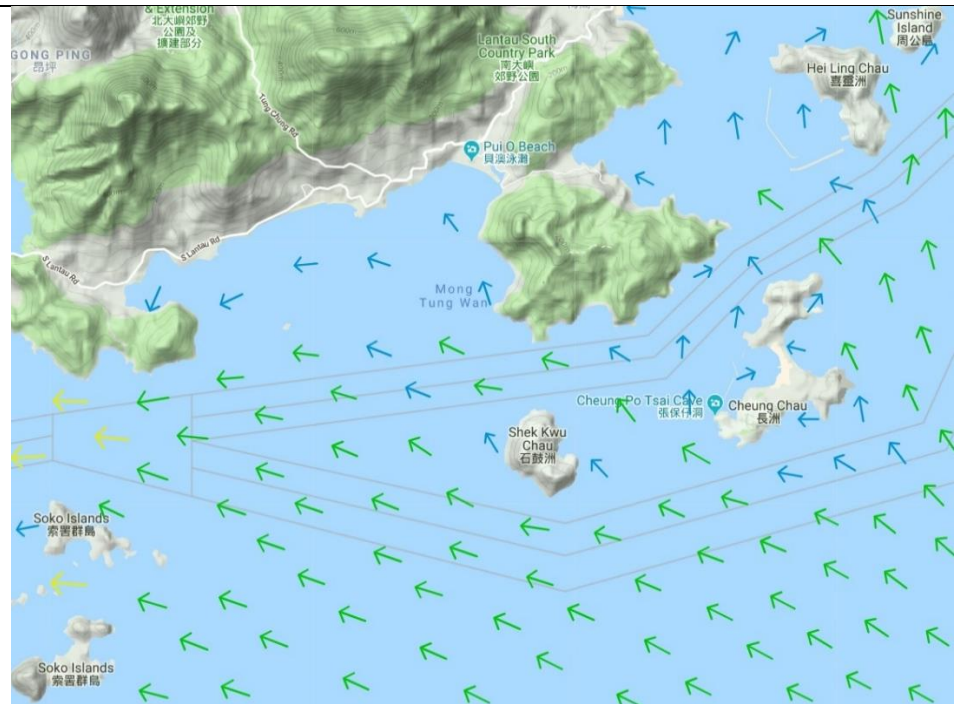
Actions taken / to be taken	<p>The damage of silt curtain at the stern near the anchor on ESC-61 was maintained on 01/04. The Contractor was reminded to keep tracking on the status of the deployed silt curtain during construction works.</p> <p>Examination of environmental performance of the Project will be continued during the weekly inspection, and the Contractor is remained to implement all applicable mitigation measures as per the Updated EM&A Manual.</p>		
Remarks	Current direction during mid-flood sampling on 25/03:
