Contract No. EP/SP/66/12 Integrated Waste Management Facilities, Phase 1 11th Quarterly EM&A Report

Quarterly EM&A Report No.11 (Period from 1 January to 31 March 2021)

(Clause 3.3, Further Environmental Permit FEP-01/429/2012/A)

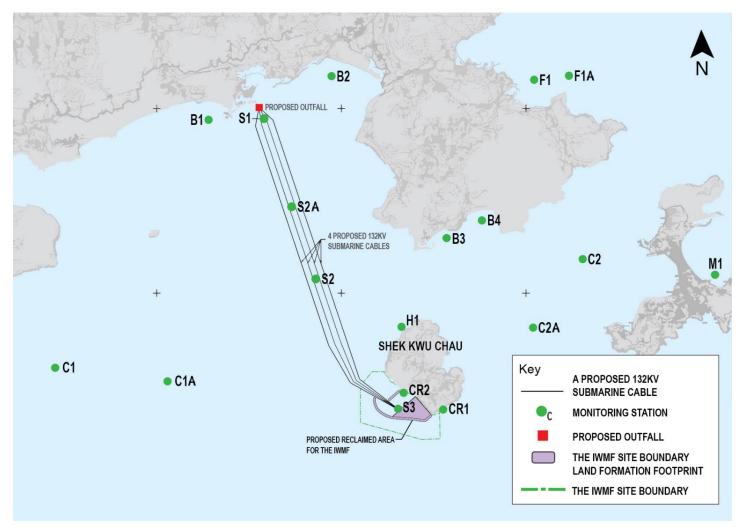
Figure 2.1 Water monitoring locations at Artificial Island near SKC

2.2.1 Impact water quality monitoring was conducted at eleven monitoring locations during general water quality monitoring as shown in **Figure 2.1**.

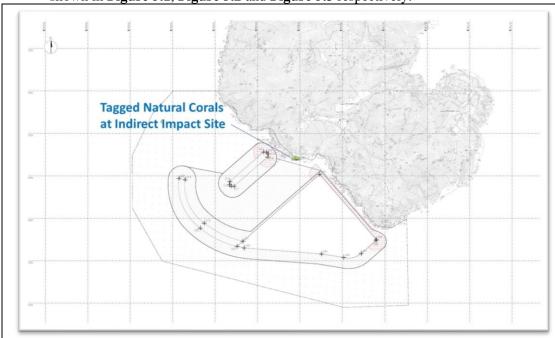
Figure 5.1 Tagged Natural Corals at Indirect Impact Site Near SKC for re-tagging after typhoon Mangkhut

Location of the ten tagged coral colonies at each of the proposed indirect impact site, control site, the recipient site R3 and REA transect at proposed indirect impact site are shown in **Figure 5.1**, **Figure 5.2** and **Figure 5.3** respectively:

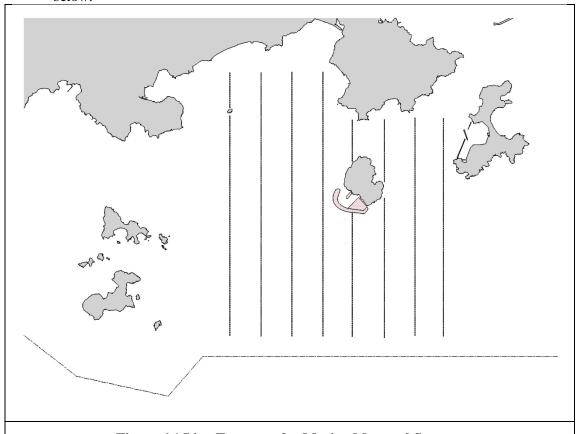
Figure 6.1 Line Transects for Marine Mammal Surveys

Eight transect lines are set at Southeast Lantau survey area, including Shek Kwu Chau, waters between Shek Kwu Chau and the Soko Islands, inshore waters of Lantau Island (e.g. Pui O Wan) as well as southwest corner of Cheung Chau as shown in **Figure 6.1** below:

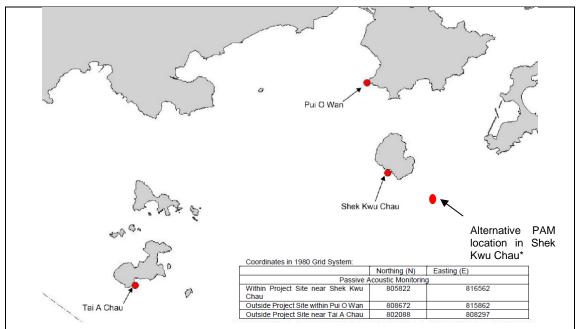
Figure 6.2 Locations of Passive Acoustic Monitoring

within Pui O Wan and to the south of Tai A Chau) and one porpoise detector within the Project Area (i.e. near Shek Kwu Chau) as shown in **Figure 6.2** below.

Note*: The alternative PAM device adjacent to the Project site was deployed from 5 Mar to 11 Apr 2019, which contained a full 37 days acoustic monitoring data set. After the confirmation of loss of the original PAM within the Project site, this data set was proposed to replace that of the original one, as consulted with AFCD accordingly.

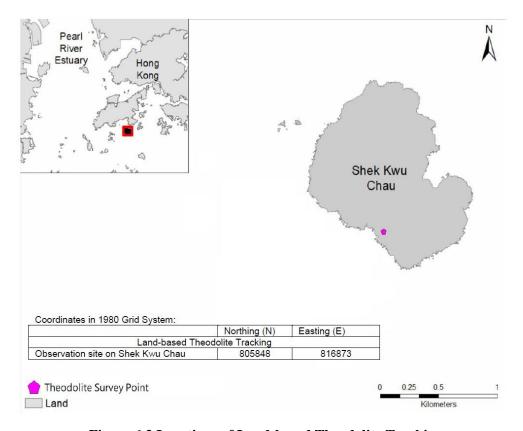
Figure 6.3 Locations of Land-based Theodolite Tracking

The Land-based Theodolite Tracking study would use the same station as in the AFCD monitoring study(same as the baseline monitoring location), which is situated at the southwest side of Shek Kwu Chau (GPS position: 22°11.47' N and 113°59.33' E) as shown in below **Figure 6.3**. The station was selected based on its height above

sea level (at least 20 metres), close proximity to shore, and relatively unobstructed views of the entire Project Area to the southwest of Shek Kwu Chau. The height of the Shek Kwu Chau Station established by the HKCRP team is 74.6 m high at mean low water, and only a few hundred metres to the IWMF reclamation site, which is ideal for the purpose for the present behavioural and movement monitoring of finless porpoises as well during construction phase considering there as an un-obstructed vantage point at a height above the Project Site.

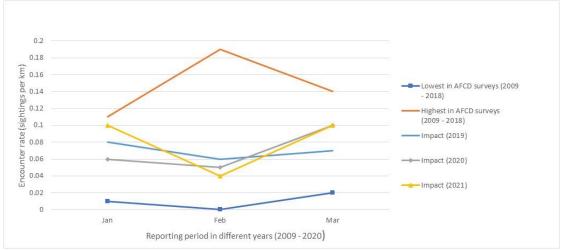
Figure 6.5 Plot of encounter rate during January to March in 2009 – 2021 from different surveys

- 6.3.1.3 A review of all the porpoise sightings in the survey area for January to March between 2009 2018 indicates that there were more sighting recorded in January to March. Given the similar survey conditions and the encounter rate recorded for porpoise in the project area during the reporting period, the encounter rate for January to March 2021 was 0.1 sighting km⁻¹, 0.04 sighting km⁻¹ and 0.1 sighting km⁻¹ respectively (see **Figure 6.5**), it is noted that the encounter rate of impact survey is similar to other years. It is noted that the reporting period was covering peak season and that works at IWMF are increasing, both which may impact encounter rates. It is also noted that the impact survey focuses on a relatively small populations of highly mobile individuals and the survey area conducted for this monitoring is very small. For January to March 2021, as was similar to the case in 2020 impact monitoring conducted by ET and some of long-term monitoring data conducted by AFCD.

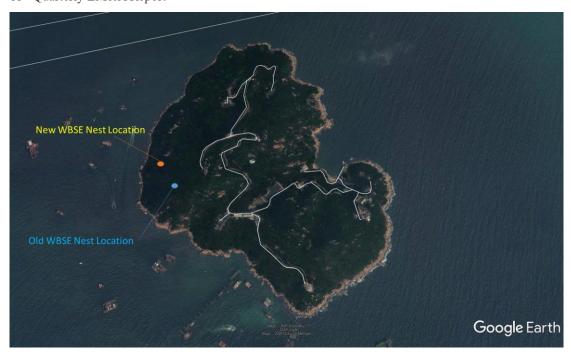
Figure 7.1 Location of WBSE Nest on SKC

- 7.2.2 Two WBSE adults were recorded near SKC island during the survey in January, February and March 2021. No abnormal behaviour of the adults were recorded during the reporting period. Adult WBSE was moved back to old nest for incubation since December 2020. Since no chick was recorded during the monitoring period, it is believed that incubation period was failed in March. All marine works during the monitoring period did not show any impact to the WBSE.
- 7.2.3 No disturbances from anthropogenic activities on the island were recorded during the monitoring survey. No invasion of other fauna species was recorded as well.
