Contract No. EP/SP/66/12
Integrated Waste Management Facilities, Phase 1
Monthly EM&A Report No.12

Monthly EM&A Report No.12 (Period from 1 June to 30 June 2019)

(Clause 3.3, Further Environmental Permit FEP-01/429/2012/A)

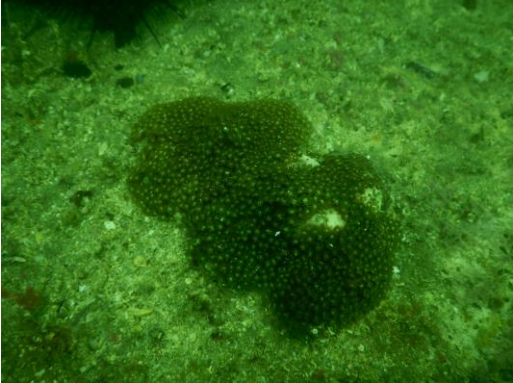
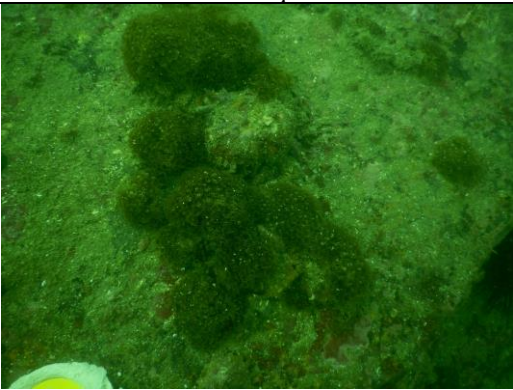
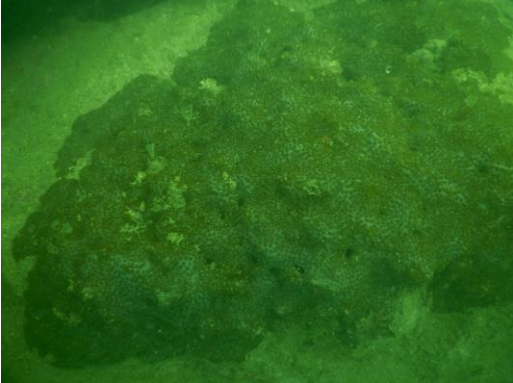
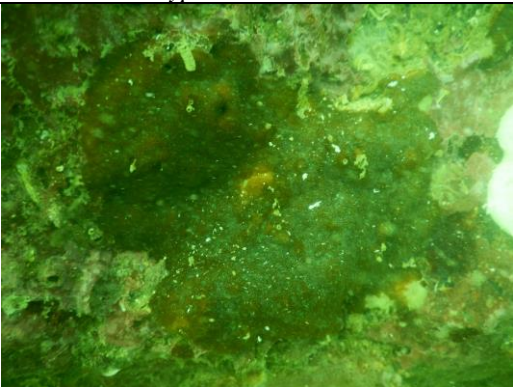
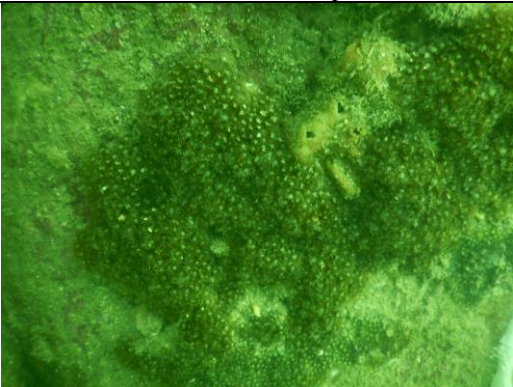
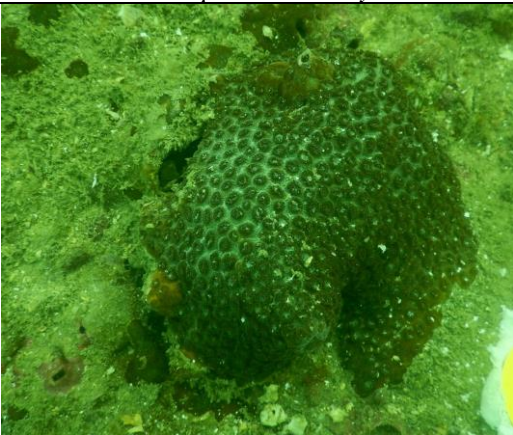
Photo Plate 5.1 Ten (10) Monitored Corals at Control Site

5.6.2 Ten (10) hard coral colonies were monitored at each Control site and Indirect Impact Site as suggested in the Construction Phase Monitoring Plan. The general health conditions (size, mortality, bleaching and sediment) were recorded and summarized in **Table 5.8** and **Table 5.9**. Photos of each coral colonies were taken during the monitoring activities shown in **Photo Plate 5.1** and **5.2**.

- 5.6.4 All tagged and re-tagged coral colonies showed good health condition during the 2nd Quarterly Construction Phase Monitoring. There was no increased level of mortality, bleaching and sediment when compared with the baseline results.

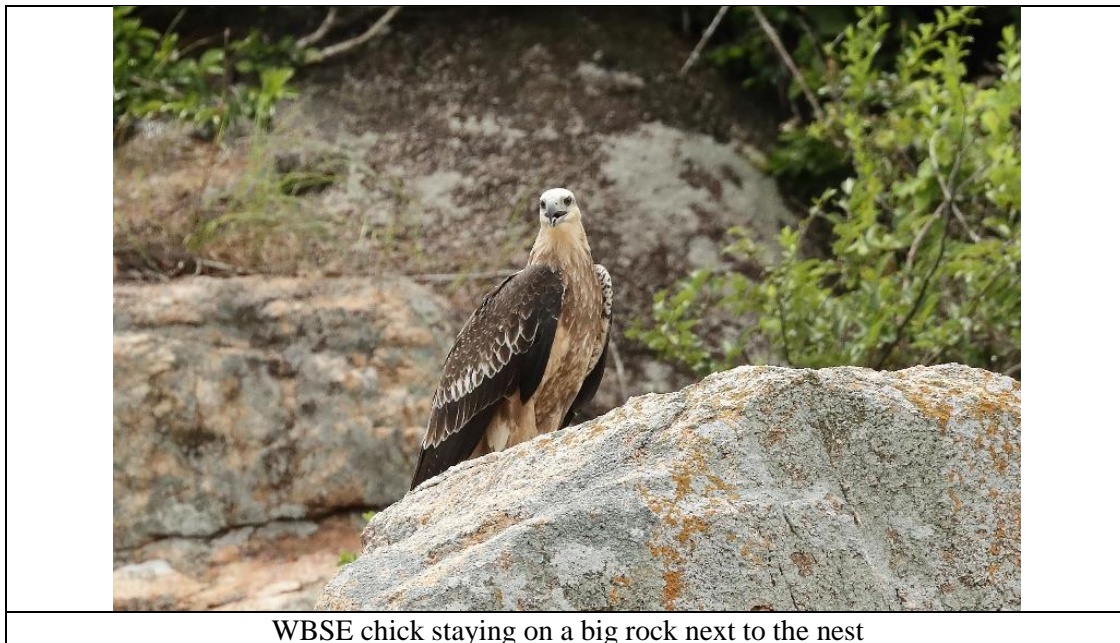
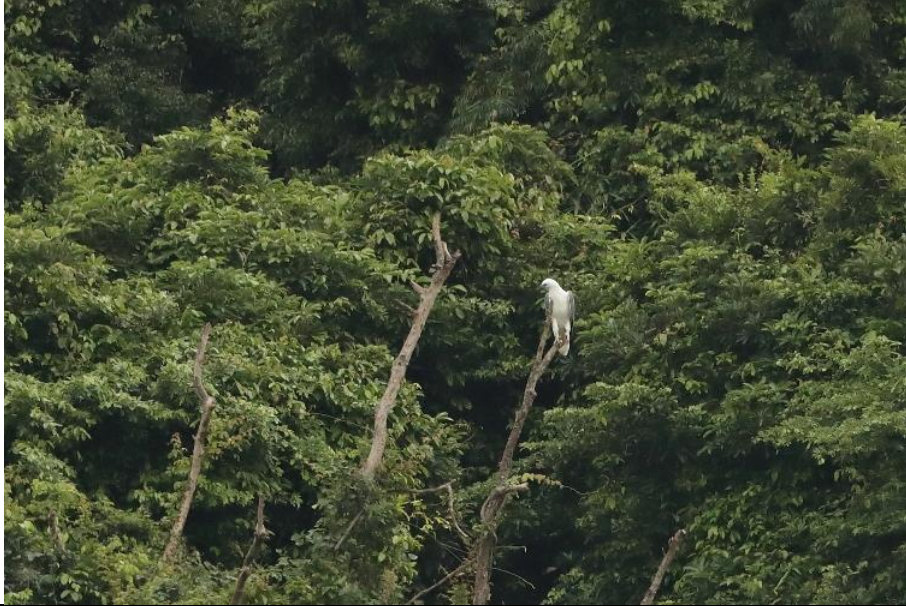
Figure 7.2 Photo Record of WBSE on SKC During the Reporting Period

7.5.4 No abnormal behaviour of the recorded adults and chick was observed during the June 2019 construction phase monitoring. Only two adults and one chick of WBSE were recorded (**Figure 7.2**). All marine works during the 12th month construction period did not show any affects to the WBSE.

WBSE chick staying on a big rock next to the nest

Adult WBSEs staying at the area next to its nest
