Contract No. EP/SP/66/12 Integrated Waste Management Facilities, Phase 1 14th Quarterly EM&A Report

Quarterly EM&A Report No.14 (Period from 1 October to 31 December 2021)

(Clause 3.3, Further Environmental Permit FEP-01/429/2012/A)

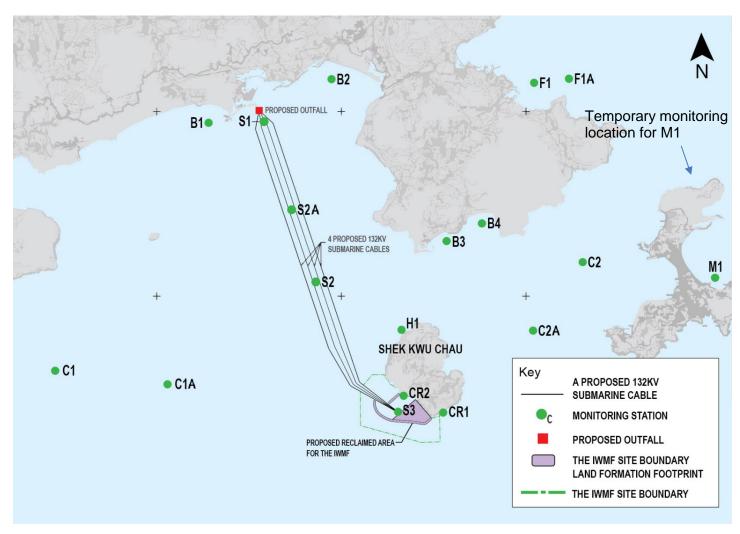
Figure 2.1 Water monitoring locations at Artificial Island near SKC

2.2.1 Impact water quality monitoring was conducted at eleven monitoring locations (i.e. B1-B4, H1, C1A, C2A, F1A, CR1, CR2 and M1) during general water quality monitoring as shown in **Figure 2.1**.

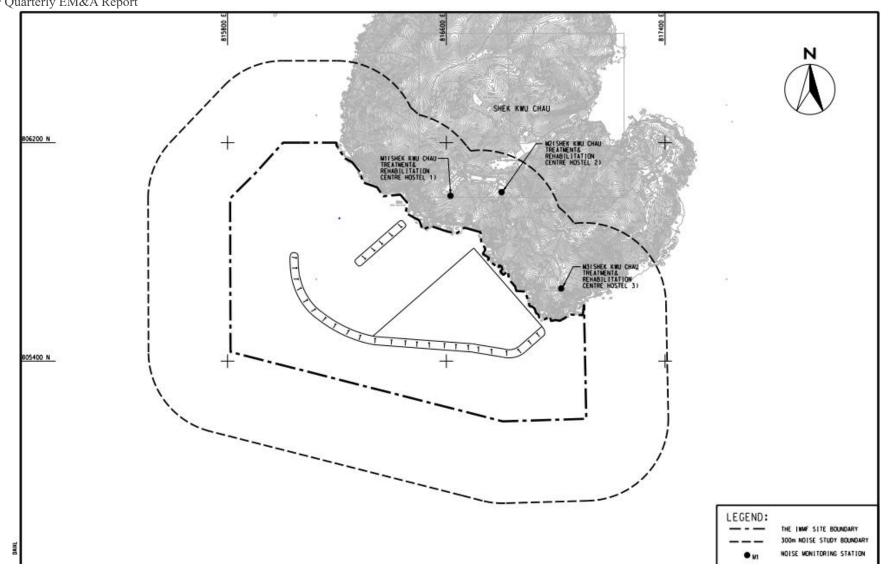
Figure 3.1 Noise monitoring locations at SKC

- 3.2 Noise Monitoring Locations
- 3.2.1 Three noise monitoring locations for impact monitoring and additional impact monitoring at the nearby sensitive receivers are shown in **Figure 3.1**

- 3.2.2 M1, M2 and M3 are Shek Kwu Chau Treatment and Rehabilitation Centre Hostel 1, 2 and 3 respectively of The Society for the Aid and Rehabilitation of Drug Abusers (SARDA) located at southern part of Shek Kwu Chau.

- 3.2.3 Measurements at M1 & M3 were conducted at a point 1m from the exterior of the sensitive receivers building façade and at a position 1.2m above the ground. Measurement setup at M3 has been varying with minor adjustment to minimize the disturbance to the users of Treatment Centre. Measurement at M2 was conducted at a point 1m from building façade of the ceiling of 1st floor level for avoidance of mutual disturbance with users of Treatment Centre. The minor adjustment of monitoring locations, which were in favour to mutual convenience with the users of Treatment Centre, were found with no effect on monitoring result based on on-site observation and experience from the Baseline monitoring of the Project.

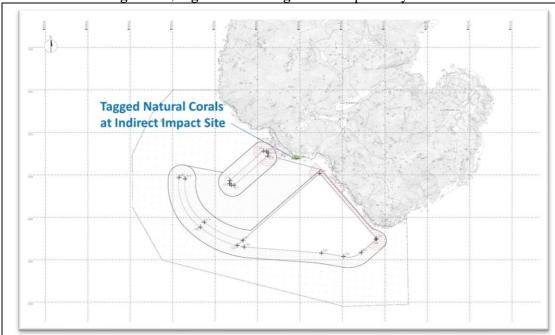
Figure 5.1 Tagged Natural Corals at Indirect Impact Site Near SKC for re-tagging after typhoon Mangkhut

Location of the ten tagged coral colonies at each of the proposed indirect impact site, control site, the recipient site R3 and REA transect at proposed indirect impact site are shown in **Figure 5.1**, **Figure 5.2** and **Figure 5.3** respectively:

- 5.4.3 The re-tagging activity had been done at both Indirect Impact Site and Control Site in November 2018 and December 2018 respectively. A total of 20 tagged coral colonies (10 at control site and 10 at indirect impact site including the re-tagged coral colonies) were monitored. Similar to the baseline results performed in June, November and December 2018 and the results of the previous five quarterly coral monitoring during construction phase, the health condition of all tagged and re-tagged coral colonies at Indirect Impact Site and Control site were good in general. No increased mortality was recorded during the survey in December 2021.

- 5.4.4 No sediment, bleaching or increased mortality in the general condition of coral colonies were observed during the 12th quarterly coral monitoring period. No deterioration of the coral community was observed in the ecological monitoring results when compared with the baseline ecological monitoring results. There is no AL/LL exceedance during the monitoring period.

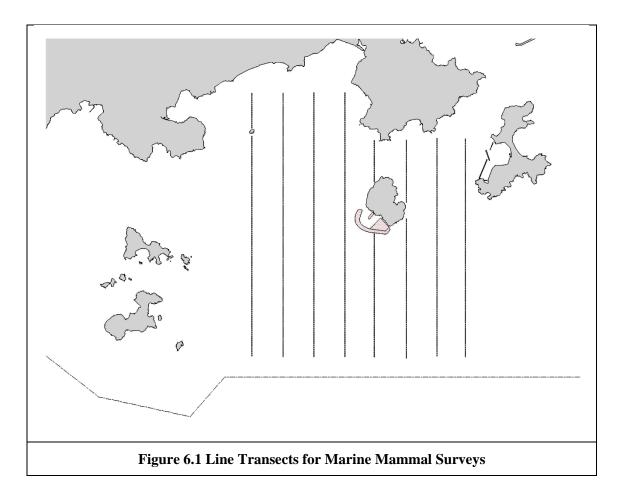
- 6.1 Survey Methods
- 6.1.1 Vessel-based Line-transect Survey
- 6.1.1.1 For the vessel-based marine mammal surveys, the monitoring team adopted the standard line-transect method (Buckland et al. 2001) as same as that adopted during the EIA study and pre-construction phase monitoring to allow fair comparison of marine mammal monitoring results.
- 6.1.1.2 Eight transect lines are set at Southeast Lantau survey area, including Shek Kwu Chau, waters between Shek Kwu Chau and the Soko Islands, inshore waters of Lantau Island (e.g. Pui O Wan) as well as southwest corner of Cheung Chau as shown in **Figure 6.1** below:

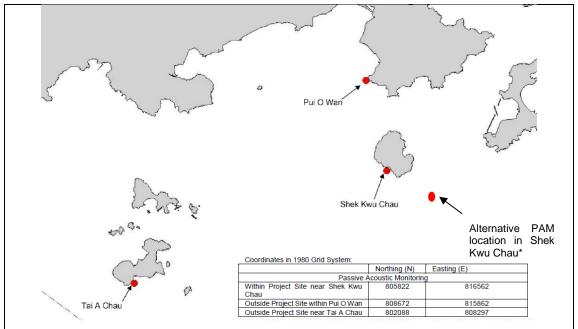
Figure 6.2 Locations of Passive Acoustic Monitoring

Finless Porpoise. During the construction period, the PAM survey will be conducted including placement of two passive porpoise detectors outside the Project Area as control site (i.e. within Pui O Wan and to the south of Tai A Chau) and one porpoise detector within the Project Area (i.e. near Shek Kwu Chau) as shown in **Figure 6.2** below.

Note*: The alternative PAM device adjacent to the Project site was deployed from 5 Mar to 11 Apr 2019, which contained a full 37 days acoustic monitoring data set. After the confirmation of loss of the original PAM within the Project site, this data set was proposed to replace that of the original one, as consulted with AFCD accordingly.

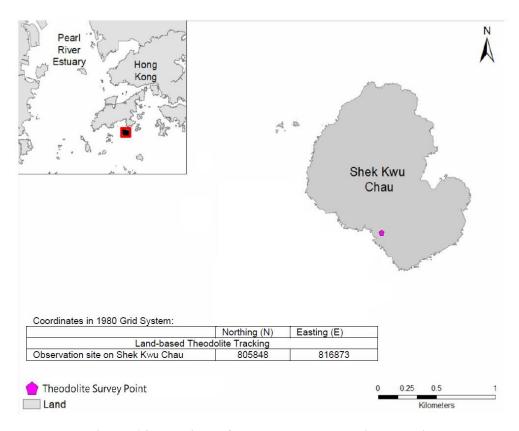
Figure 6.3 Locations of Land-based Theodolite Tracking

6.1.3.1 The Land-based Theodolite Tracking study would use the same station as in the AFCD monitoring study(same as the baseline monitoring location), which is situated at the southwest side of Shek Kwu Chau (GPS position: 22o11.47' N and 113o59.33' E) as shown in below **Figure 6.3**. The station was selected based on its height above sea level (at least 20 metres), close proximity to shore, and relatively unobstructed views of the entire Project Area to the southwest of Shek Kwu Chau. The height of the Shek Kwu Chau Station established by the HKCRP team is 74.6 m high at mean low water, and only a few hundred metres to the IWMF reclamation site, which is ideal for the purpose for the present behavioural and movement monitoring of finless porpoises as well during construction phase considering there as an un-obstructed vantage point at a height above the Project Site.

6.1.3.2 During the construction phase, Land-based Theodolite Tracking will be carried out for approximately six hours of tracking for each day of field work for a period listed as **Table 6.2** below, preferably at the initial stage of the construction period (i.e. December 2018 to May 2019).

- 6.3.2.4 Theodolite surveys were completed in May 2019. In total, thirty four days of theodolite tracking were completed between February May 2019, comprising 167 hours and 49 minutes of observation. No Chinese white dolphin was observed and only one finless was recorded. The finless porpoise encounter rate was calculated as 0.006 finless porpoise per hour, in all weather conditions.

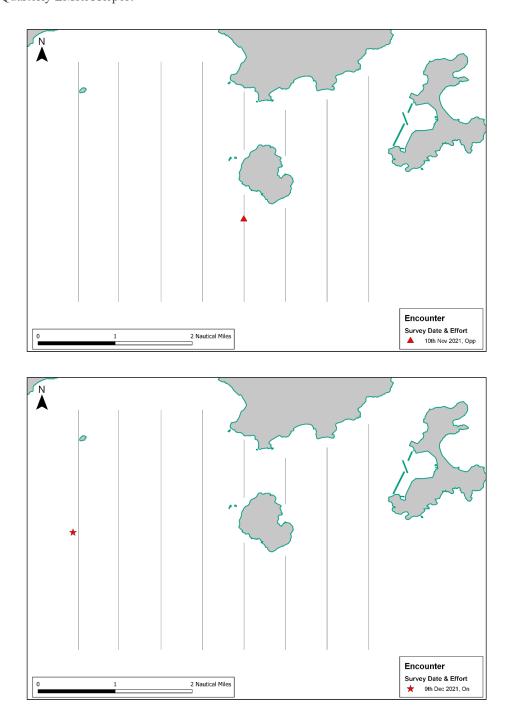
Figure 6.4 Location of sightings recorded during October to December 2021 Vesselbased Line-transect Survey

Date	Species	Sighting No.	Time	Group Size	PSD	Behaviour	Lat.	Long.	Area	Effort	Season
10 Nov 2021	Finless Porpoise	99	12:22	1	N/A	Travelling	22.18479	113.9835	SEL	On	AUTUMN
9 Dec 2021	Finless Porpoise	100	10:40	1	14	Unknown	22.1929	113.9437	SEL	On	WINTER

- 6.3.1.4 A review of all the porpoise sightings in the survey area for October to December between 2009 2021 indicates that there is no sighting usually recorded in October to December. Given the similar survey conditions and the encounter rate recorded for porpoise in the project area during the reporting period, the encounter rate for October to December 2021 were between 0.00km⁻¹ and 0.02km⁻¹ (see Figure 6.5), it is noted that the encounter rate of impact survey is low when compared to other years. It is noted that the reporting period was covering between both non-peak and peak season and that construction not related to IWMF is ongoing on the southern boundary of the study site, both which may impact encounter rates. It is also noted that the impact survey focuses on a relatively small populations of highly mobile individuals and the survey area conducted for this monitoring is very small. For October to December 2021, the number of recorded sightings was similar to the case in 2019 impact monitoring conducted by ET.

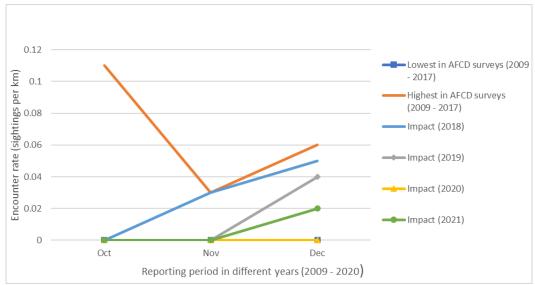
Figure 6.5 Plot of encounter rate during October to December in 2009 – 2021 from different surveys

- 6.3.1.2 A review of the long term AFCD marine mammal monitoring programme, the EIA and the pre-construction baseline monitoring report for this project was conducted. Both the EIA and the pre-construction baseline monitoring were conducted during the peak porpoise months Dec 2008 to May 2009 and Feb to April 2018, respectively. The AFCD long term monitoring data and impact monitoring in 2019 and 2020 should be compared directly to Impact Survey results of the reporting periods.

- 6.3.1.3 A review of the Beaufort Sea state survey conditions between 2009 and 2018 (only data available from AFCD at time of writing; (AFCD 2018; 2017; 2016; 2015; 2014; 2013; 2012; 2011; 2010)) shows that survey conditions in October and November 2021 were better than average for previous AFCD surveys conducted while survey conditions in December was within the % limits of previous AFCD long-term monitoring surveys.

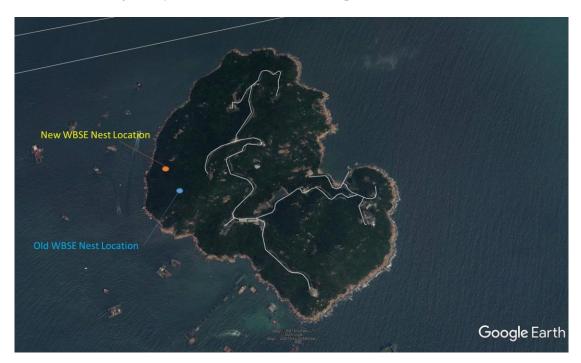
Figure 7.1 Location of WBSE Nest on SKC

- 7.2.2 Two adult WBSEs were recorded near Shek Kwu Chau area. It was found that the WBSEs moved to new nest for incubation since the early December 2021. No abnormal behavior of the recorded adults during the December 2021 construction phase monitoring. All marine works during the monitoring period did not show any impact to the WBSE.
- 7.2.3 No disturbances from anthropogenic activities on the island were recorded during the monitoring survey. No invasion of other fauna species was recorded as well.
