Contract No. EP/SP/66/12
Integrated Waste Management Facilities, Phase 1
Monthly EM&A Report No.14

Monthly EM&A Report No.14 (Period from 1 August to 31 August 2019)

(Clause 3.3, Further Environmental Permit FEP-01/429/2012/A)

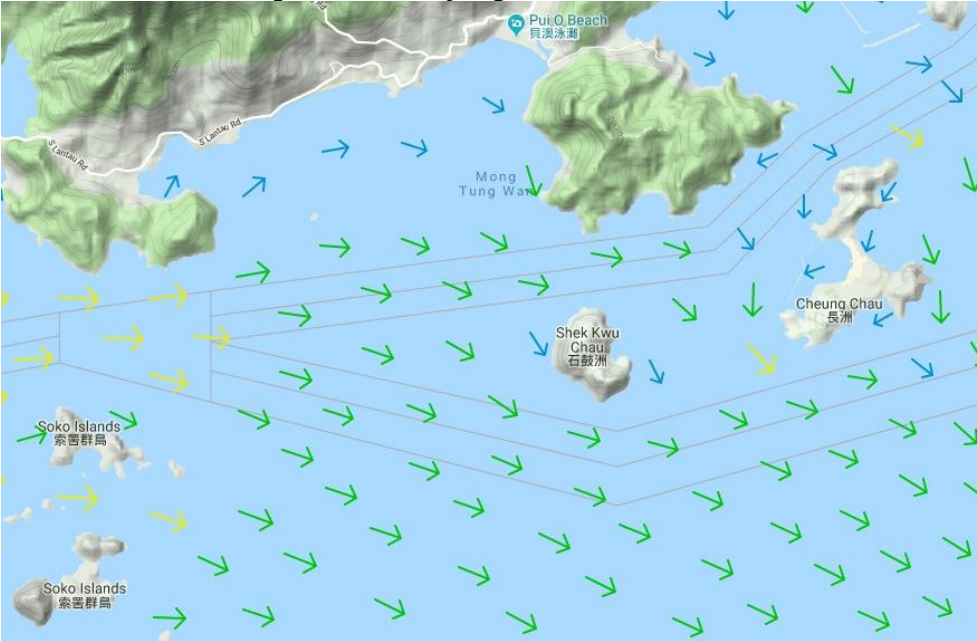
<p>Remarks</p>	<p>Current direction during mid-ebb sampling on 30/08:</p>
