Contract No. EP/SP/66/12
Integrated Waste Management Facilities, Phase 1
Monthly EM&A Report No.27

Monthly EM&A Report No.27 **(Period from 1 September to 30 September 2020)**

(Clause 3.3, Further Environmental Permit FEP-01/429/2012/A)

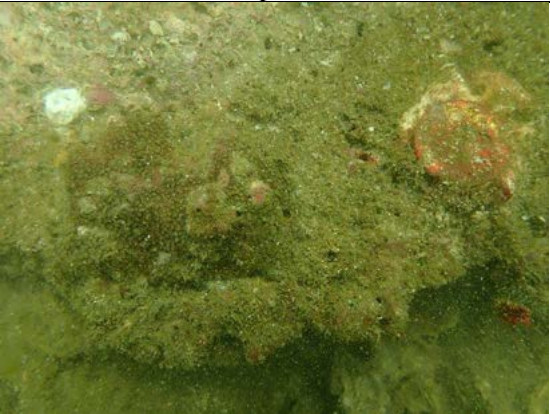
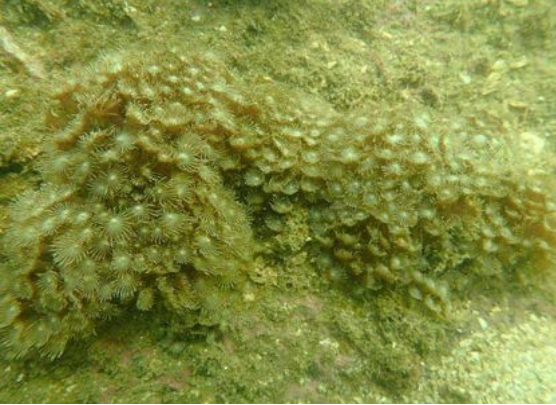
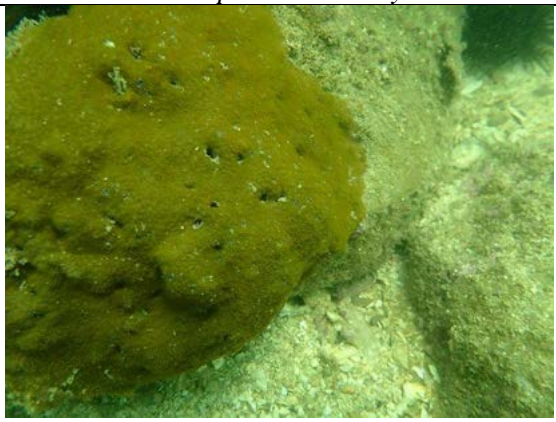
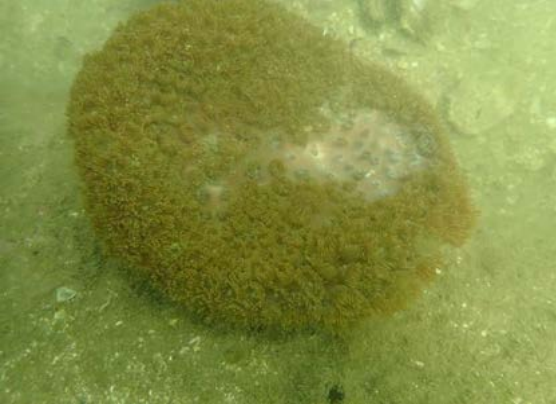
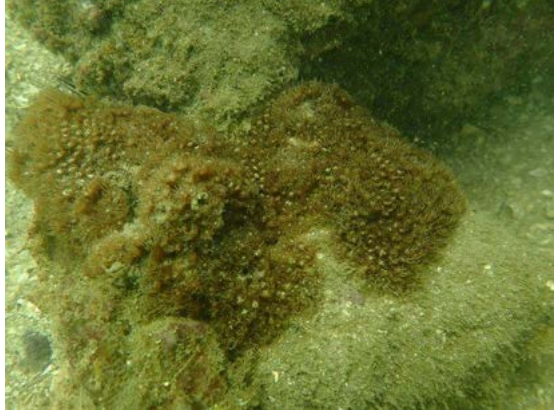
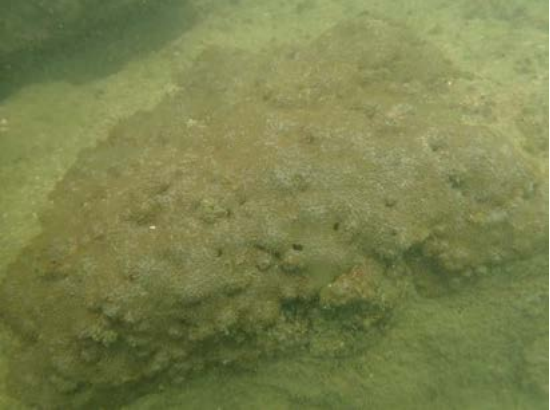
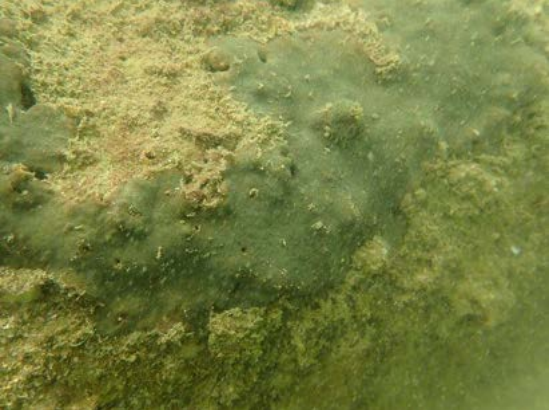
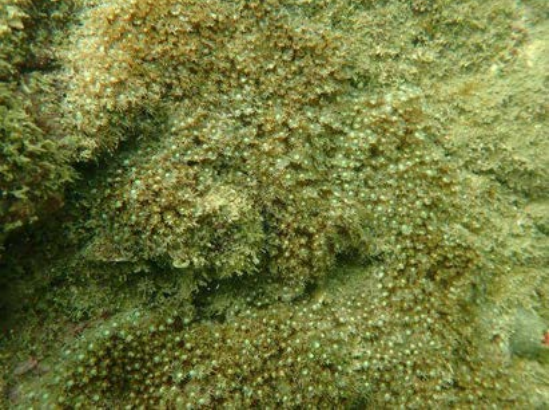
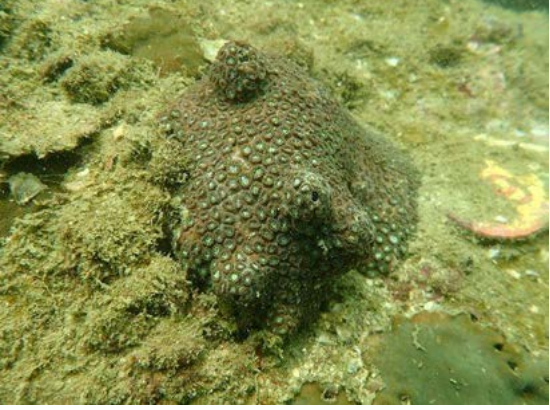
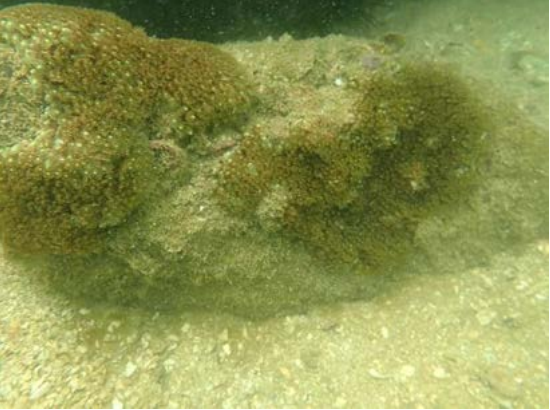
Photo Plate 5.1 Ten (10) Monitored Corals at Control Site

5.6.2 Ten (10) hard coral colonies were monitored at each Control site and Indirect Impact Site as suggested in the Construction Phase Monitoring Plan. The general health conditions (size, mortality, bleaching and sediment) were recorded and summarized in **Table 5.8** and **Table 5.9**. Photos of each coral colonies were taken during the monitoring activities shown in **Photo Plate 5.1** and **5.2**.

Tag #	Species	Size (cm) – Max. Diameter	Condition	Mortality (%)		Bleaching (%)		Sediment (%)	
				Baseline	3/9	Baseline	3/9	Baseline	3/9
1	<i>Goniopora stutchburyi</i>	25	Fair	0	0	0	0	0	0
2R	<i>Goniopora stutchburyi</i>	10	Good	0	0	0	0	0	0
3	<i>Psammocora superficialis</i>	18	Fair	0	0	0	0	0	0
4	<i>Turbinaria peltata</i>	13	Good	0	0	0	0	0	0
5R	<i>Goniopora stutchburyi</i>	18	Good	0	0	0	0	0	0
6	<i>Cyphastrea serailia</i>	43	Fair	0	0	0	0	0	0
7R	<i>Coscinaraea</i> sp.	15	Good	0	0	0	0	0	0
8	<i>Goniopora stutchburyi</i>	21	Good	0	0	0	0	0	0
9	<i>Goniopora stutchburyi</i>	11	Fair	0	0	0	0	0	0
10R	<i>Goniopora stutchburyi</i>	20	Good	0	0	0	0	0	0

- 5.6.4 All tagged and re-tagged coral colonies showed good health condition during the 7th Quarterly Construction Phase Monitoring. There was no increased level of mortality, bleaching and sediment when compared with the baseline results.

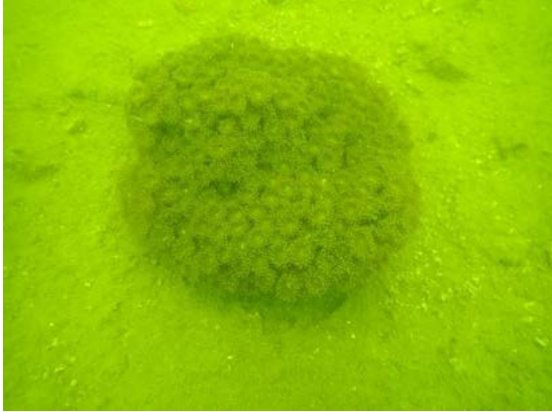
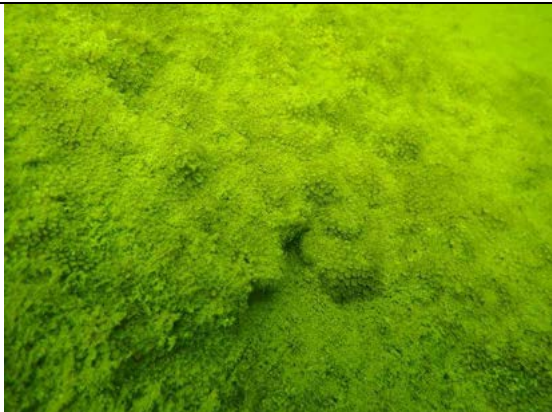
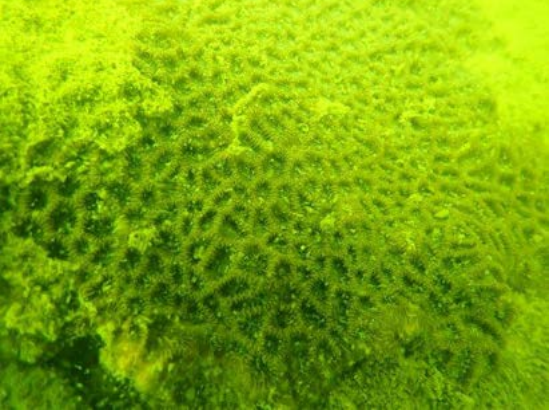
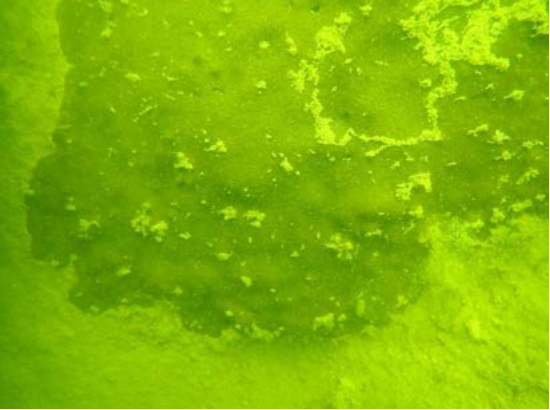
Photo Plate 5.2 Ten (10) Monitored Corals at Indirect Impact Site

Tag #	Species	Size (cm) – Max. Diameter	Condition	Mortality (%)		Bleaching (%)		Sediment (%)	
				Baseline	3/9	Baseline	3/9	Baseline	3/9
11R	<i>Cyphastrea serailia</i>	48	Good	0	0	0	0	0	0
12R	<i>Favites chinensis</i>	27	Good	0	0	0	0	0	0
13R	<i>Turbinaria peltata</i>	21	Good	0	0	0	0	0	0
14R	<i>Favites chinensis</i>	8	Good	0	0	0	0	0	0
15R	<i>Goniopora stutchburyi</i>	11	Good	0	0	0	0	0	0
16R	<i>Psammocora superficialis</i>	27	Good	0	0	0	0	0	0
17R	<i>Favites chinensis</i>	15	Good	0	0	0	0	0	0
18R	<i>Psammocora superficialis</i>	39	Good	0	0	0	0	0	0
19R	<i>Psammocora superficialis</i>	42	Good	0	0	0	0	0	0
20R	<i>Psammocora superficialis</i>	29	Good	0	0	0	0	0	0

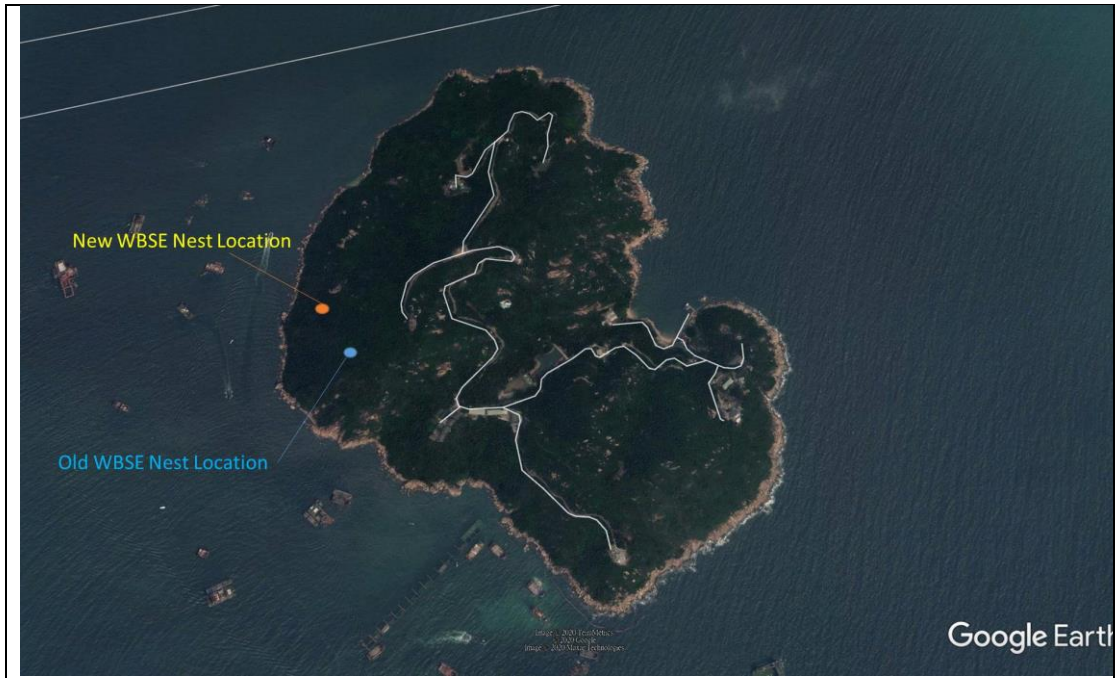
Figure 7.1 Location of WBSE Nest on SKC

7.5.2 During the monitoring survey, two adult WBSEs were recorded near Shek Kwu Chau area. However, it was found that the WBSEs moved to a new nest which is about 150 m away from the old nest (**Figure 7.1**). No abnormal behavior of the recorded adults during the September 2020 construction phase monitoring. Only two adults of WBSE (**Figure 7.2**) were only recorded during the morning surveys. All marine works during the monitoring period did not show any impact to the WBSE.

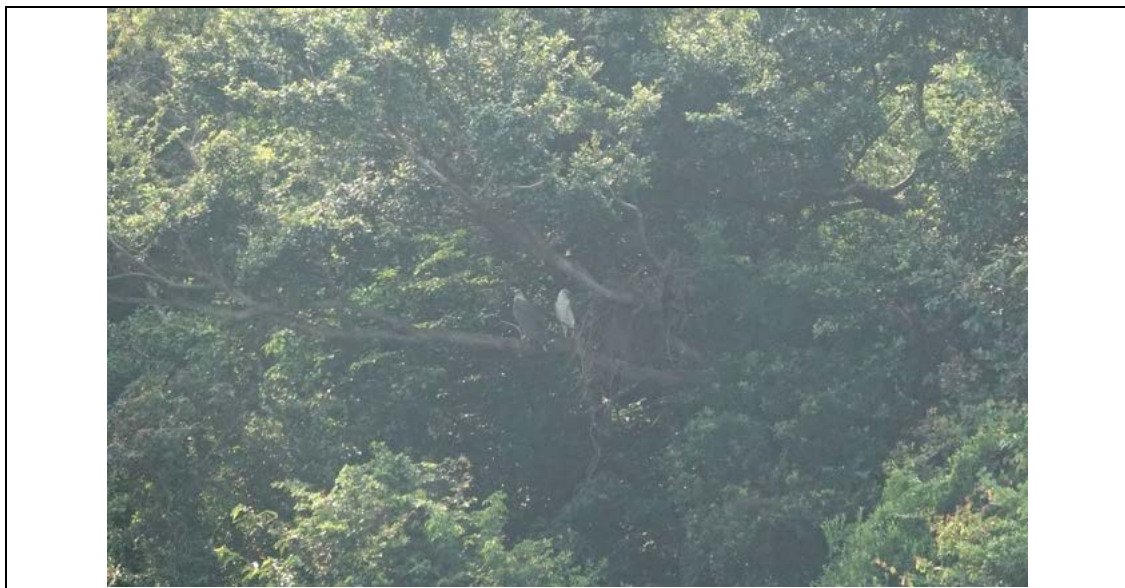
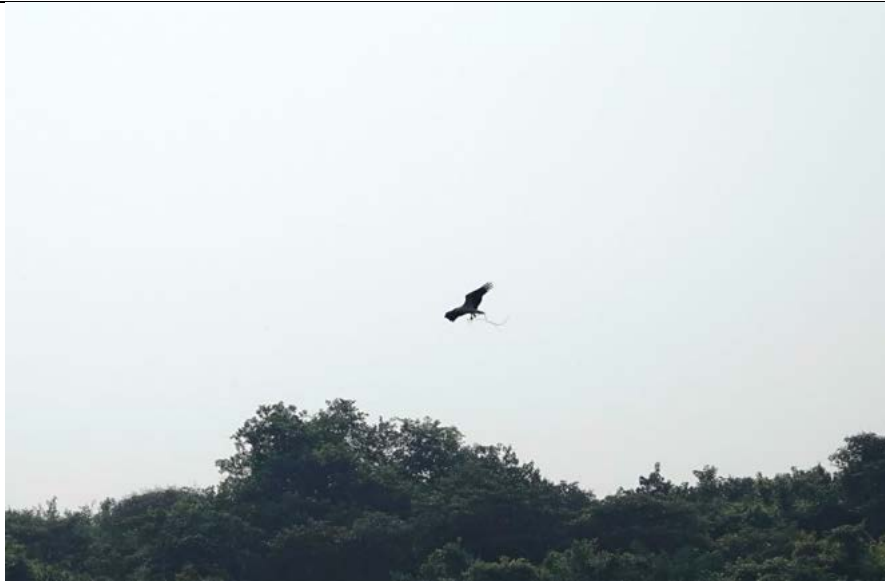
Figure 7.2 Photo Records of WBSE on SKC During the Reporting Period

Adult WBSEs recorded next to the new nest in Shek Kwu Chau

Adult WBSE was carrying a tree branch for building the new nest in SKC
