Contract No. EP/SP/66/12
Integrated Waste Management Facilities, Phase 1
Monthly EM&A Report No.30

Monthly EM&A Report No.30
(Period from 1 December to 31 December 2020)

(Clause 3.3, Further Environmental Permit FEP-01/429/2012/A)

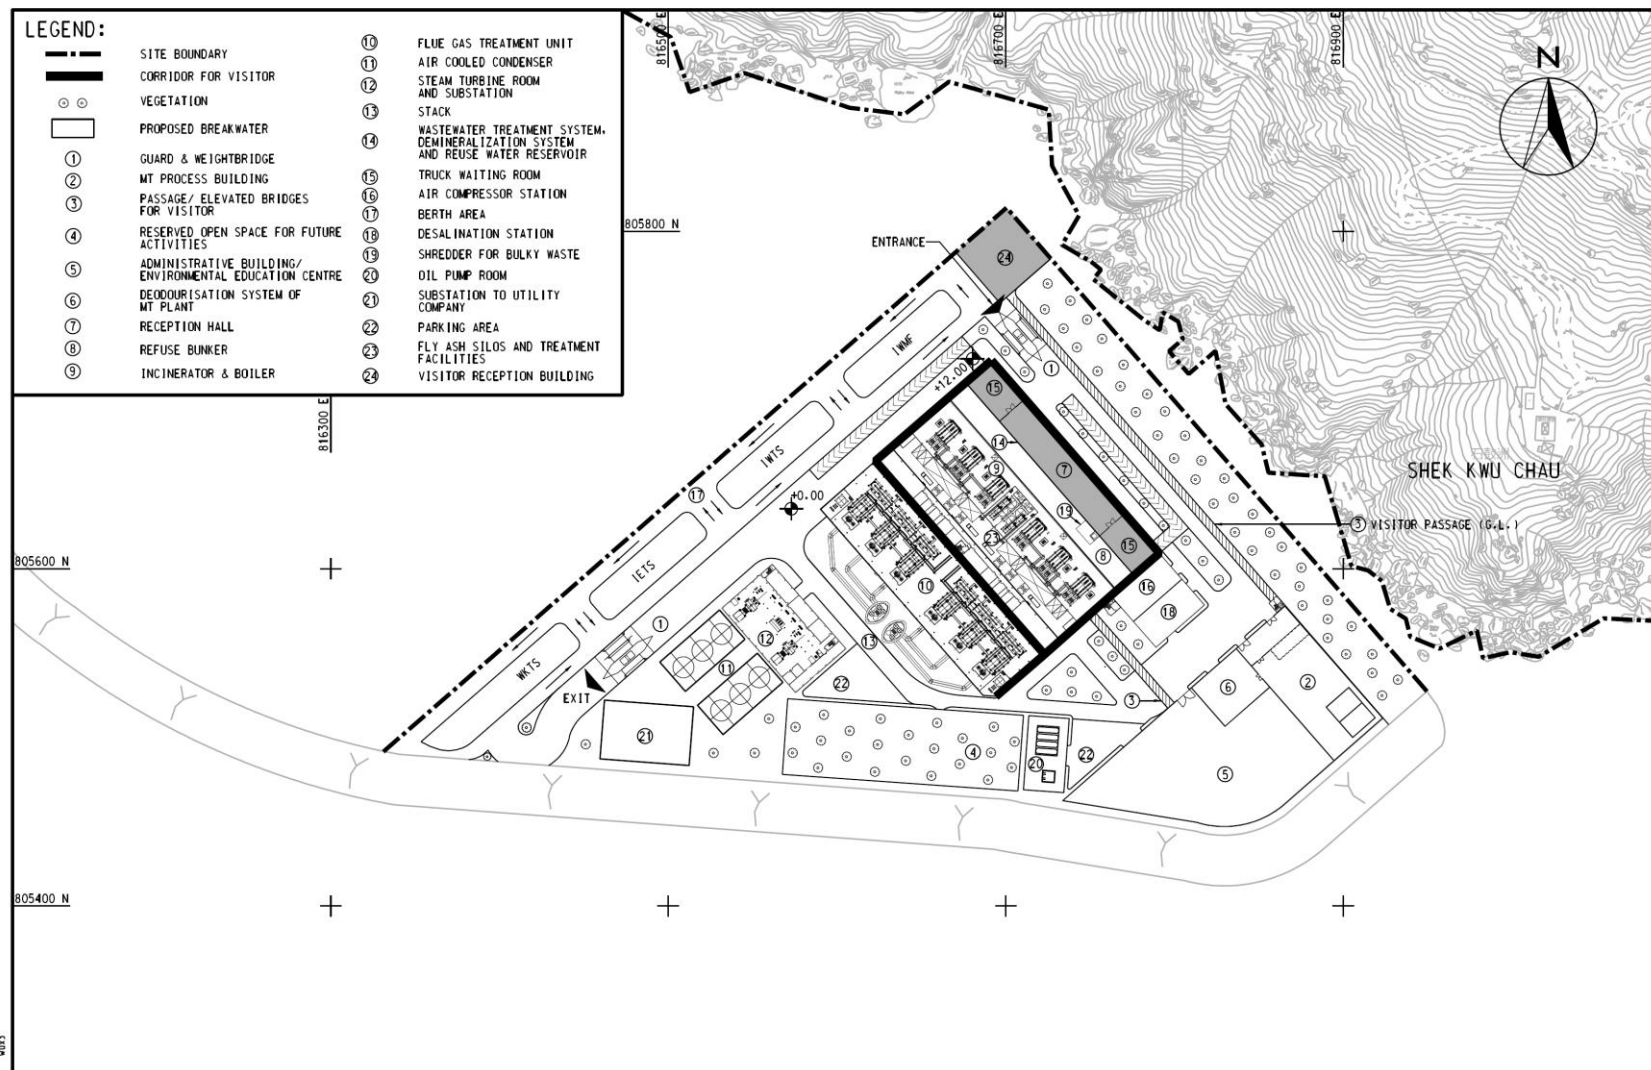
Figure 1.2 General Layout of the IWMF at the Artificial Island near SKC

- 1.1.5 The location of the IWMF near Shek Kwu Chau (SKC) and general layout of IWMF are shown in **Figure 1.1** and **Figure 1.2** respectively.

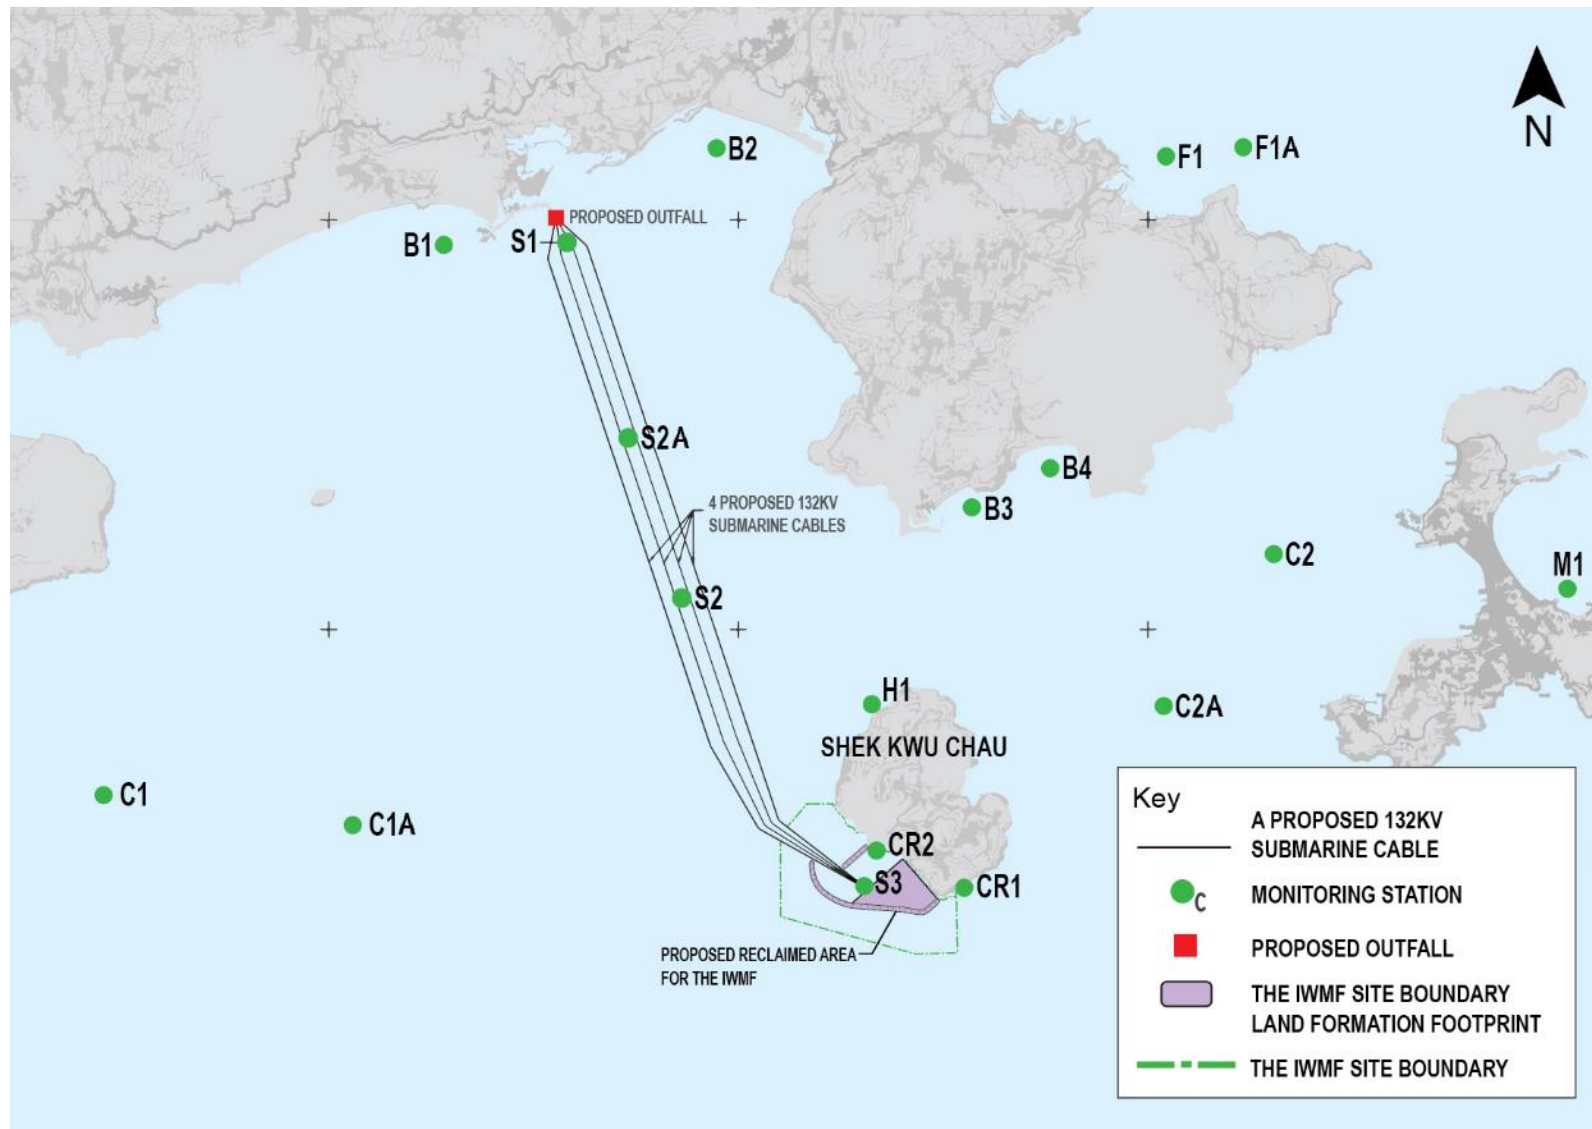
Figure 2.1 Water monitoring locations at Artificial Island near SKC

2.3.1 Impact water quality monitoring was conducted at eleven monitoring locations (B1-B4, H1, C1, C2, F1, CR1, CR2 & M1) during general water quality monitoring as shown in **Figure 2.1**. As per the relocation proposal verified by IEC and approved by EPD, the monitoring location C1, C2, S2, F1 are relocated at C1A, C2A, S2A, F1A as equivalent points respectively to clear up the concerns from stakeholders.

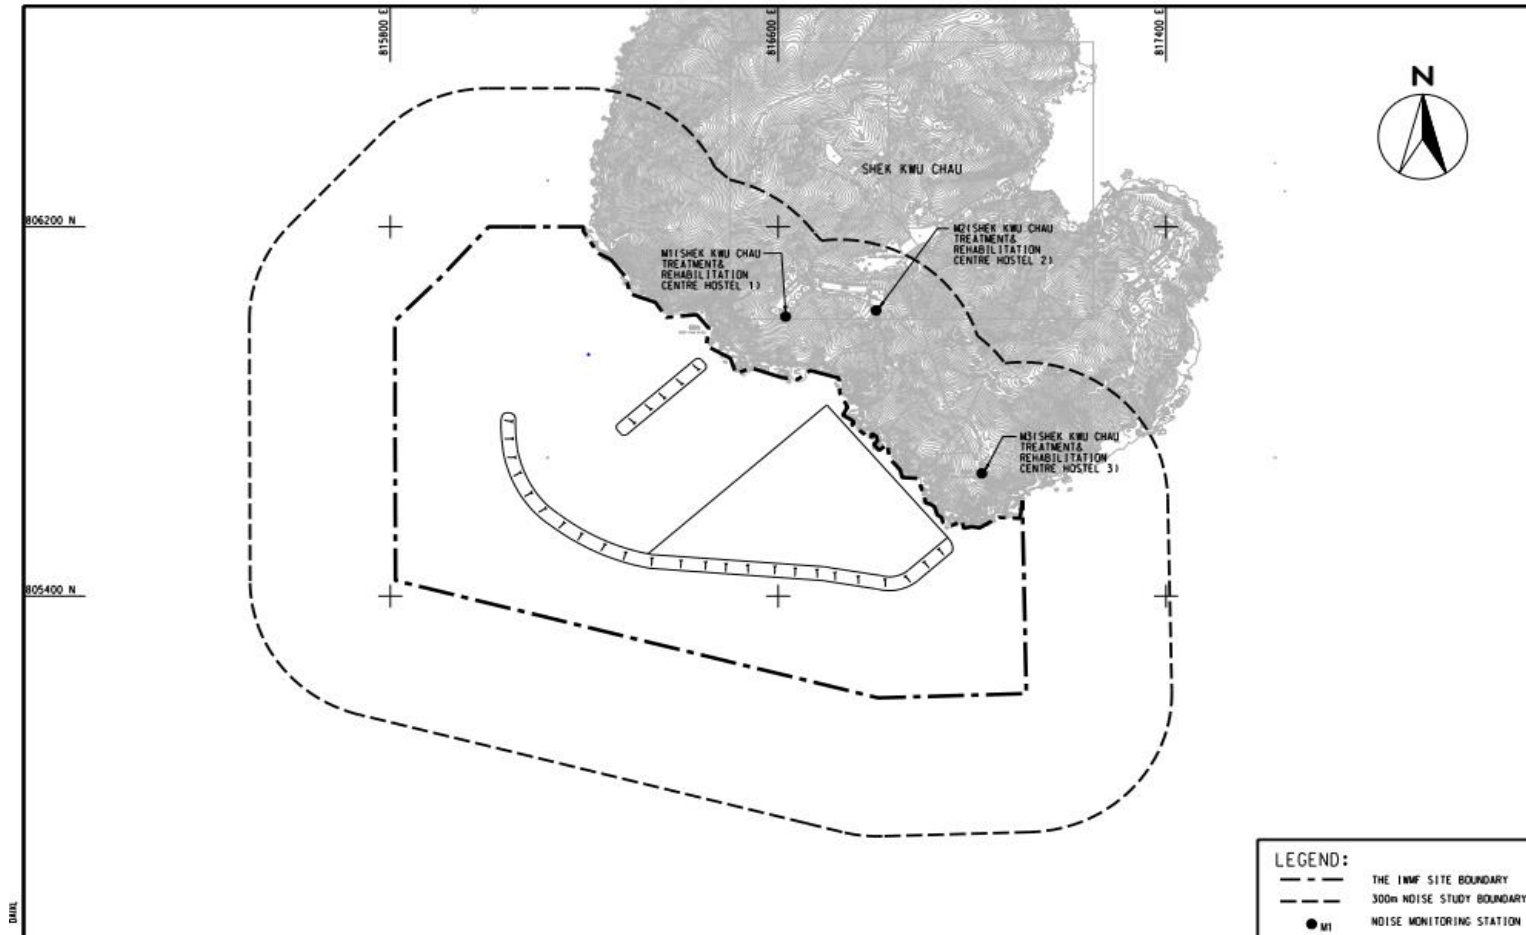
Figure 3.1 Noise monitoring locations at SKC

3.3.1 Three noise monitoring locations for impact monitoring and additional impact monitoring at the nearby sensitive receivers are shown in **Figure 3.1**.

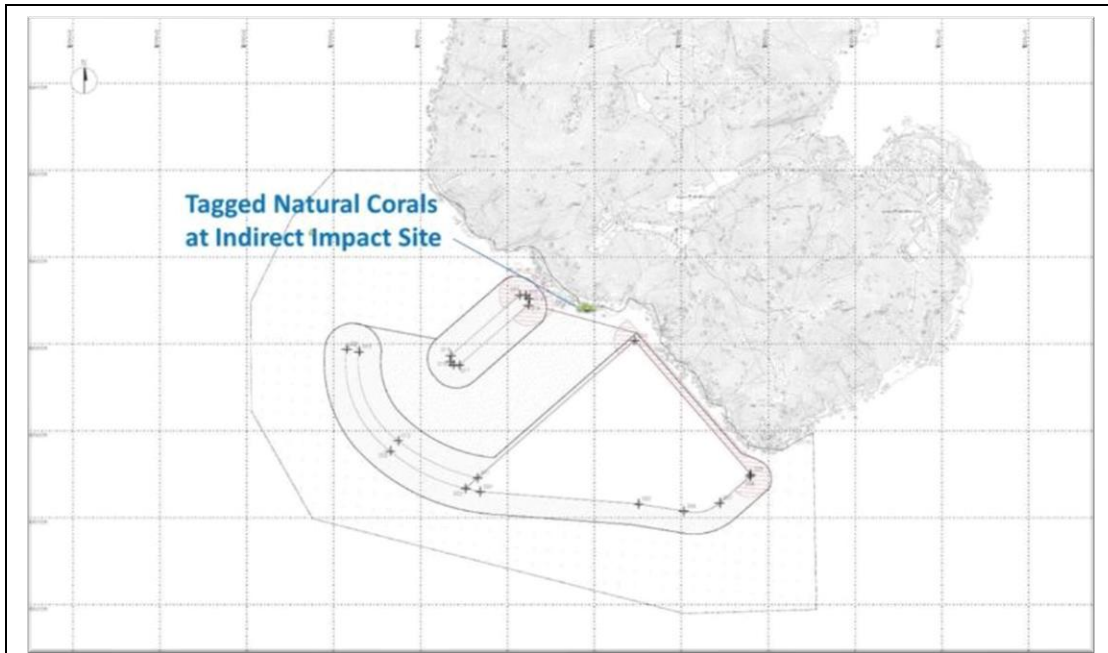
Figure 5.1 Tagged Natural Corals at Indirect Impact Site Near SKC for re-tagging after typhoon Mangkhut

5.3.1 Location of the ten tagged coral colonies at each of the proposed indirect impact site (re-tagging after typhoon Mangkhut), control site (baseline) and recipient site R3 (translocation) are shown in **Figure 5.1**, **Figure 5.2** and **Figure 5.3** respectively:

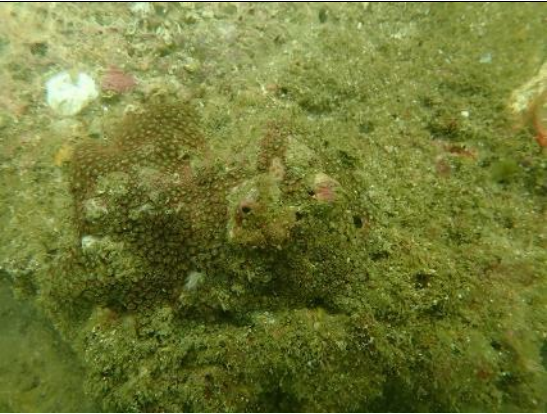
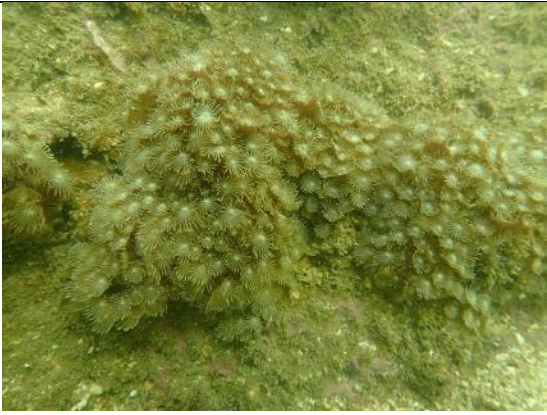
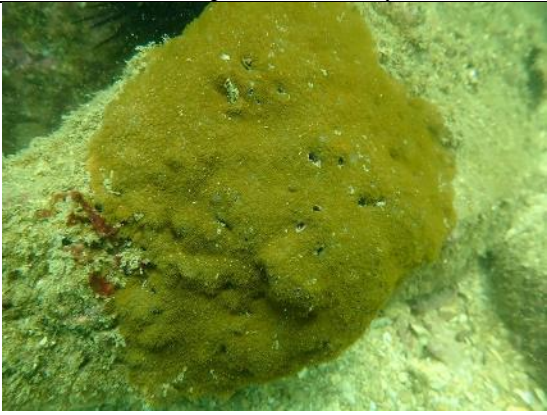
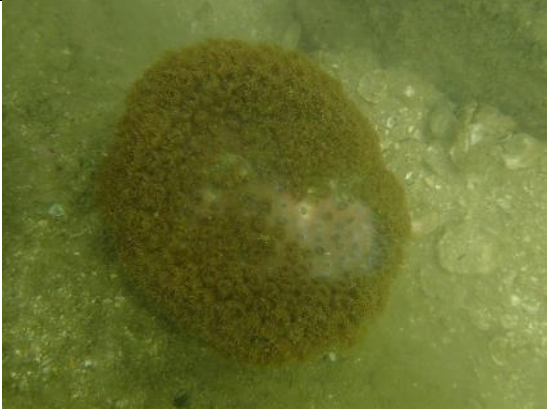
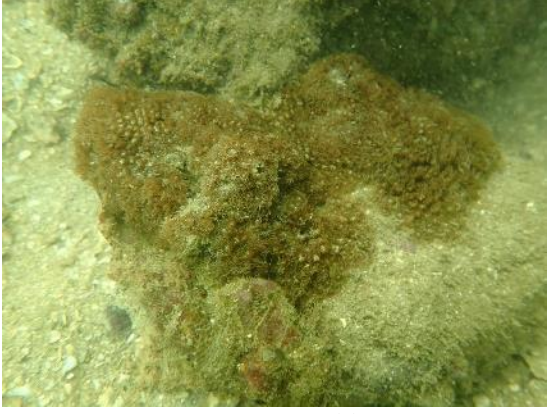
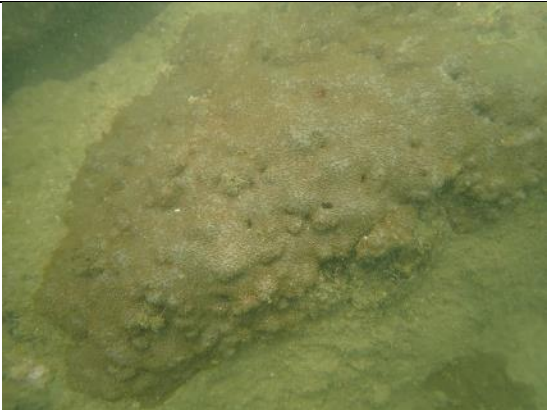
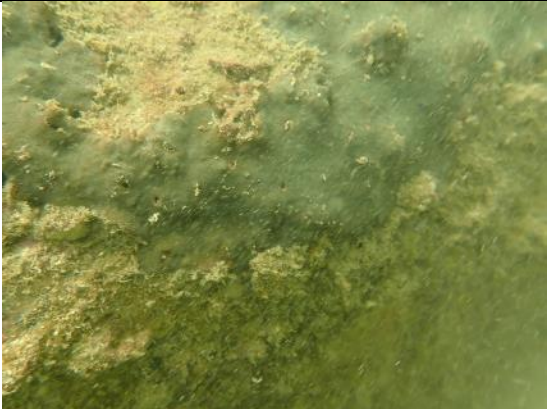
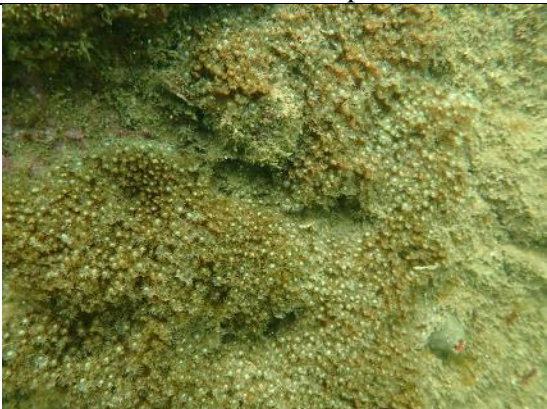
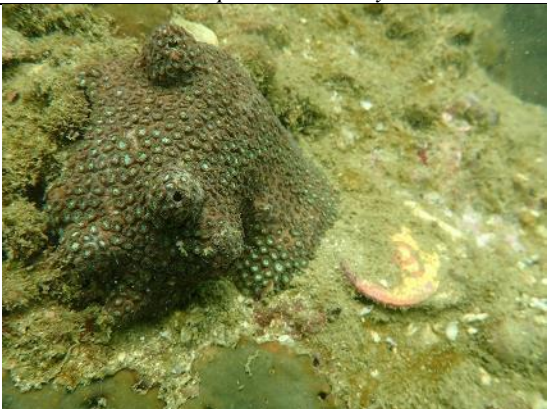
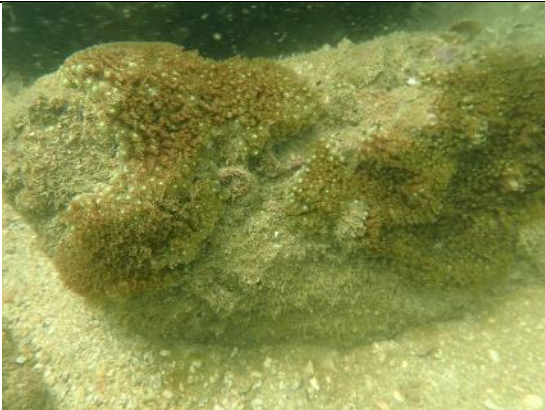
5.6.2 Ten (10) hard coral colonies were monitored at each Control site and Indirect Impact Site as suggested in the Construction Phase Monitoring Plan. The general health conditions (size, mortality, bleaching and sediment) were recorded and summarized in **Table 5.8** and **Table 5.9**. Photos of each coral colonies were taken during the monitoring activities shown in **Photo Plate 5.1** and **5.2**.

- 5.6.4 All tagged and re-tagged coral colonies showed good health condition during the 8th Quarterly Construction Phase Monitoring. There was no increased level of mortality, bleaching and sediment when compared with the baseline results.

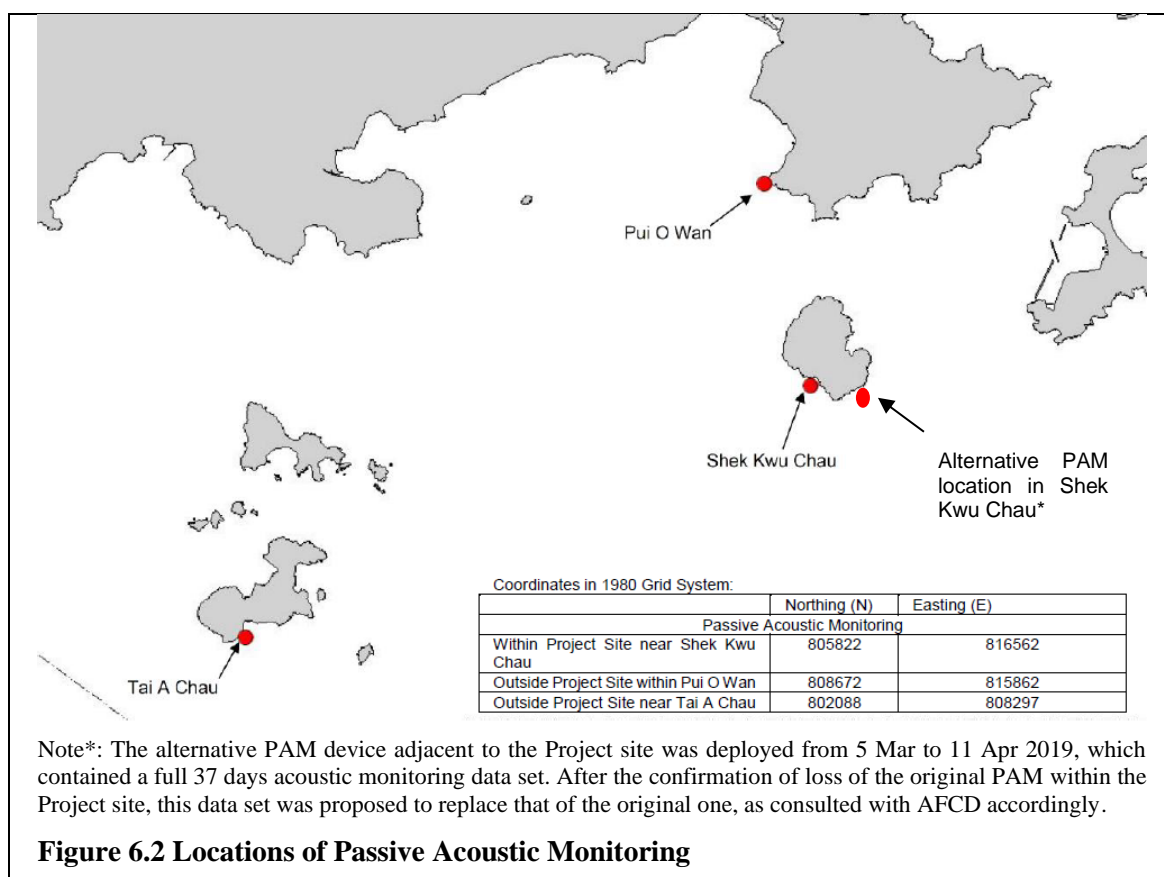
Figure 6.2 Locations of Passive Acoustic Monitoring

The PAM aims to study the usage of an area by Finless Porpoise by using an array of automated static porpoise detectors (e.g. C-POD) which would be deployed at different locations to detect the unique ultra-high frequency sounds produced by Finless Porpoise. During the construction period, the PAM survey will be conducted including placement of two passive porpoise detectors outside the Project Area as control site (i.e. within Pui O Wan and to the south of Tai A Chau) and one porpoise detector within the Project Area (i.e. near Shek Kwu Chau) as shown in **Figure 6.2** below.

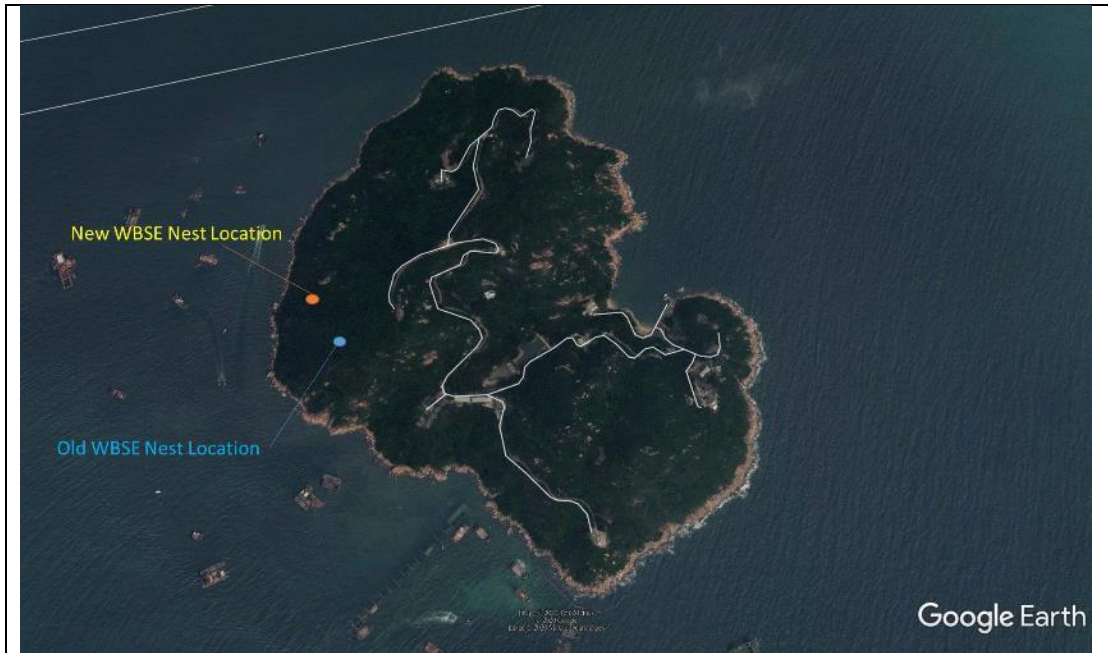
Figure 7.1 Location of WBSE Nest on SKC

7.5.4 Since incubation was recorded, construction phase monitoring (twice per month) were changed to weekly monitoring starting from 31 December 2020. Also, as it is not possible to record the number of eggs in the nest, weekly monitoring will be continued until chick was seen in the nest.

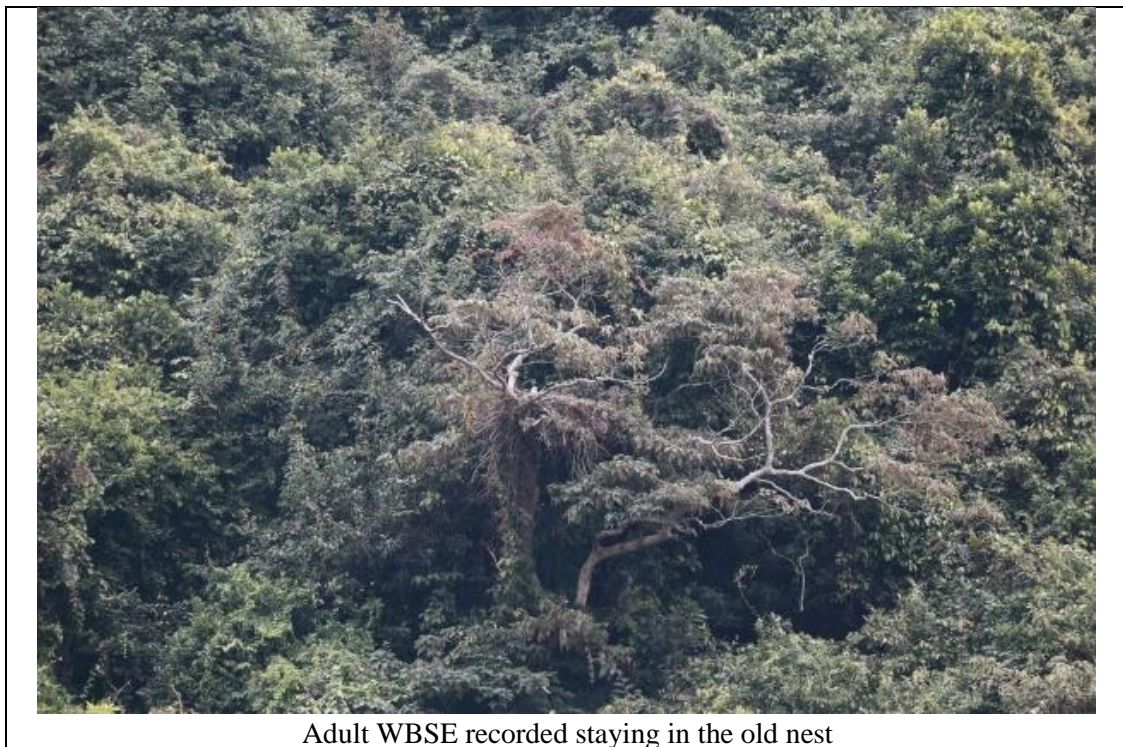
Adult WBSE recorded staying in the old nest

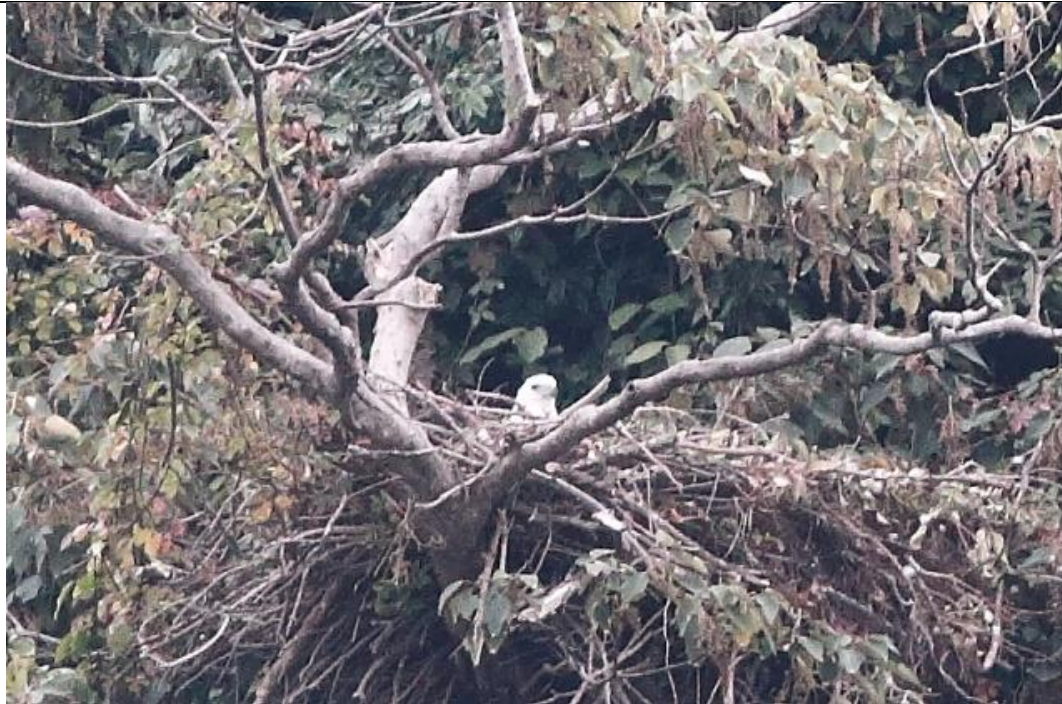
Adult WBSE recorded staying in the old nest

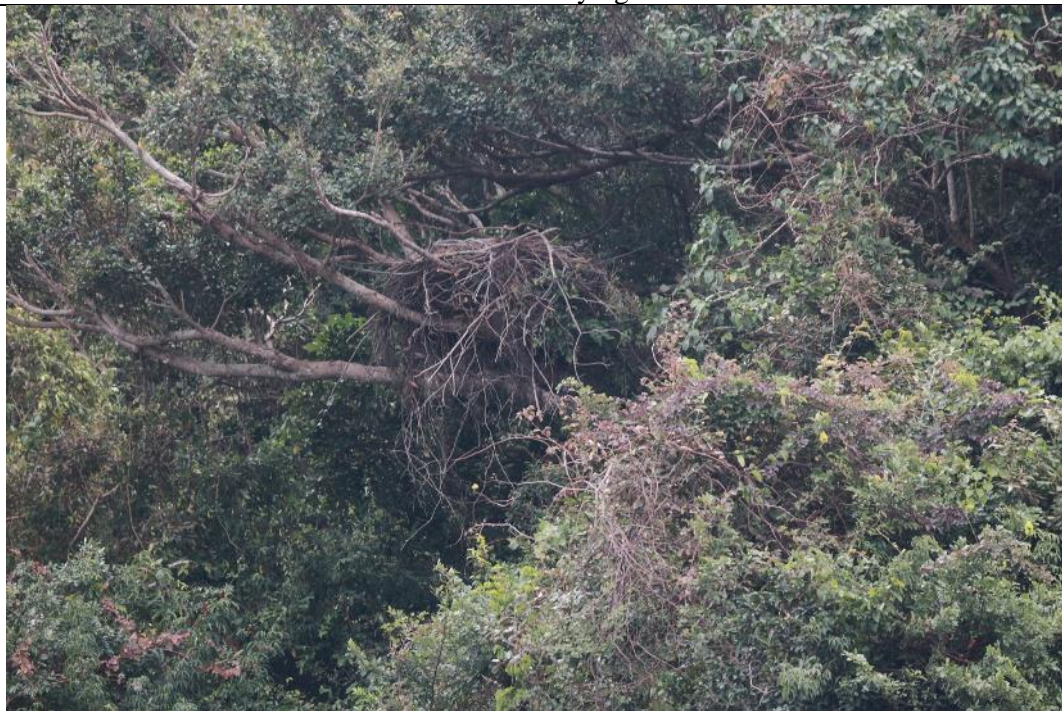
Empty new nest

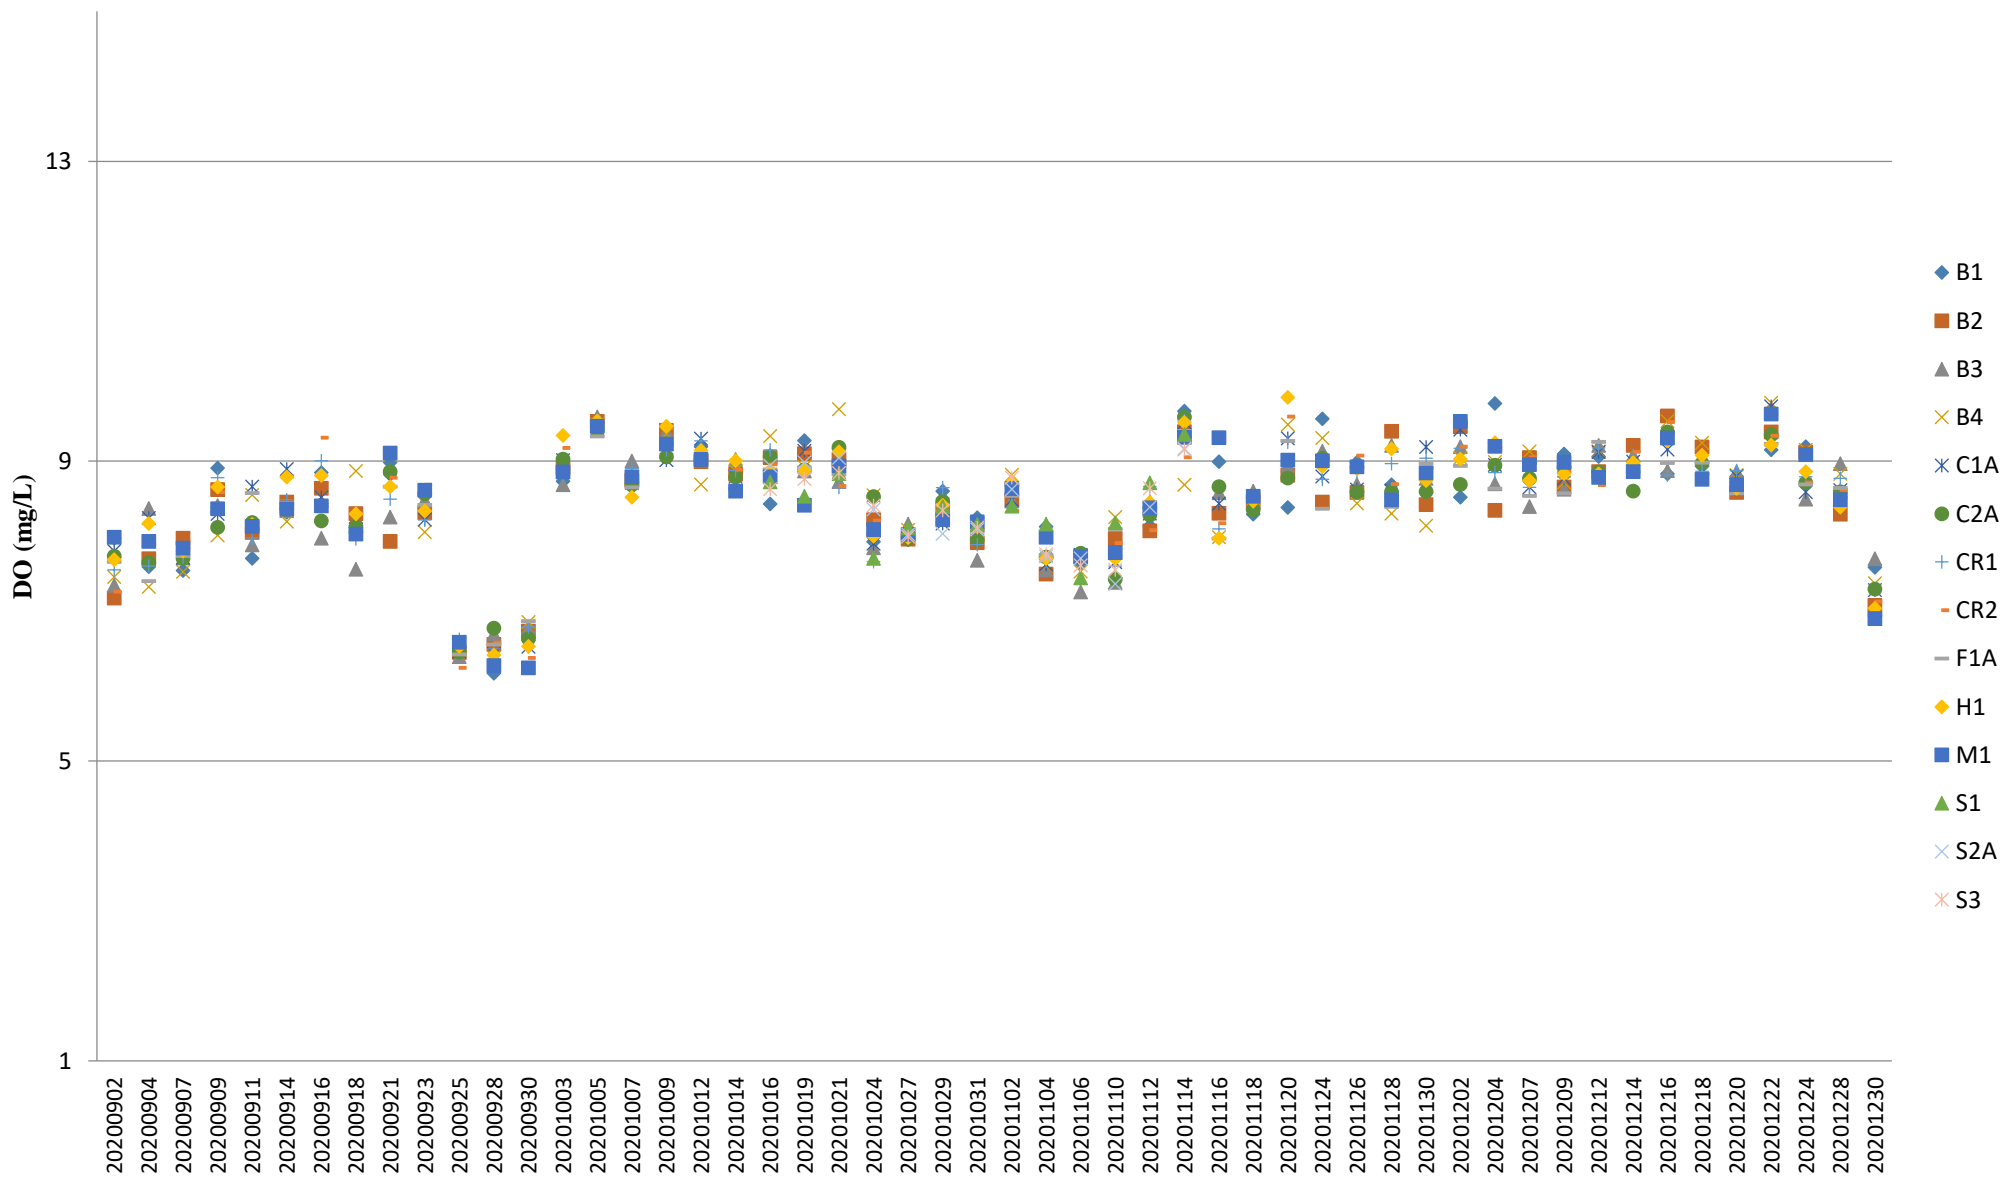
Dissolved Oxygen (Surface & Middle) during MID-FLOOD

Note: The Action and Limit Level of dissolved oxygen can be referred to **Table 2.8** of the monthly EM&A report.

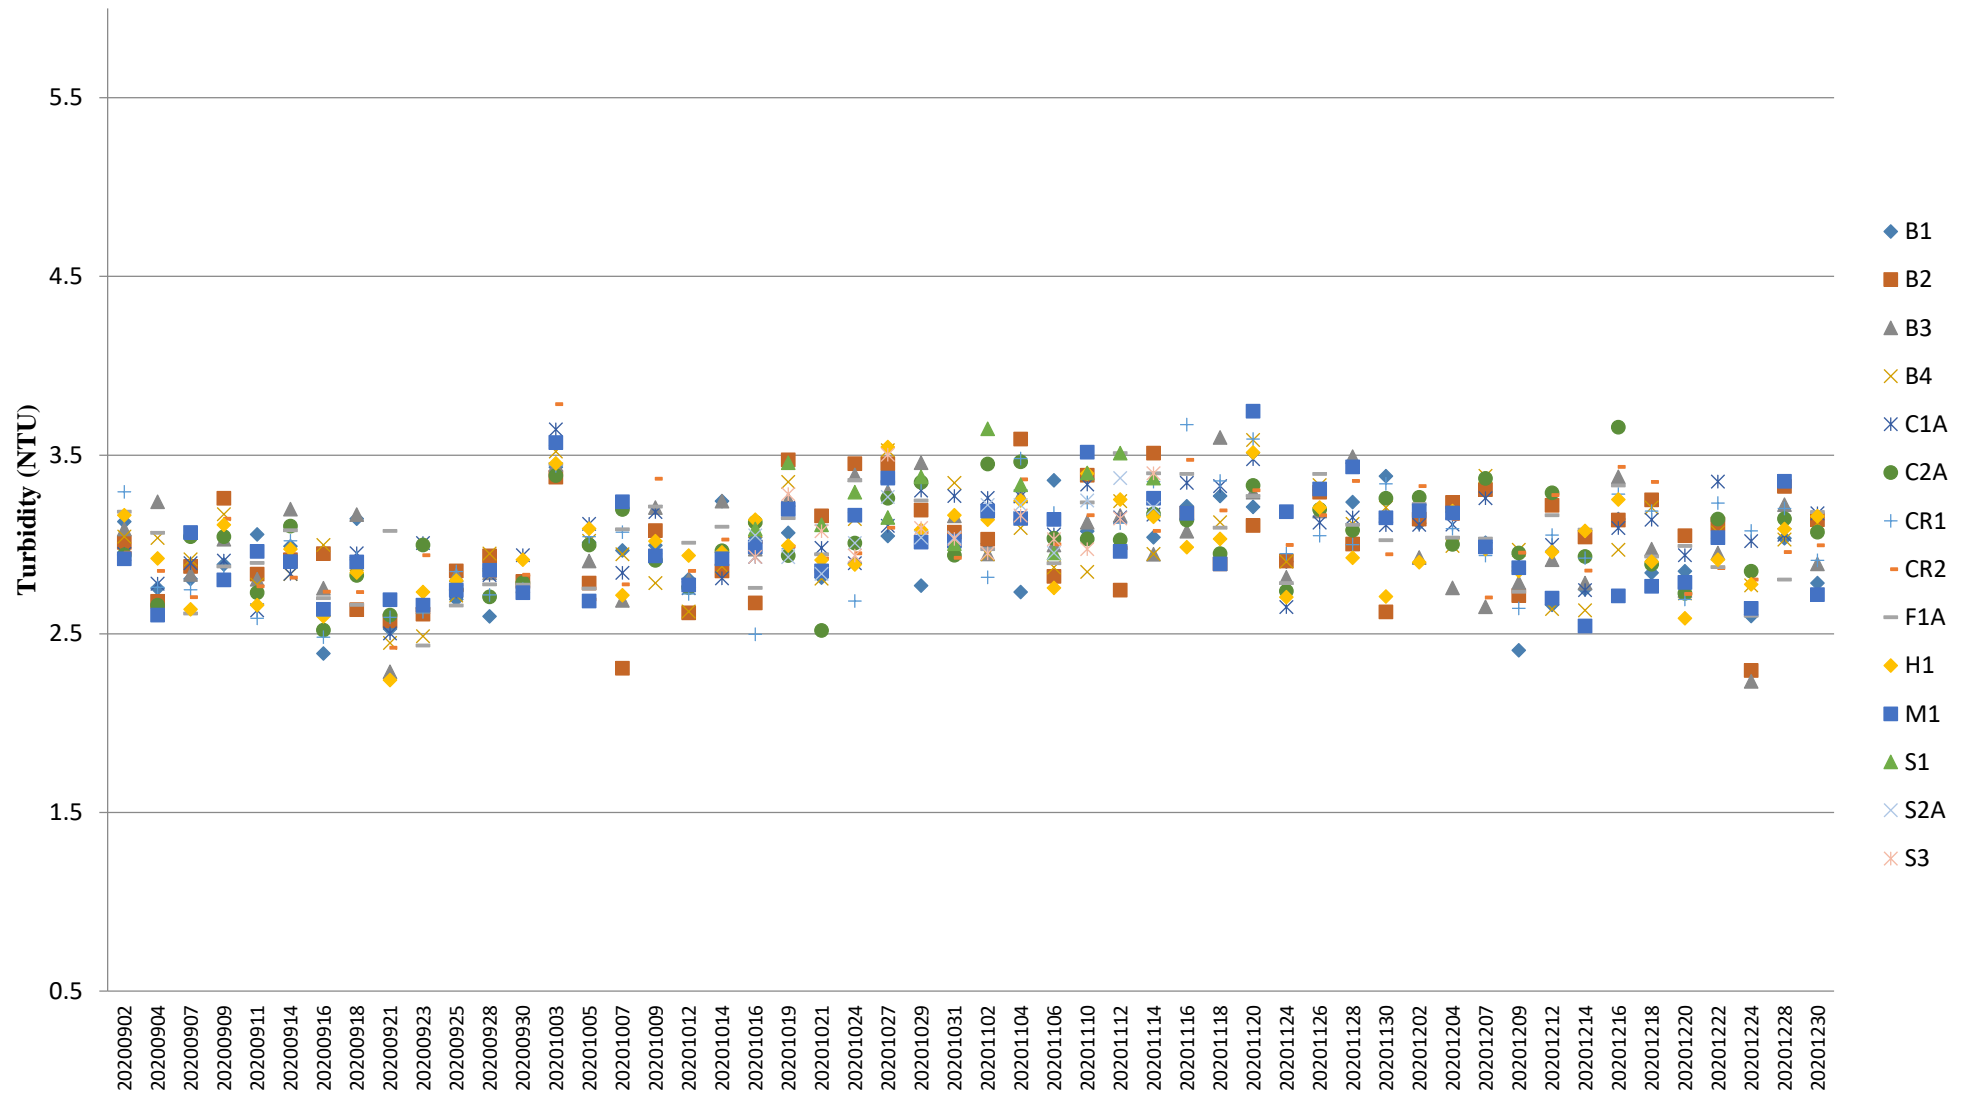
Turbidity (Depth-averaged) during MID-FLOOD

Note: The Action and Limit Level of turbidity can be referred to **Table 2.8** of the monthly EM&A report.

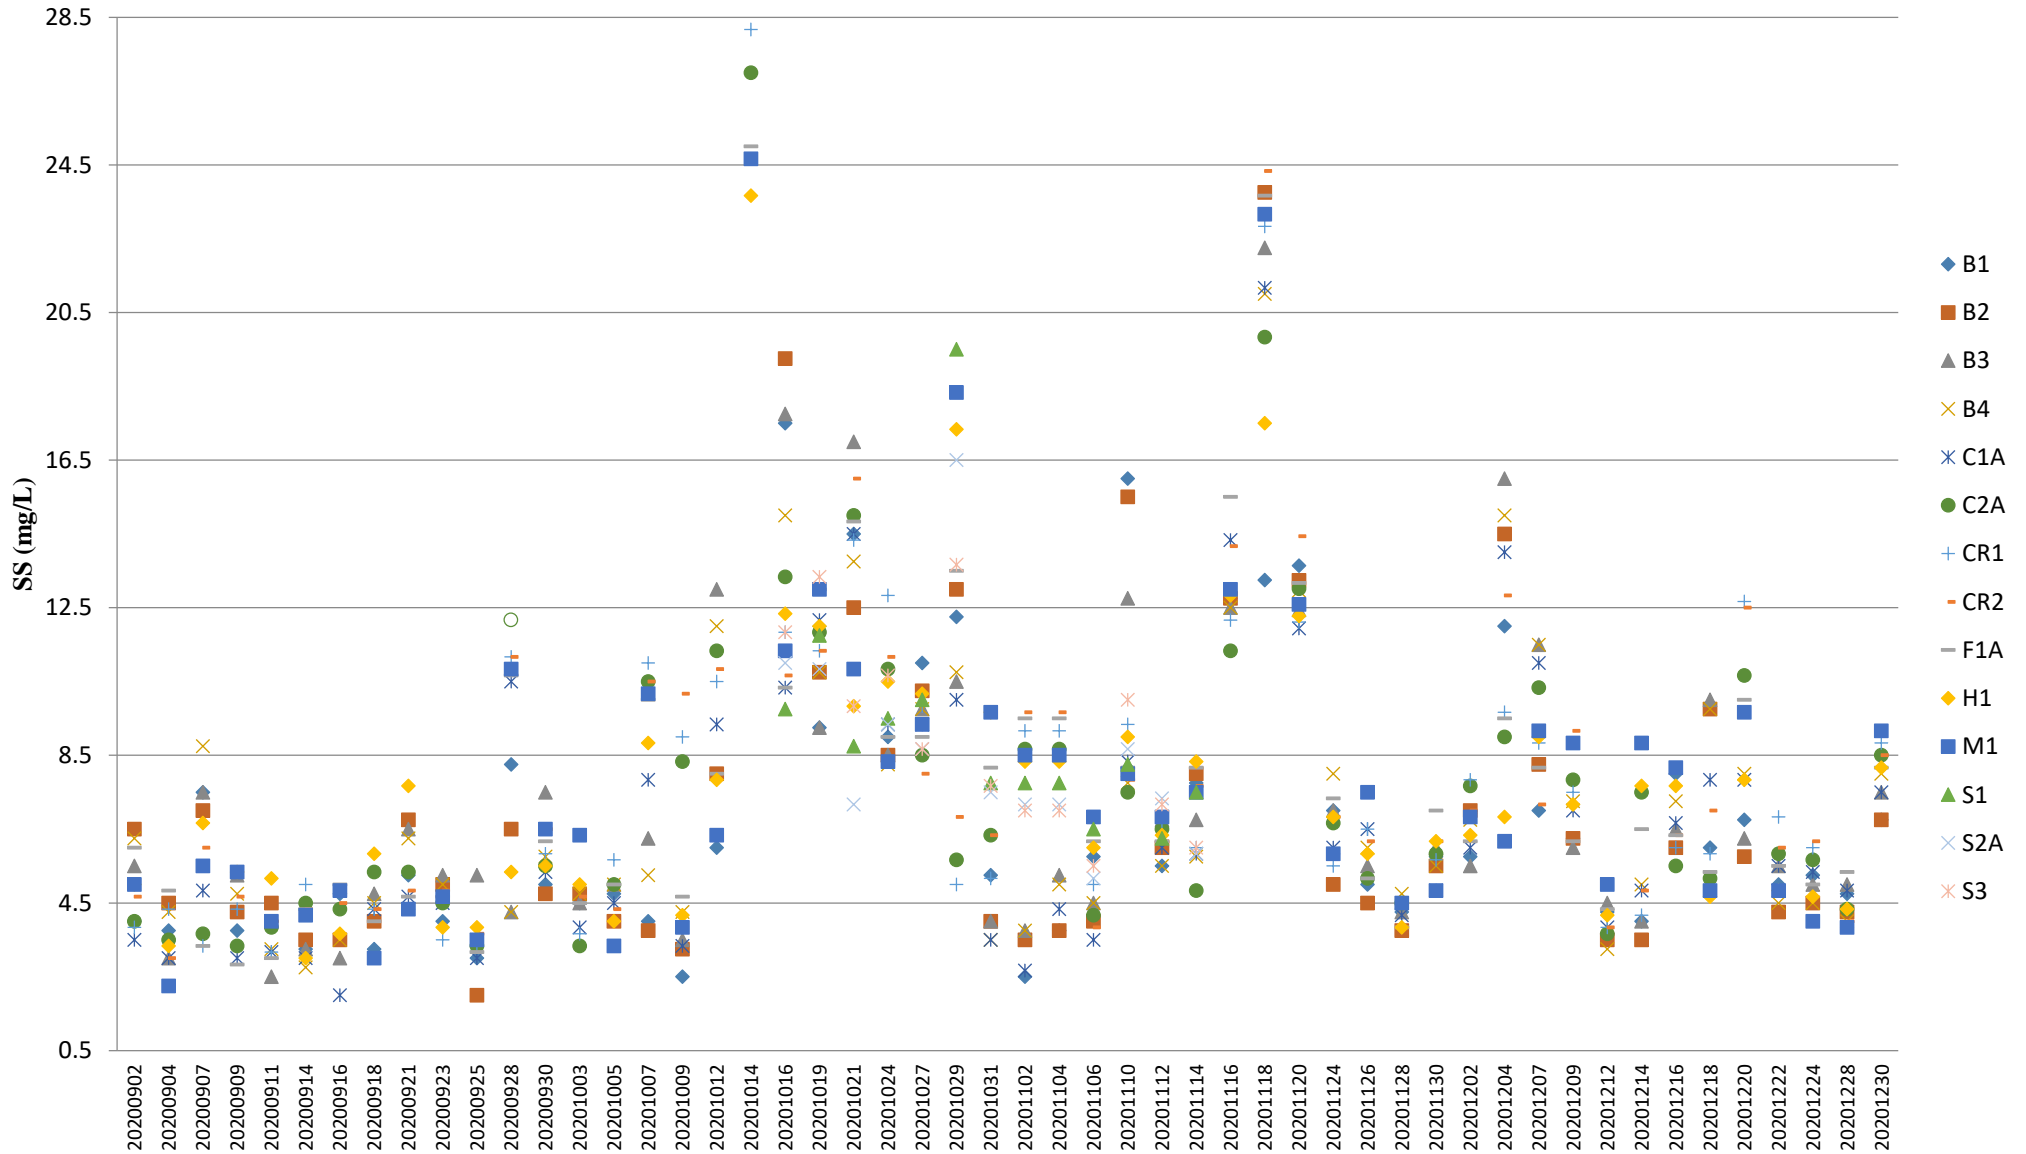
Suspended Solids (Depth-averaged) during MID-FLOOD

Note: The Action and Limit Level of suspended solids can be referred to **Table 2.8** of the monthly EM&A report.

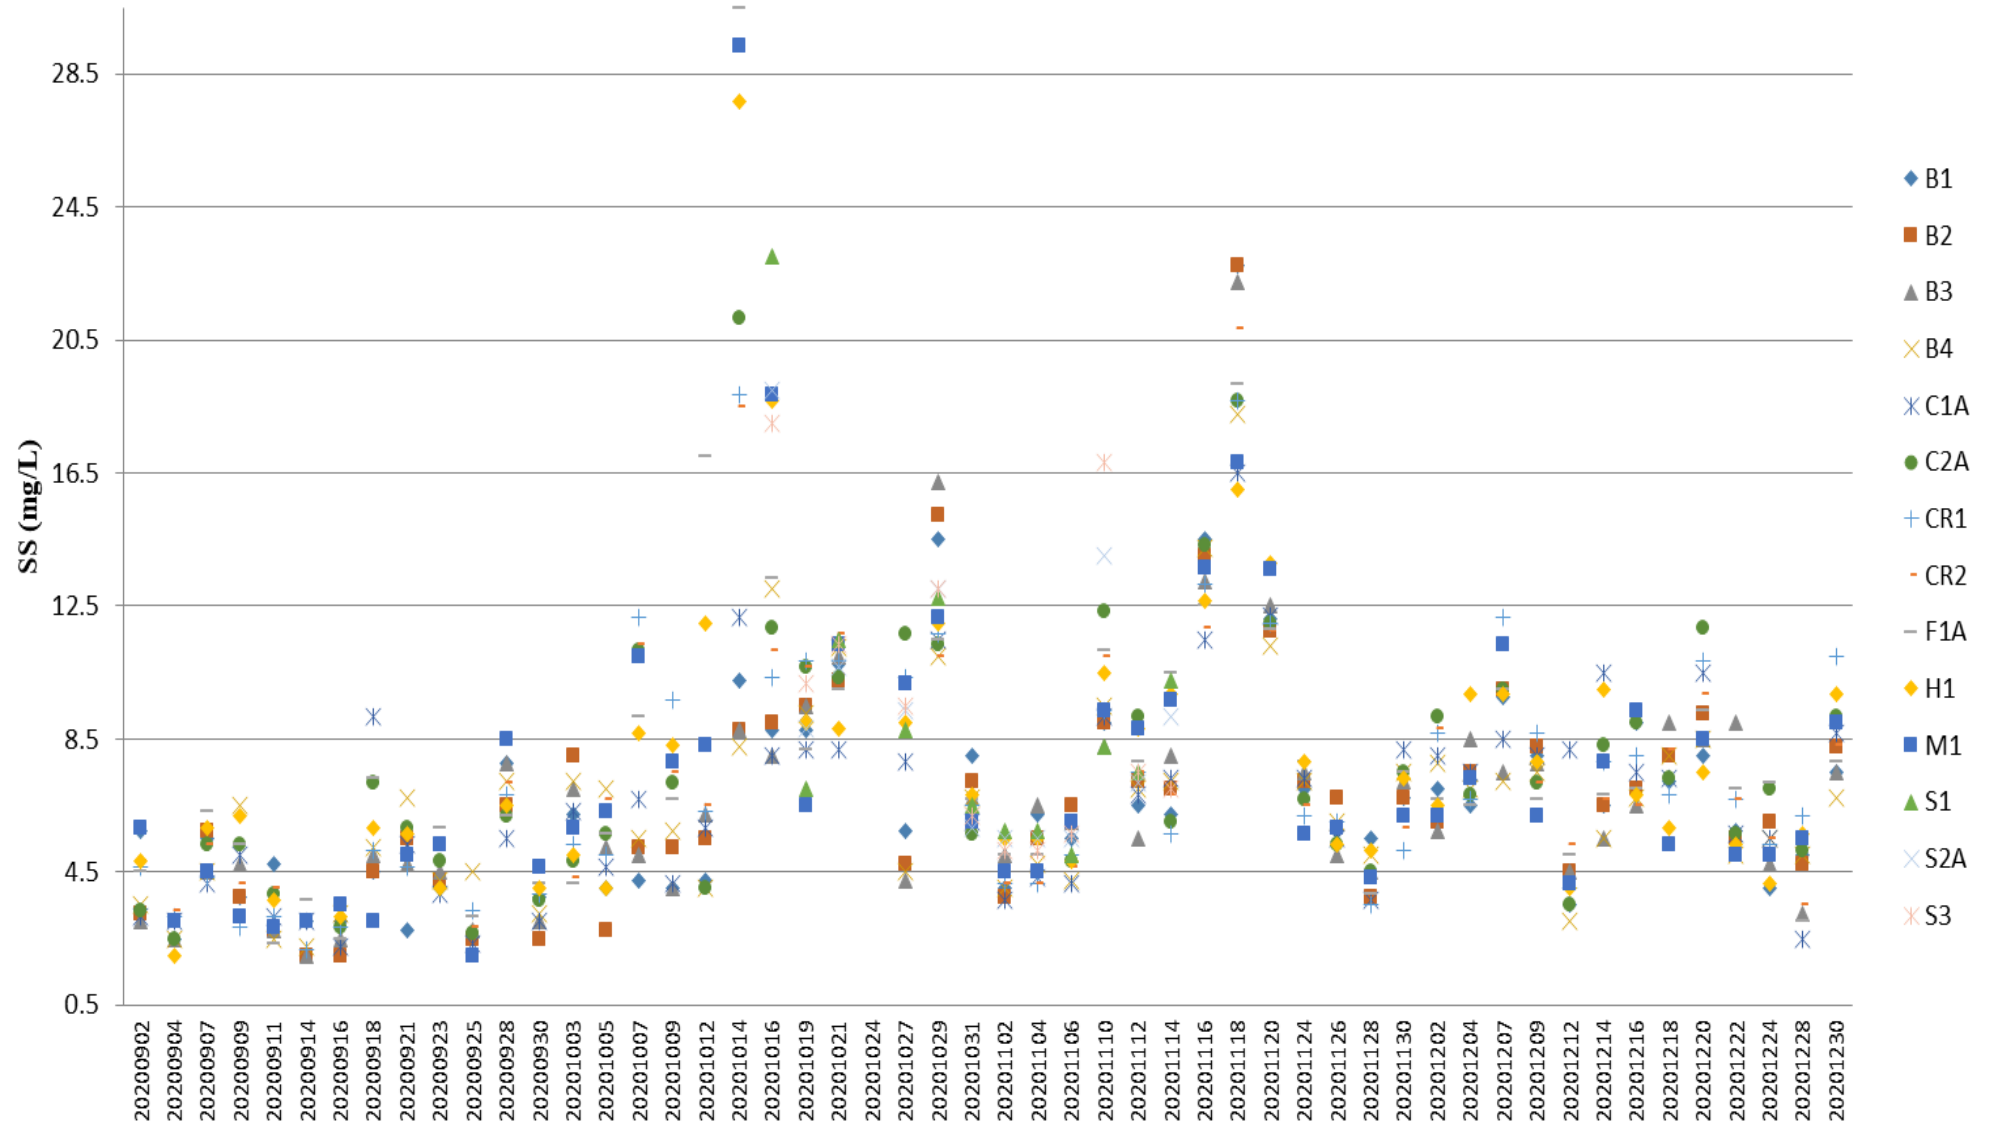
Suspended Solids (Depth-averaged) during MID-EBB

Note: The Action and Limit Level of suspended solids can be referred to **Table 2.8** of the monthly EM&A report.

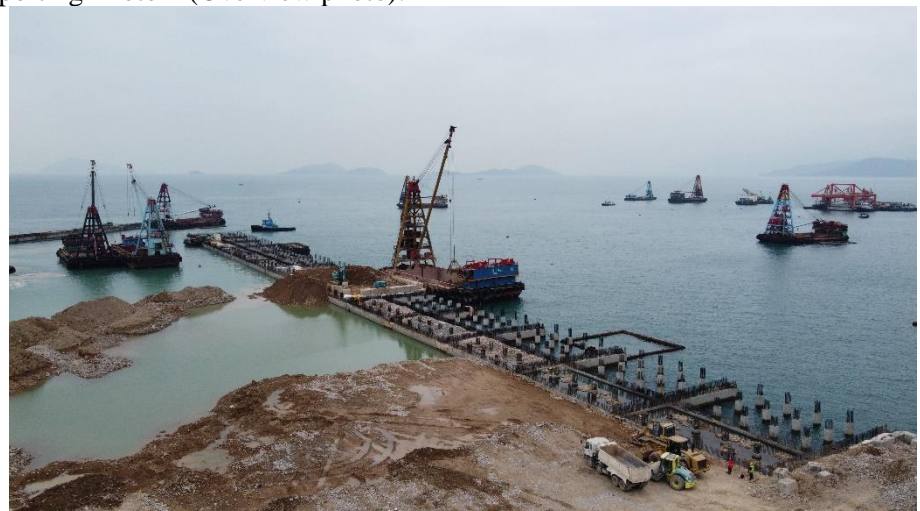
Supporting Photo 1 (Overview photo):

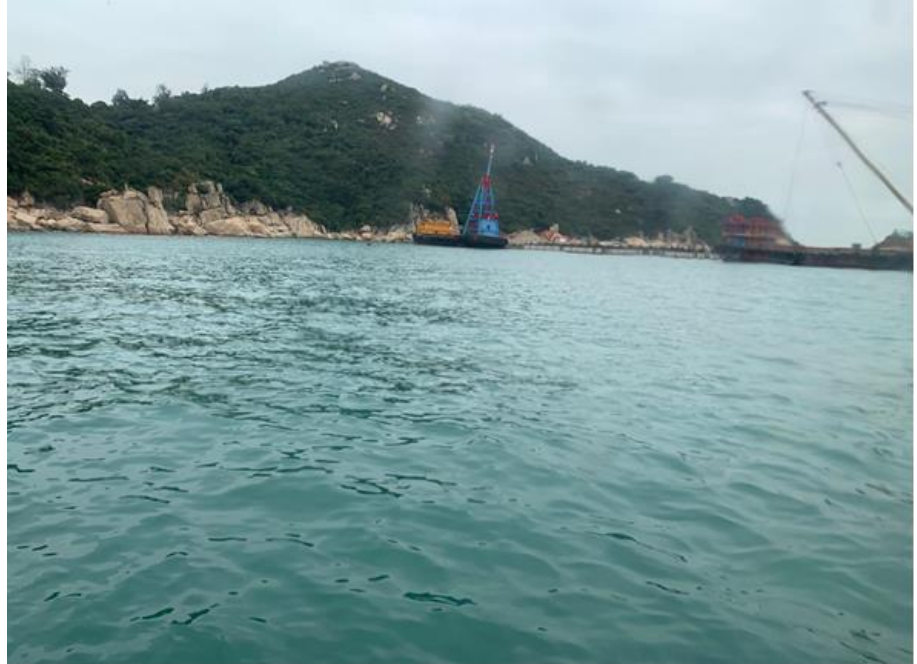
Supporting Photo 2 (Water sampling at CR2 during Mid-ebb):
