Contract No. EP/SP/66/12
Integrated Waste Management Facilities, Phase 1
Monthly EM&A Report No.30

Monthly EM&A Report No.30
(Period from 1 December to 31 December 2020)

(Clause 3.3, Further Environmental Permit FEP-01/429/2012/A)

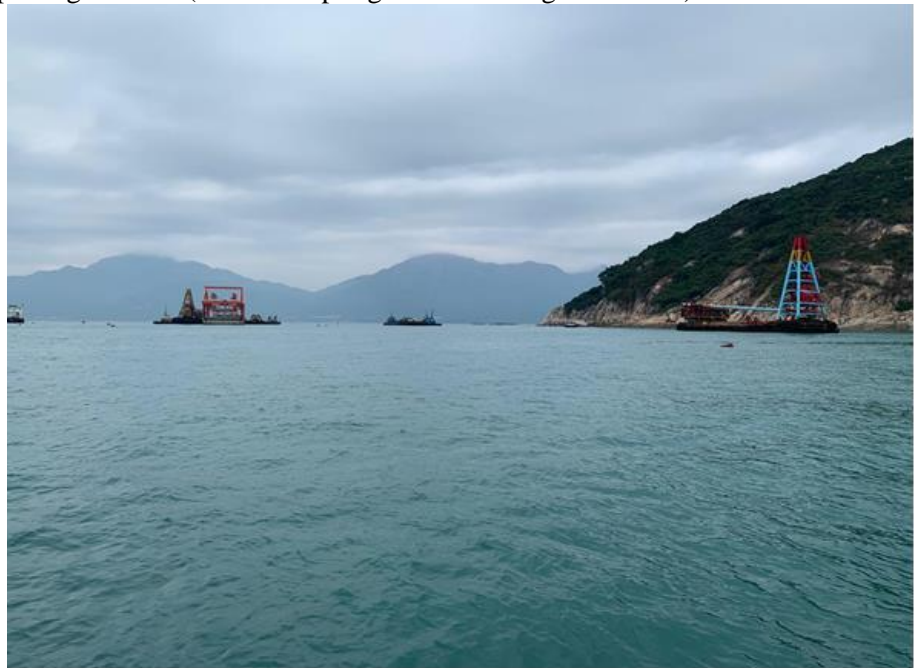
Supporting Photo 3 (Water sampling at CR2 during Mid-flood):
