Contract No. EP/SP/66/12 Integrated Waste Management Facilities, Phase 1 Monthly EM&A Report No.33

Monthly EM&A Report No.33 (Period from 1 March to 31 March 2021)

(Clause 3.3, Further Environmental Permit FEP-01/429/2012/A)

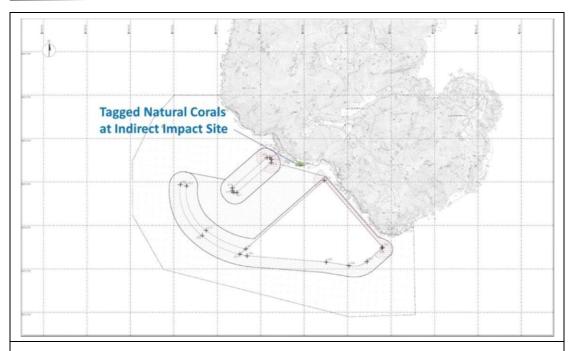
Figure 5.1 Tagged Natural Corals at Indirect Impact Site Near SKC for re-tagging after typhoon Mangkhut

5.3.1 Location of the ten tagged coral colonies at each of the proposed indirect impact site (re-tagging after typhoon Mangkhut), control site (baseline) and recipient site R3 (translocation) are shown in **Figure 5.1**, **Figure 5.2** and **Figure 5.3** respectively:

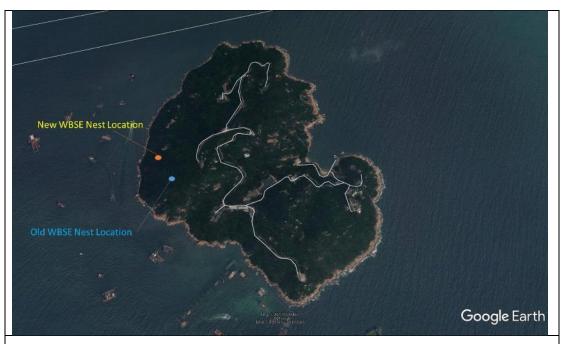
Figure 7.1 Location of WBSE Nest on SKC

- 7.5.4 Since the incubation period was failed, the construction phase monitoring will be continued at twice per month frequency during the breeding season (between December to May) in order to monitor the incubation period, utilization of the area by WBSE and their responses to construction disturbance.
