Contract No. EP/SP/66/12
Integrated Waste Management Facilities, Phase 1
Monthly EM&A Report No.47

Monthly EM&A Report No.47 (Period from 1 May to 31 May 2022)

(Clause 3.3, Further Environmental Permit FEP-01/429/2012/A)

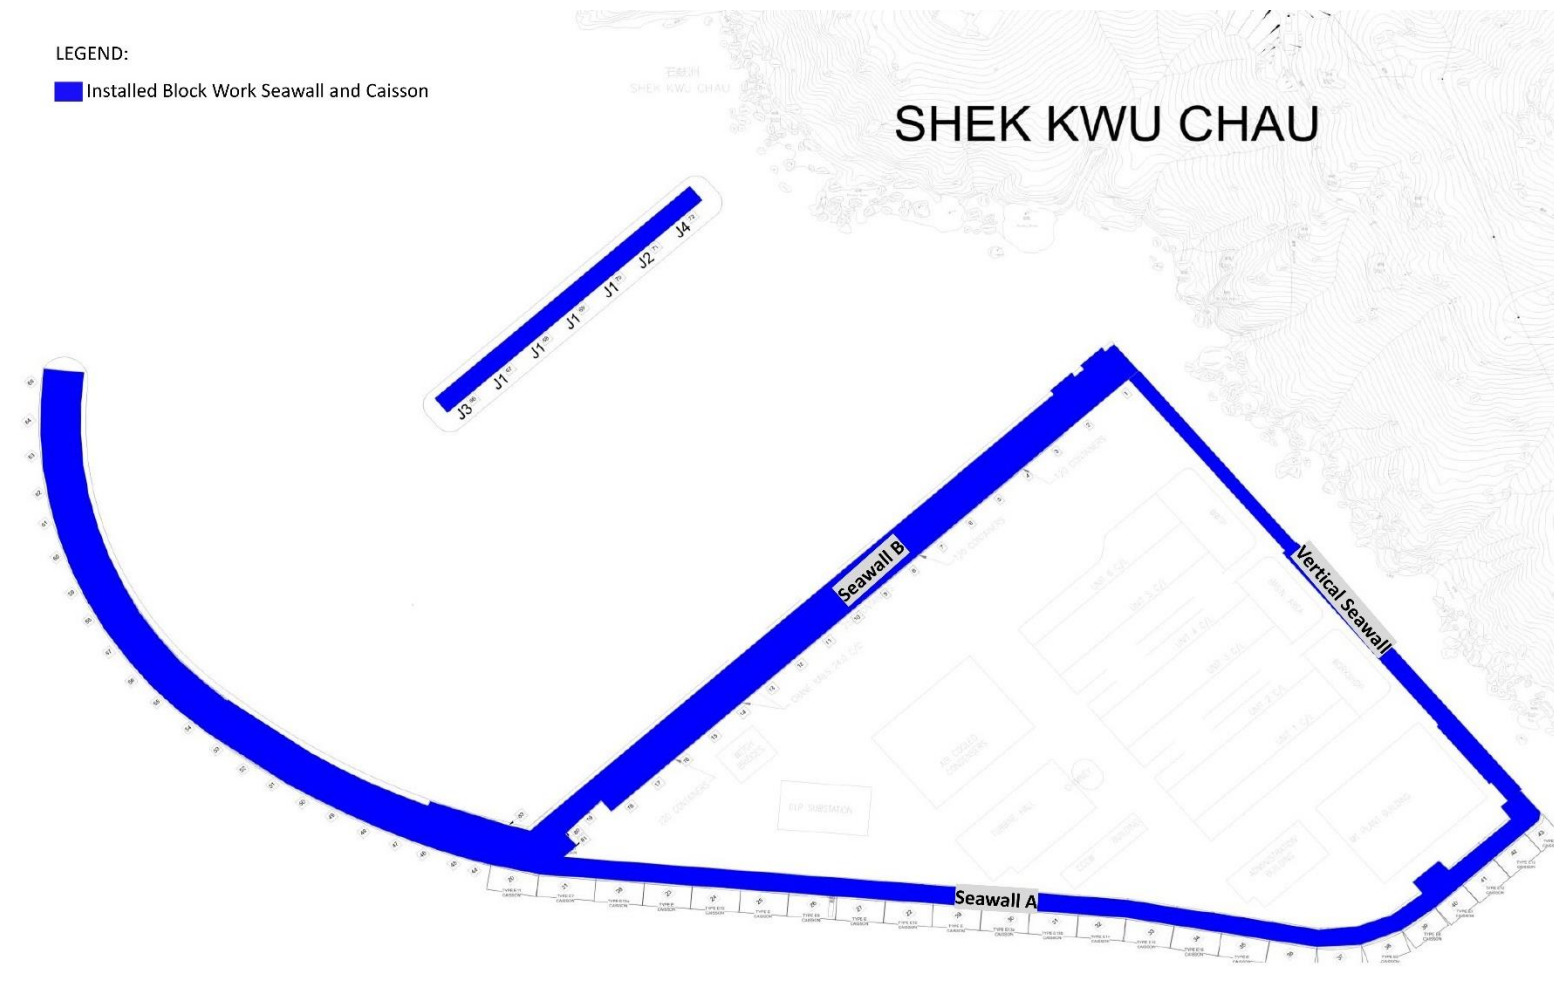
Figure 1.4 Location of Major Construction Activities Undertaken during the Reporting Month

Location of works	Construction activities undertaken	Remarks on progress
Reclamation area	<ul style="list-style-type: none"> • Reclamation works • Installation of Instrumentation • Site Investigation works for foundation • Foundation works (including Driven H Pile, Socketed H Pile and Bored Pile) • Pile cap construction 	<ul style="list-style-type: none"> • On-going • On-going • On-going • On-going • On-going
Seawall portion	<ul style="list-style-type: none"> • Installation of caisson^[1] • Installation of Chinese Pod • Caisson extension works, from +3mPD to +6mPD, at Seawall A and B • Construction of wave wall along the vertical seawall 	<ul style="list-style-type: none"> • Completed • On-going • On-going • On-going

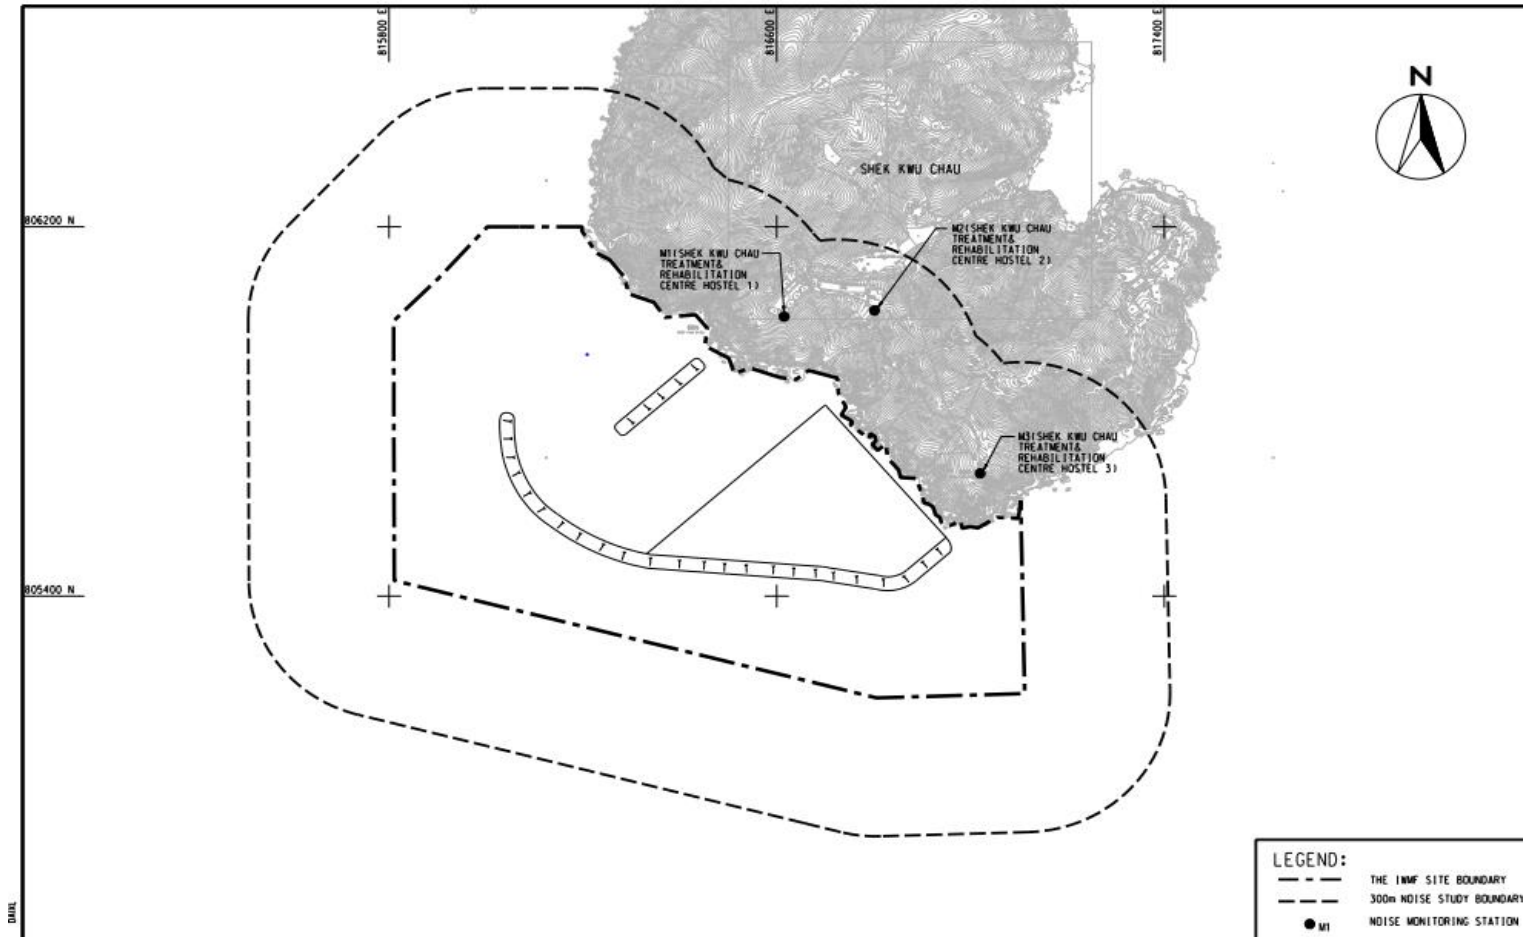
Figure 3.1 Noise monitoring locations at SKC

3.3.1 Three noise monitoring locations for impact monitoring and additional impact monitoring at the nearby sensitive receivers are shown in **Figure 3.1**.

3.3.2 M1, M2 and M3 are Shek Kwu Chau Treatment and Rehabilitation Centre Hostel 1, 2 and 3 respectively of The Society for the Aid and Rehabilitation of Drug Abusers (SARDA) located at southern part of Shek Kwu Chau.

3.3.3 Measurements at M1 & M3 were conducted at a point 1m from the exterior of the sensitive receivers building façade and at a position 1.2m above the ground. Measurement setup at M3 has been varying with minor adjustment to minimize the disturbance to the users of Treatment Centre. Measurement at M2 was conducted at a point 1m from building façade of the ceiling of 1st floor level for avoidance of mutual disturbance with users of Treatment Centre. The minor adjustment of monitoring locations, which were in favour to mutual convenience with the users of Treatment Centre, were found with no effect on monitoring result based on on-site observation and experience from the Baseline monitoring of the Project. The noise monitoring stations are summarized in **Table 3.2** below.

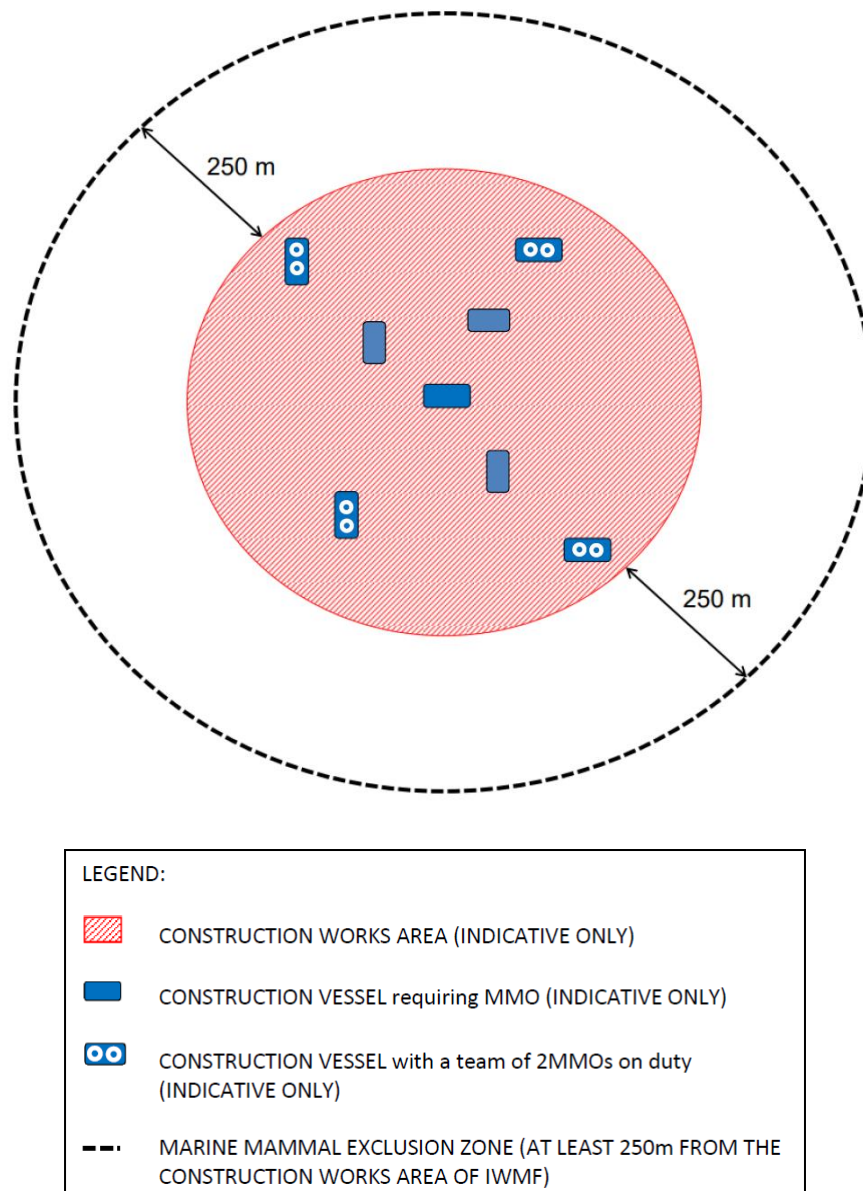
Figure 6.4 Illustration of Typical MMEZ

6.3.1.3 A MMEZ with 250 m distance from the boundary of a work area shall be established during the above situation. A typical MMEZ is indicated in **Figure 6.4** for reference. The MMEZ serves as a monitoring approach to provide appropriate and immediate actions once finless porpoise or Chinese White Dolphin is sighted within the MMEZ. All MMEZ will be monitored by competent Marine Mammal Observers (MMOs) to be provided by the Environmental Team (ET) for the IWMF and trained by the Marine Mammal Monitoring Specialist of the ET who is independent from KSZHJV.

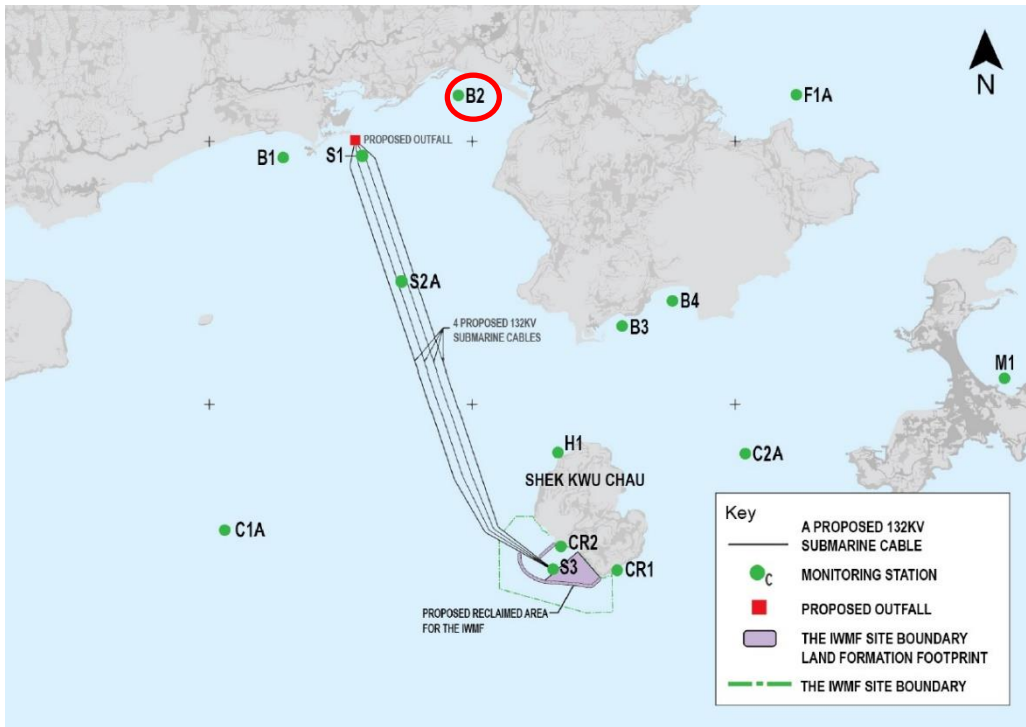
Project	Integrated Waste Management Facilities, Phase 1		
Date	13 May 2022 (Lab result received on 20 May 2022)		
Time	07:35 – 13:23 (Mid-Ebb)		
Mid-Ebb			
Monitoring Location	B2

Parameter	Suspended Solid (SS)		
Action & Limit Levels	Action Level		Limit Level
	≥ 12.0 mg/L		≥ 14.0 mg/L
Measurement Level	Impact Station(s) of Exceedance	Control Stations	Impact Station(s) without Exceedance

22.3 mg/L (B2)	5.0 mg/L (C1A) 7.5 mg/L (C2A)	7.5 mg/L (B1) 11.3 mg/L (B3) 4.3 mg/L (B4) 5.8 mg/L (F1A) 5.7 mg/L (H1) 6.0 mg/L (M1) 5.7 mg/L (CR1) 6.2 mg/L (CR2)
Possible reason for Action or Limit Level Non-compliance	<p>Works scheduled on site on 13 May 2022 include infilling of caisson at Breakwater A, levelling of G200 rockfill at Breakwater B CH 160 – CH 210, landfilling works for below +6.00mPD, landfilling works for above +6.00mPD, installation of instrumentation, piling pre-drilling works, piling works, piling works for driven pile, piling works for pre-bored socketed H-pile, piling works for bored pile, pile cap construction and blockwork seawall and existing caisson extension.</p> <p>Dominant sea current direction was found to be from Northwest to Southeast at waters around Shek Kwu Chau.</p> <p>An exceedance of limit level was found at B2.</p> <p>B2 is located at unrelated stream direction (neither upstream nor downstream, far away) to the works location. The exceedance is deemed to be unrelated to the Project.</p>

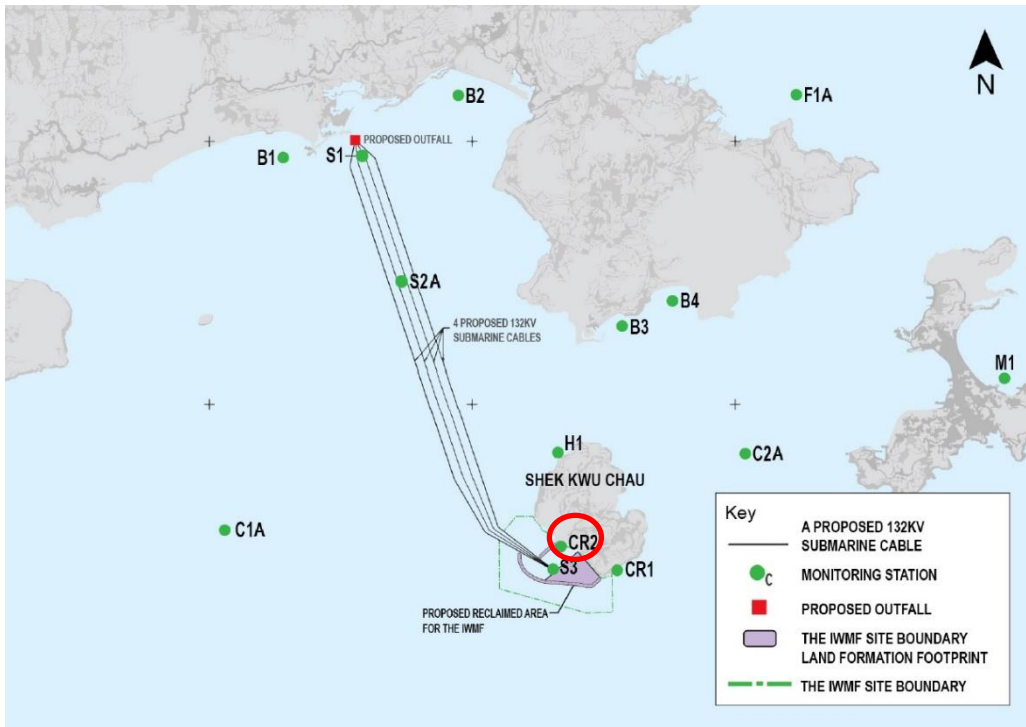
Project	Integrated Waste Management Facilities, Phase 1		
Date	27 May 2022 (Lab result received on 02 June 2022)		
Time	08:00 – 13:42 (Mid-Ebb)		
Mid-Ebb			
Monitoring Location	CR2

Parameter	Suspended Solid (SS)		
Action & Limit Levels	Action Level		Limit Level
	≥ 12.0 mg/L		≥ 14.0 mg/L
Measurement Level	Impact Station(s) of Exceedance	Control Stations	Impact Station(s) without Exceedance

15.8 mg/L (CR2)	4.2 mg/L (C1A) 3.7 mg/L (C2A)	4.0 mg/L (B1) 4.3 mg/L (B2) 4.7 mg/L (B3) 5.0 mg/L (B4) 4.5 mg/L (F1A) 4.5 mg/L (H1) 8.7 mg/L (M1) 7.8 mg/L (CR1)
Possible reason for Action or Limit Level Non-compliance	<p>Works scheduled on site on 27 May 2022 include infilling of 1.85T armour rock at Caisson No. 48 - 49, diver inspection work at the rock base at Caisson No.65, installation of stoppers at Caissons 55-56, 56-57, 57-58, 58-59, infilling of caisson, landfilling works for below +6.00mPD, landfilling works for above +6.00mPD, installation of instrumentation, piling pre-drilling works, piling works, piling works for driven pile, piling works for pre-bored socketed H-pile, piling works for bored pile, Pile Cap Construction and blockwork seawall and existing caisson extension.</p> <p>Dominant sea current direction was found to be from Northwest to Southeast at waters around Shek Kwu Chau.</p> <p>An exceedance of limit level was found at CR2.</p>

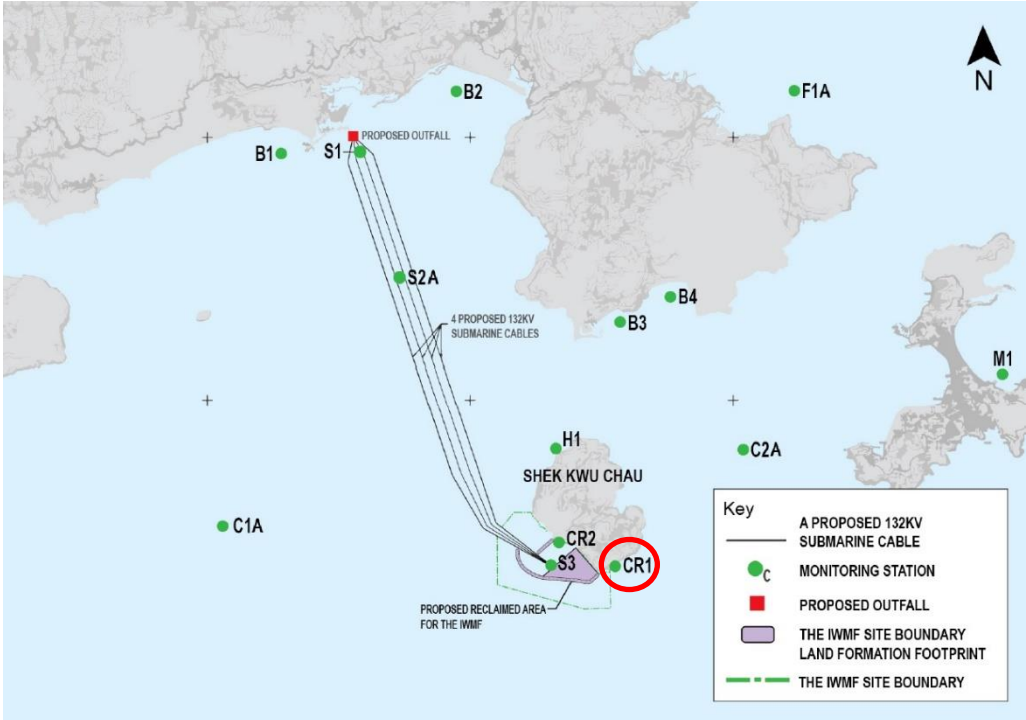
Project	Integrated Waste Management Facilities, Phase 1		
Date	30 May 2022 (Lab result received on 06 June 2022)		
Time	08:51 – 15:53 (Mid-Ebb) 15:53 – 22:32 (Mid-Flood)		
Mid-Ebb			
Monitoring Location	CR1

Parameter	Suspended Solid (SS)		
Action & Limit Levels	Action Level		Limit Level
	≥ 13.8 mg/L (120% of C1A)		≥ 15.0 mg/L (130% of C1A)
Measurement Level	Impact Station(s) of Exceedance	Measurement Level	Impact Station(s) without Exceedance

15.3 mg/L (CR1)	11.5 mg/L (C1A) 6.3 mg/L (C2A)	6.5 mg/L (B1) 7.3 mg/L (B2) 6.3 mg/L (B3) 7.0 mg/L (B4) 10.3 mg/L (M1) 7.8 mg/L (F1A) 8.7 mg/L (H1) 11.8 mg/L (CR2)
Possible reason for Action or Limit Level Non-compliance	<p>Works scheduled on site on 30 May 2022 include transloading 1.85T armour rock from rock barge, installation of Caisson No.65, diver inspection work at the stopper at CH40 - CH100 and CH160 - CH180, landfilling works for below +6.00mPD, landfilling works for above +6.00mPD, installation of instrumentation, piling pre-drilling works, piling works, piling works for driven pile, piling works for pre-bored socketed H-pile, piling works for bored pile, Pile Cap Construction and blockwork seawall and existing caisson extension.</p> <p>Dominant sea current direction was found to be from Northwest to Southeast at waters around Shek Kwu Chau.</p> <p>An exceedance of limit level was found at CR1.</p>

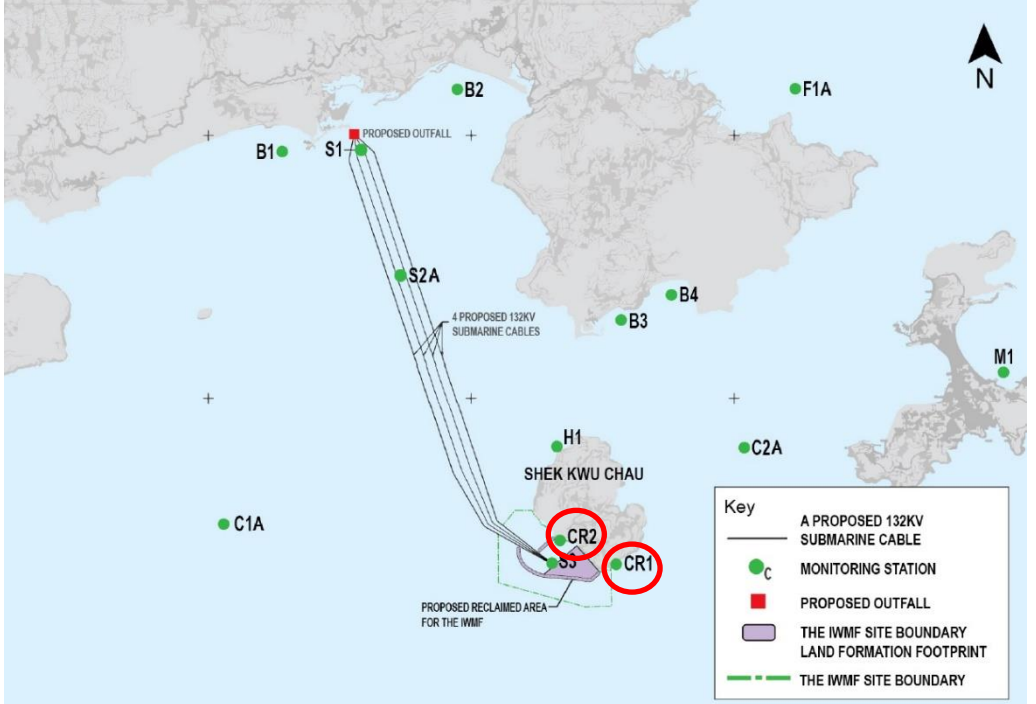
<p>Monitoring Location</p>	<p>CR1, CR2</p>

<p>The map shows the Shek Kwu Chau area with various monitoring stations marked with green dots: B1, B2, B3, B4, C1A, C2A, F1A, H1, M1, CR1, CR2, S1, and S2A. A red square marks the 'PROPOSED OUTFALL' at station S1. Four blue lines represent '4 PROPOSED 132KV SUBMARINE CABLES' extending from S1. A purple shaded area indicates 'THE IWMF SITE BOUNDARY LAND FORMATION FOOTPRINT', and a green dashed line shows 'THE IWMF SITE BOUNDARY'. A north arrow is in the top right corner.</p>		
<p>Parameter</p>	<p>Suspended Solid (SS)</p>		
<p>Action & Limit Levels</p>	<p>Action Level ≥ 12.0 mg/L</p>	<p>Limit Level ≥ 14.0 mg/L</p>	
<p>Measurement Level</p>	<p>Impact Station(s) of Exceedance 17.3 mg/L (CR1) 12.5 mg/L (CR2)</p>	<p>Control Stations 7.3 mg/L (C1A) 5.8 mg/L (C2A)</p>	<p>Impact Station(s) without Exceedance 6.5 mg/L (B1) 7.5 mg/L (B2) 6.5 mg/L (B3) 8.0 mg/L (B4) 6.0 mg/L (F1A) 8.2 mg/L (H1) 8.2 mg/L (M1)</p>

<p>Possible reason for Action or Limit Level Non-compliance</p>	<p>Works scheduled on site on 30 May 2022 include transloading 1.85T armour rock from rock barge, installation of Caisson No.65, diver inspection work at the stopper at CH40 - CH100 and CH160 - CH180, landfilling works for below +6.00mPD, landfilling works for above +6.00mPD, installation of instrumentation, piling pre-drilling works, piling works, piling works for driven pile, piling works for pre-bored socketed H-pile, piling works for bored pile, Pile Cap Construction and blockwork seawall and existing caisson extension.</p> <p>Dominant sea current direction was found to be from Southeast to Northwest at waters around Shek Kwu Chau.</p> <p>An exceedance of limit level was found at CR1 and an exceedance of action level was found at CR2.</p> <p>CR1 and CR2 are located within the Project site while no marine work was conducted on 30 May 2022.</p> <p>The installation of caisson No.19 was completed on 18 Mar 2021, the reclamation area was enclosed.</p>
