Contract No. EP/SP/66/12 Integrated Waste Management Facilities, Phase 1 Monthly EM&A Report No.48

Monthly EM&A Report No.48 (Period from 1 June to 30 June 2022)

(Clause 3.3, Further Environmental Permit FEP-01/429/2012/A)

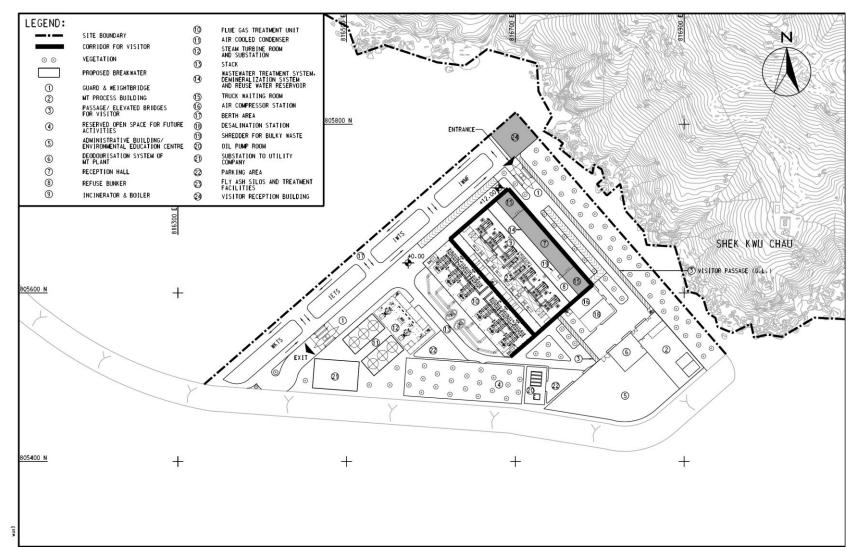
Figure 1.2 General Layout of the IWMF at the Artificial Island near SKC

1.1.5 The location of the IWMF near Shek Kwu Chau (SKC) and general layout of IWMF are shown in **Figure 1.1** and **Figure 1.2** respectively.

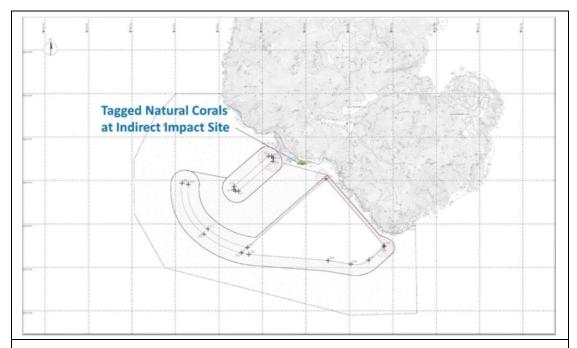
Figure 5.1 Tagged Natural Corals at Indirect Impact Site Near SKC for re-tagging after typhoon Mangkhut

5.3.1 Location of the ten tagged coral colonies at each of the proposed indirect impact site (re-tagging after typhoon Mangkhut), control site (baseline) and recipient site R3 (translocation) are shown in **Figure 5.1**, **Figure 5.2** and **Figure 5.3** respectively:
