Contract No. EP/SP/66/12 Integrated Waste Management Facilities, Phase 1 Monthly EM&A Report No.49

Monthly EM&A Report No.49 (Period from 1 July to 31 July 2022)

(Clause 3.3, Further Environmental Permit FEP-01/429/2012/A)

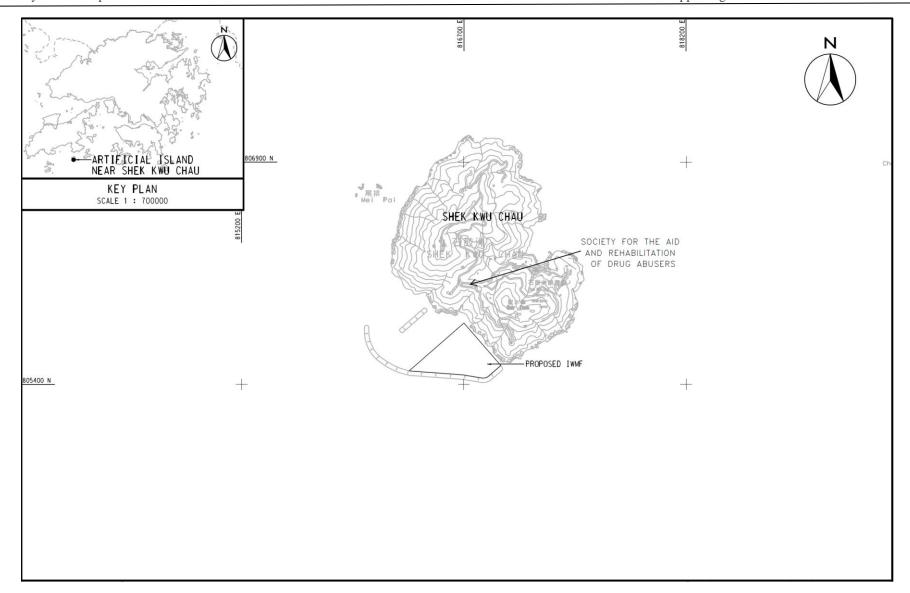
Figure 1.1 Location of the IWMF at the Artificial Island near SKC

1.1.5 The location of the IWMF near Shek Kwu Chau (SKC) and general layout of IWMF are shown in **Figure 1.1** and **Figure 1.2** respectively.

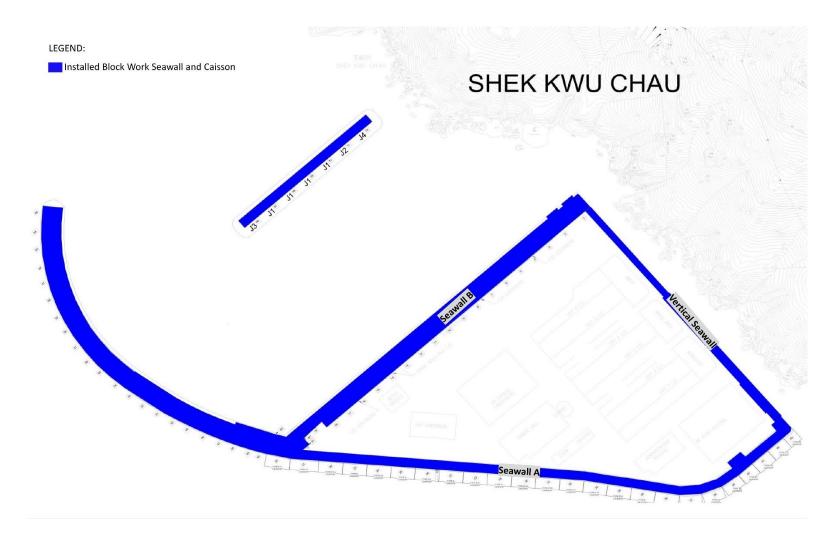
Figure 1.4 Location of Major Construction Activities Undertaken during the Reporting Month

Location of works	Construction activities undertaken	Remarks on progress
Reclamation area	Reclamation works	On-going
	Installation of Instrumentation	On-going
	Site Investigation works for foundation	On-going
	Foundation works (including Driven H Pile, Socketed H Pile and Bored Pile)	On-going
	Pile cap construction	On-going
Seawall portion	Installation of Chinese Pod	On-going
	• Caisson extension works, from +3mPD to +6mPD, at Seawall A and B	On-going
	Construction of wave wall along the vertical seawall	On-going

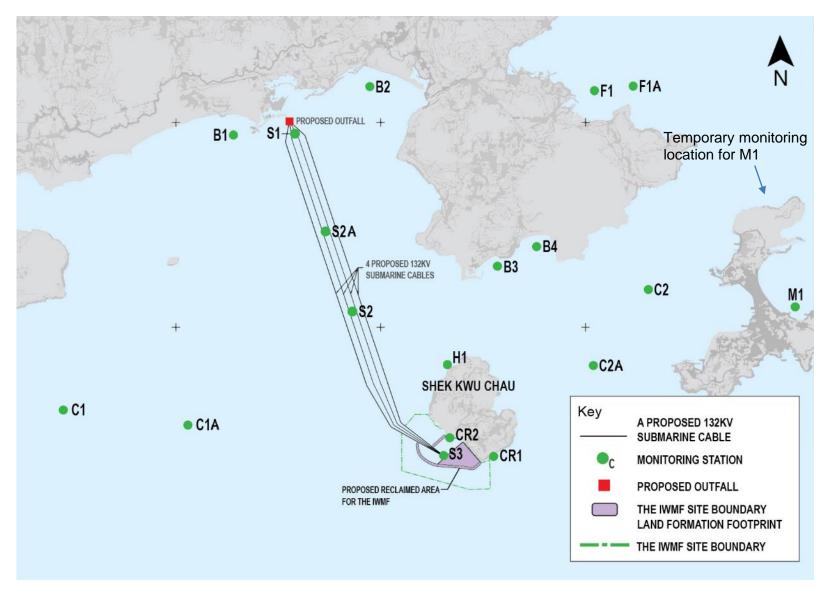
Figure 2.1 Water monitoring locations at Artificial Island near SKC

2.3.1 Impact water quality monitoring was conducted at eleven monitoring locations (B1-B4, H1, C1, C2, F1, CR1, CR2 & M1) during general water quality monitoring in the reporting period as shown in **Figure 2.1**. As per the relocation proposal verified by IEC and approved by EPD, the monitoring location C1, C2, S2, F1 are relocated at C1A, C2A, S2A, F1A as equivalent points respectively to clear up the concerns from stakeholders.

- 2.3.2 B1 to B4 are located at 4 beaches respectively at the southern shore of Lantau Island. Monitoring station H1 is located at the horseshoe crab habitat at northern SKC, while CR1 and CR2 are located at the coral communities at southwestern shore of SKC. Monitoring station F1 is located at the Cheung Sha Wan Fish Culture Zone while monitoring station M1 is located at Tung Wan at Cheung Chau. Monitoring station F1A is relocated for F1 at the Cheung Sha Wan Fish Culture Zone. S1, S2 and S3 are located at the northern landing site, midway and southern landing site of the proposed submarine cable, respectively. S2A is the relocated monitoring station of S2 which represents the midway landing site of the proposed submarine cable. S1, S2/S2A and S3 are required for monitoring due to the laying of submarine cable. Control stations C1 and C2 at far field locations are for comparison. Control stations C1A and C2A are relocated for C1 and C2 respectively as equivalent far field locations for comparison.

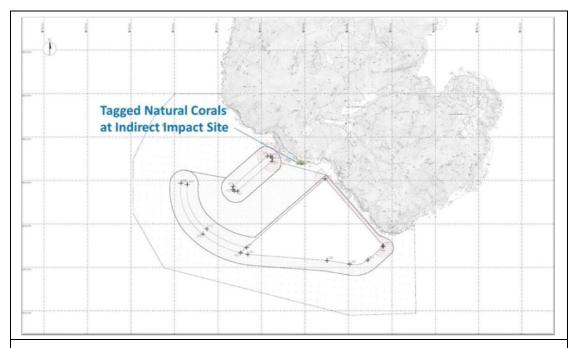
Figure 5.1 Tagged Natural Corals at Indirect Impact Site Near SKC for re-tagging after typhoon Mangkhut

5.3.1 Location of the ten tagged coral colonies at each of the proposed indirect impact site (re-tagging after typhoon Mangkhut), control site (baseline) and recipient site R3 (translocation) are shown in **Figure 5.1**, **Figure 5.2** and **Figure 5.3** respectively:

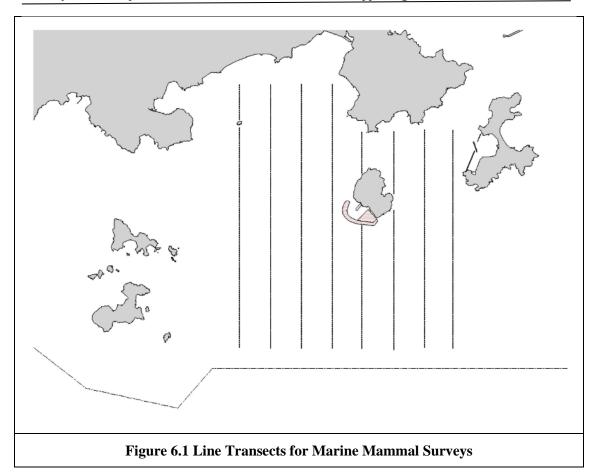
- 6.2.1 Vessel-based Line-transect Survey
- 6.2.1.1 For the vessel-based marine mammal surveys, the monitoring team adopted the standard line-transect method (Buckland et al. 2001) as same as that adopted during the EIA study and pre-construction phase monitoring to allow fair comparison of marine mammal monitoring results.
- 6.2.1.2 Eight transect lines are set at Southeast Lantau survey area, including Shek Kwu Chau, waters between Shek Kwu Chau and the Soko Islands, inshore waters of Lantau Island (e.g. Pui O Wan) as well as southwest corner of Cheung Chau as shown in **Figure 6.1** below:

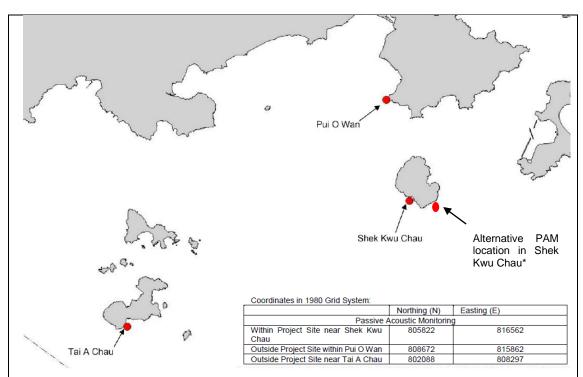
Figure 6.2 Locations of Passive Acoustic Monitoring

The PAM aims to study the usage of an area by Finless Porpoise by using an array of automated static porpoise detectors (e.g. C-POD) which would be deployed at different locations to detect the unique ultra-high frequency sounds produced by Finless Porpoise. During the construction period, the PAM survey will be conducted including placement of two passive porpoise detectors outside the Project Area as control site (i.e. within Pui O Wan and to the south of Tai A Chau) and one porpoise detector within the Project Area (i.e. near Shek Kwu Chau) as shown in **Figure 6.2** below.

Note*: The alternative PAM device adjacent to the Project site was deployed from 5 Mar to 11 Apr 2019, which contained a full 37 days acoustic monitoring data set. After the confirmation of loss of the original PAM within the Project site, this data set was proposed to replace that of the original one, as consulted with AFCD accordingly.

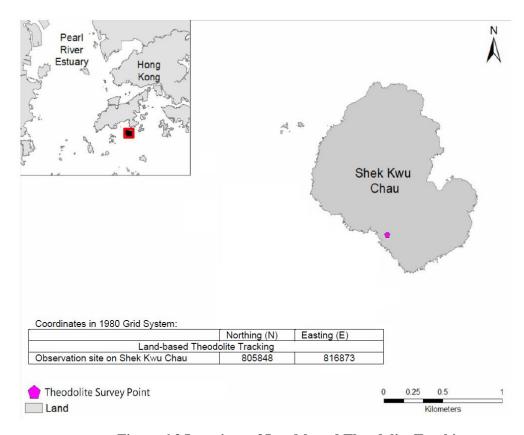
Figure 6.3 Locations of Land-based Theodolite Tracking

- 6.2.4 Land-based Theodolite Tracking
- 6.2.4.1 The Land-based Theodolite Tracking study would use the same station as in the AFCD monitoring study (same as the baseline monitoring location), which is situated at the southwest side of Shek Kwu Chau (GPS position: 22°11.47' N and 113°59.33' E) as shown in below **Figure 6.3**. The station was selected based on its height above sea level (at least 20 metres), close proximity to shore, and relatively unobstructed views of the entire Project Area to the southwest of Shek Kwu Chau. The height of the Shek Kwu Chau Station established by the HKCRP team is 74.6 m high at mean low water, and only a few hundred metres to the IWMF reclamation site, which is ideal for the purpose for the present behavioural and movement monitoring of finless porpoises as well during construction phase considering there as an un-obstructed vantage point at a height above the Project Site.

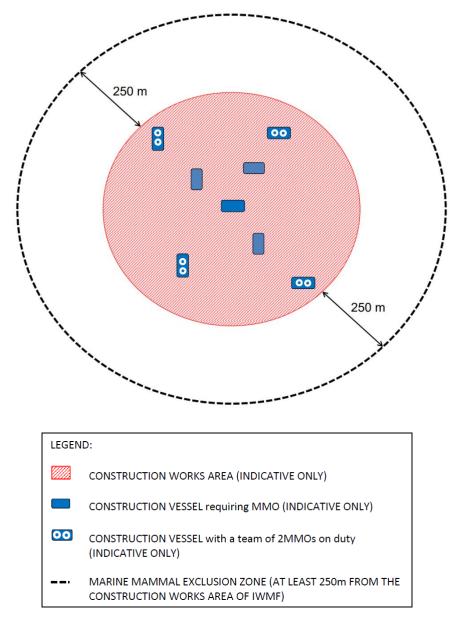
Figure 6.4 Illustration of Typical MMEZ

6.3.1.3 A MMEZ with 250 m distance from the boundary of a work area shall be established during the above situation. A typical MMEZ is indicated in **Figure 6.4** for reference. The MMEZ serves as a monitoring approach to provide appropriate and immediate actions once finless porpoise or Chinese White Dolphin is sighted within the MMEZ. All MMEZ will be monitored by competent Marine Mammal Observers (MMOs) to be provided by the Environmental Team (ET) for the IWMF and trained by the Marine Mammal Monitoring Specialist of the ET who is independent from KSZHJV.

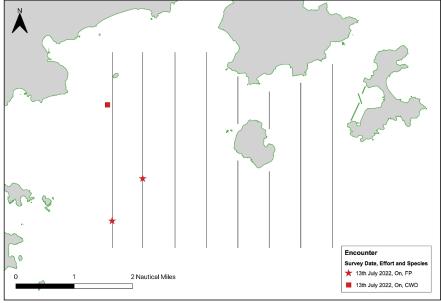
Figure 6.5 Location of sightings recorded during July 2022 Vessel-based Line-transect Survey

Date	Species	Sighting No.	Time	Group Size	PSD	Behaviour	Lat.	Long.	Area	Effort	Season
13 July 2022	Finless Porpoise	127	12:58	1	211	Unknow	22.18536	113.9543	SEL	On	Summer
13 July 2022	Chinese White Dolphin	128	13:24	1	157	Other	22.20642	113.9435	SEL	On	Summer
13 July 2022	Finless Porpoise	129	13:42	10	193	Other	22.17325	113.9449	SEL	On	Summer

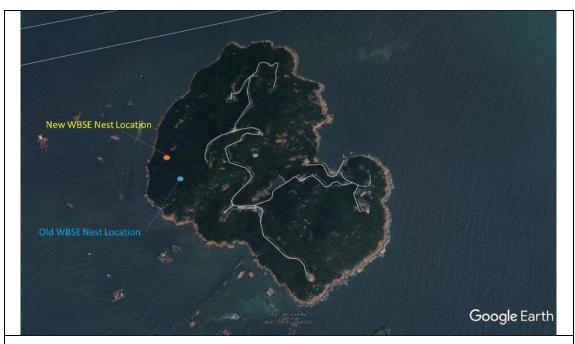
Figure 7.1 Location of WBSE Nest on SKC

- 7.5.2 During the monitoring survey, the two adult WBSEs and one juvenile were recorded staying around the new nest (**Figure 7.1**). No abnormal behaviors of the adults and chick were recorded.
- 7.5.3 All marine works during the monitoring period did not show any effect to the WBSE.
- 7.5.4 No disturbances from anthropogenic activities on the island were recorded during the monitoring survey. However, fishing boats were observed moving close to the shore. No invasion of other fauna species was recorded.
- 7.5.5 There was no sign of using the construction site as a foraging ground.
- 7.5.6 A construction phase monitoring will be continued once per month outside their core breeding season (between June to November) in order to monitor the utilization of the area by WBSE and their responses to construction disturbance.

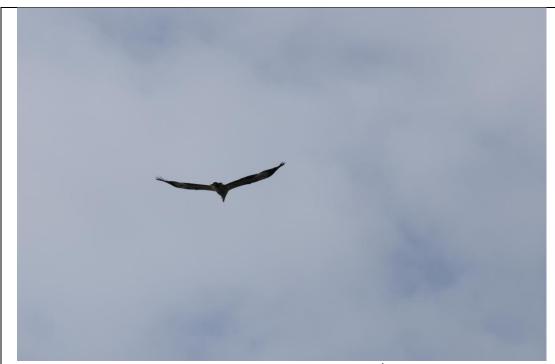
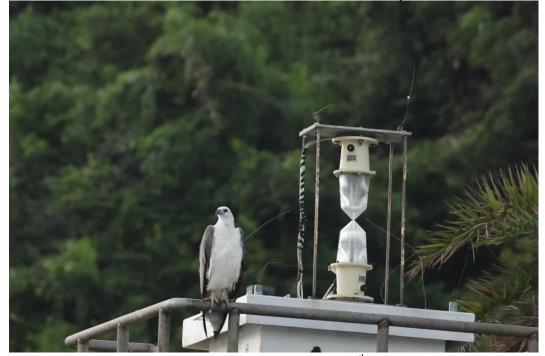
Figure 7.2 Photo Records of WBSE on SKC during the Reporting Period

Juvenile WBSE recorded near the nest on 27th July 2022

Adult WBSE staying near the nest on 27th July 2022

7.5.7 Photo record of WBSE from the survey this month is shown below:
