Contract No. EP/SP/66/12
Integrated Waste Management Facilities, Phase 1
Monthly EM&A Report No.50

Monthly EM&A Report No.50 (Period from 1 August to 31 August 2022)

(Clause 3.3, Further Environmental Permit FEP-01/429/2012/A)

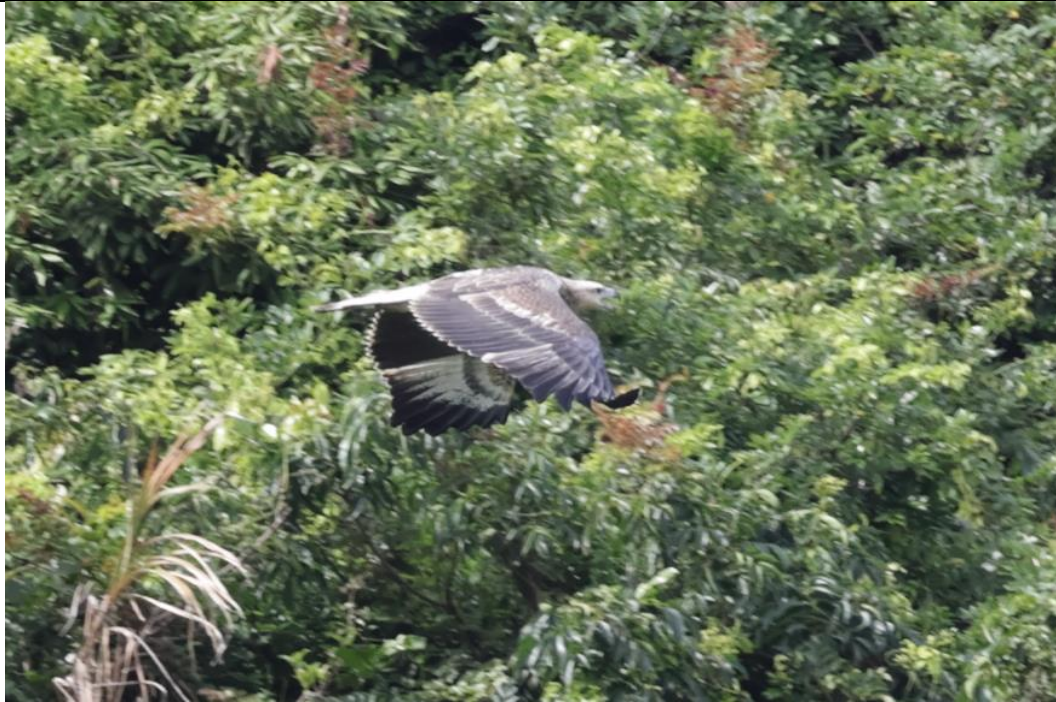
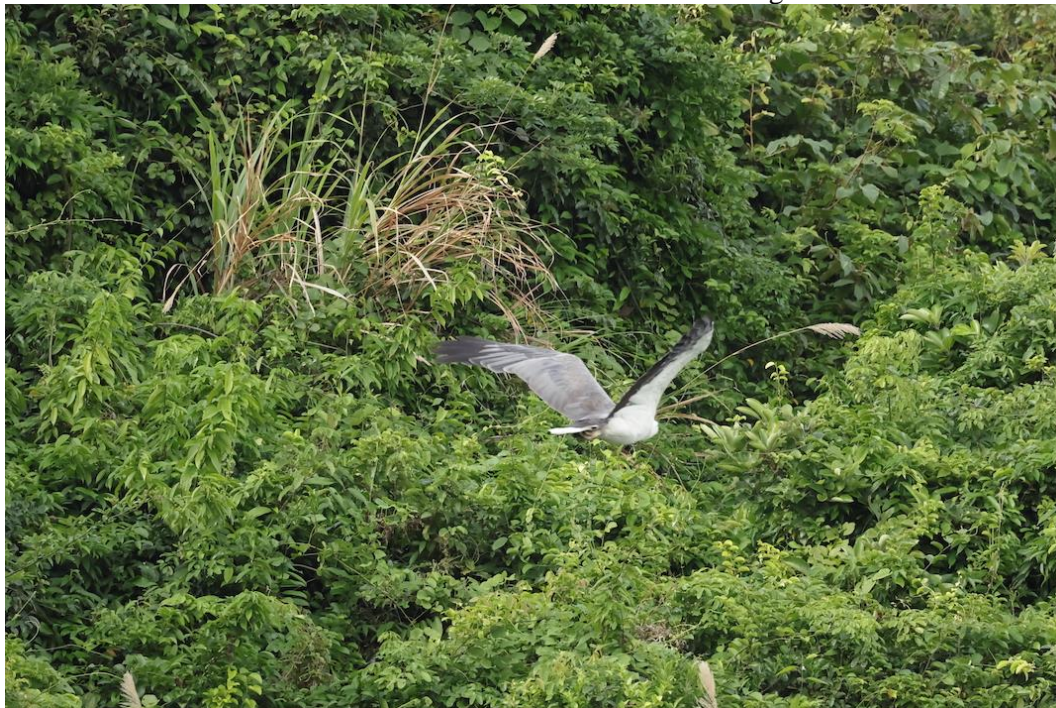
Figure 7.2 Photo Records of WBSE on SKC during the Reporting Period

7.5.7 Photo record of WBSE from the survey in this reporting month is shown below:

Juvenile WBSE recorded near the nest on 29th August 2022

Adult WBSE staying near the nest on 29th August 2022
