Contract No. EP/SP/66/12 Integrated Waste Management Facilities, Phase 1 Monthly EM&A Report No.62

Monthly EM&A Report No.62 (Period from 1 August to 31 August 2023)

(Clause 3.3, Further Environmental Permit FEP-01/429/2012/A)

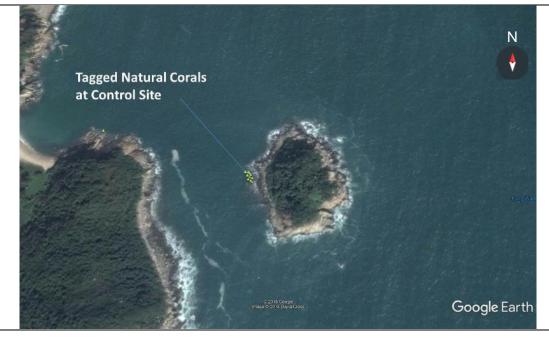
Figure 5.2 Tagged Natural Corals at Control Site Near Yuen Kong Chau for retagging after typhoon Mangkhut

5.3.1 Location of the ten tagged coral colonies at each of the proposed indirect impact site (re-tagging after typhoon Mangkhut), control site (baseline) and recipient site R3 (translocation) are shown in **Figure 5.1**, **Figure 5.2** and **Figure 5.3** respectively:

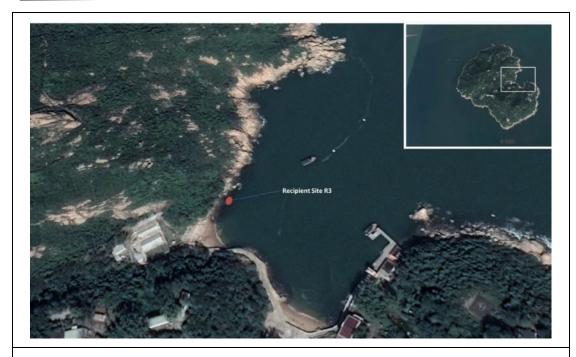
Figure 5.3 Tagged Translocation Corals at Recipient Site R3 near SKC

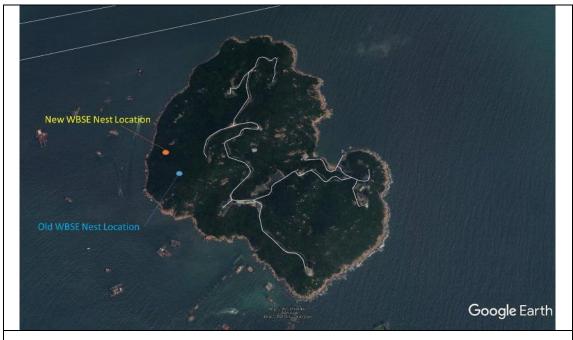
Figure 7.1 Location of WBSE Nest on SKC
