Contract No. EP/SP/66/12 Integrated Waste Management Facilities, Phase 1 Monthly EM&A Report No.65

Monthly EM&A Report No.65 (Period from 1 November to 30 November 2023)

(Clause 3.3, Further Environmental Permit FEP-01/429/2012/A)

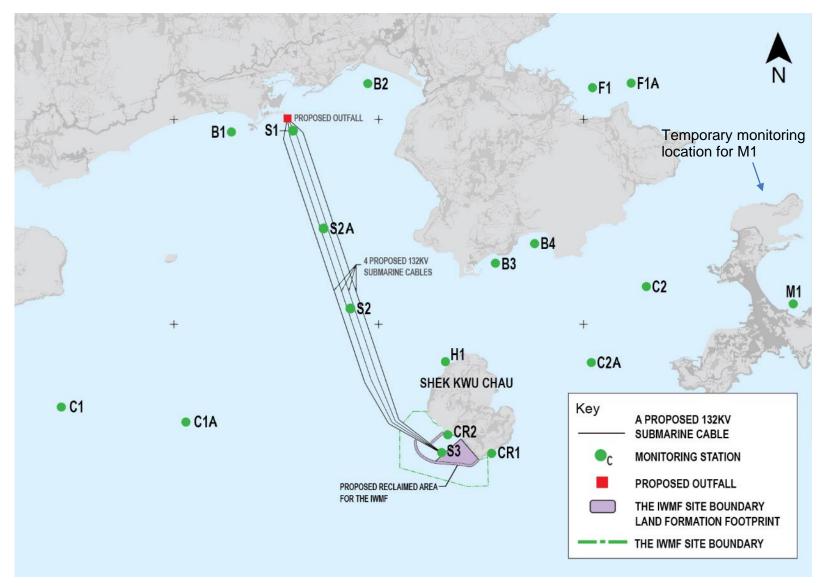
Figure 2.1 Water monitoring locations at Artificial Island near SKC

- 2.3 Water Quality Monitoring Locations
- 2.3.1 Impact water quality monitoring was conducted at eleven monitoring locations (B1-B4, H1, C1, C2, F1, CR1, CR2 & M1) during general water quality monitoring in the reporting period as shown in **Figure 2.1**. As per the relocation proposal verified by IEC and approved by EPD, the monitoring location C1, C2, S2, F1 are relocated at C1A, C2A, S2A, F1A as equivalent points respectively to clear up the concerns from stakeholders.

- 2.3.2 B1 to B4 are located at 4 beaches respectively at the southern shore of Lantau Island. Monitoring station H1 is located at the horseshoe crab habitat at northern SKC, while CR1 and CR2 are located at the coral communities at southwestern shore of SKC. Monitoring station F1 is located at the Cheung Sha Wan Fish Culture Zone while monitoring station M1 is located at Tung Wan at Cheung Chau. Monitoring station F1A is relocated for F1 at the Cheung Sha Wan Fish Culture Zone. S1, S2 and S3 are located at the northern landing site, midway and southern landing site of the proposed submarine cable, respectively. S2A is the relocated monitoring station of S2 which represents the midway landing site of the proposed submarine cable. S1, S2/S2A and S3 are required for monitoring due to the laying of submarine cable. Control stations C1 and C2 at far field locations are for comparison. Control stations C1A and C2A are relocated for C1 and C2 respectively as equivalent far field locations for comparison.

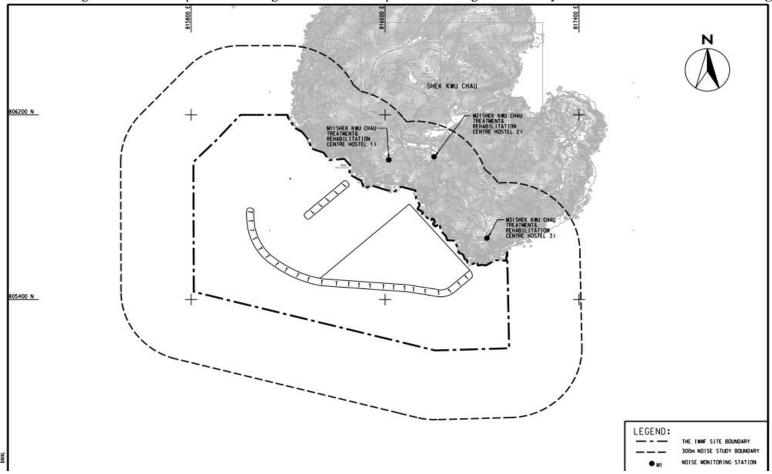
Figure 3.1 Noise monitoring locations at SKC

3.3.1 Three noise monitoring locations for impact monitoring and additional impact monitoring at the nearby sensitive receivers are shown in **Figure 3.1.**

- 3.3.2 M1, M2 and M3 are Shek Kwu Chau Treatment and Rehabilitation Centre Hostel 1, 2 and 3 respectively of The Society for the Aid and Rehabilitation of Drug Abusers (SARDA) located at southern part of Shek Kwu Chau.

- 3.3.3 Measurements at M1 & M3 were conducted at a point 1m from the exterior of the sensitive receivers building façade and at a position 1.2m above the ground. Measurement setup at M3 has been varying with minor adjustment to minimize the disturbance to the users of Treatment Centre. Measurement at M2 was conducted at a point 1m from building façade of the ceiling of 1st floor level for avoidance of mutual disturbance with users of Treatment Centre. The minor adjustment of monitoring locations, which were in favour to mutual convenience with the users of Treatment Centre, were found with no effect on monitoring result based on on-site observation and experience from the Baseline monitoring of the Project. The noise monitoring stations are summarized in **Table 3.2** below.

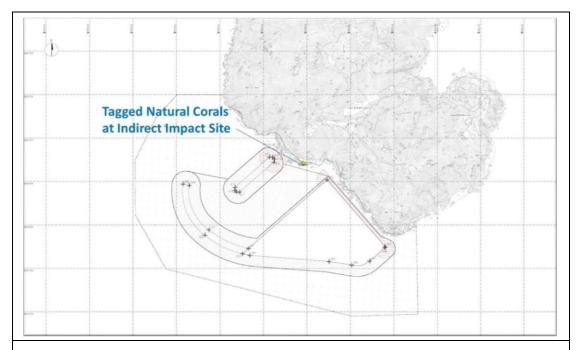
Figure 5.1 Tagged Natural Corals at Indirect Impact Site Near SKC for re-tagging after typhoon Mangkhut

5.3.1 Location of the ten tagged coral colonies at each of the proposed indirect impact site (re-tagging after typhoon Mangkhut), control site (baseline) and recipient site R3 (translocation) are shown in **Figure 5.1**, **Figure 5.2** and **Figure 5.3** respectively:

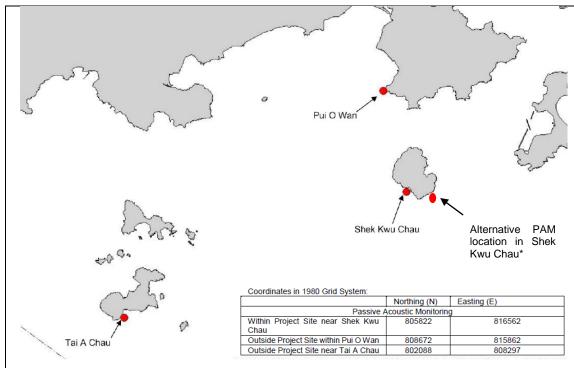
Figure 6.2 Locations of Passive Acoustic Monitoring

The PAM aims to study the usage of an area by Finless Porpoise by using an array of automated static porpoise detectors (e.g. C-POD) which would be deployed at different locations to detect the unique ultra-high frequency sounds produced by Finless Porpoise. During the construction period, the PAM survey will be conducted including placement of two passive porpoise detectors outside the Project Area as control site (i.e. within Pui O Wan and to the south of Tai A Chau) and one porpoise detector within the Project Area (i.e. near Shek Kwu Chau) as shown in **Figure 6.2** below.

Note*: The alternative PAM device adjacent to the Project site was deployed from 5 Mar to 11 Apr 2019, which contained a full 37 days acoustic monitoring data set. After the confirmation of loss of the original PAM within the Project site, this data set was proposed to replace that of the original one, as consulted with AFCD accordingly.

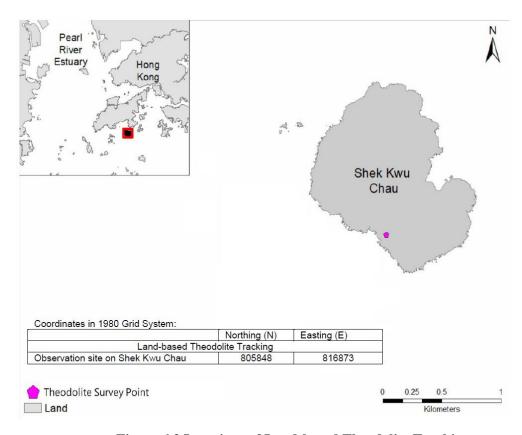
Figure 6.3 Locations of Land-based Theodolite Tracking

- 6.2.4 Land-based Theodolite Tracking
- 6.2.4.1 The Land-based Theodolite Tracking study would use the same station as in the AFCD monitoring study (same as the baseline monitoring location), which is situated at the southwest side of Shek Kwu Chau (GPS position: 22°11.47' N and 113°59.33' E) as shown in below **Figure 6.3**. The station was selected based on its height above sea level (at least 20 metres), close proximity to shore, and relatively unobstructed views of the entire Project Area to the southwest of Shek Kwu Chau. The height of the Shek Kwu Chau Station established by the HKCRP team is 74.6 m high at mean low water, and only a few hundred metres to the IWMF reclamation site, which is ideal for the purpose for the present behavioural and movement monitoring of finless porpoises as well during construction phase considering there as an un-obstructed vantage point at a height above the Project Site.

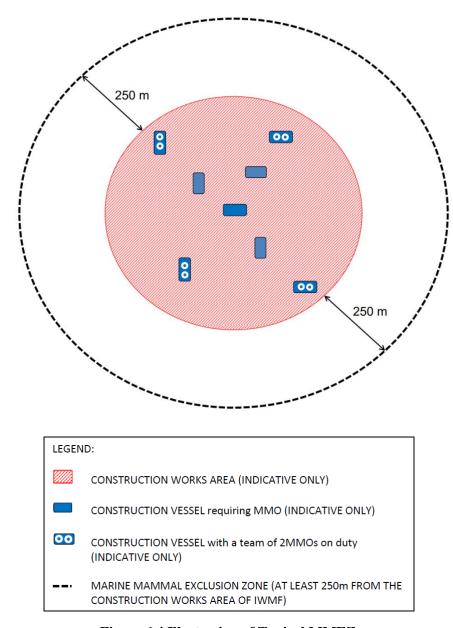
Figure 6.4 Illustration of Typical MMEZ

6.3.1.3 A MMEZ with 250 m distance from the boundary of a work area shall be established during the above situation. A typical MMEZ is indicated in **Figure 6.4** for reference. The MMEZ serves as a monitoring approach to provide appropriate and immediate actions once finless porpoise or Chinese White Dolphin is sighted within the MMEZ. All MMEZ will be monitored by competent Marine Mammal Observers (MMOs) to be provided by the Environmental Team (ET) for the IWMF and trained by the Marine Mammal Monitoring Specialist of the ET who is independent from KSZHJV.
