Contract No. EP/SP/66/12
Integrated Waste Management Facilities, Phase 1
Monthly EM&A Report No.66

Monthly EM&A Report No.66 (Period from 1 December to 31 December 2023)

(Clause 3.3, Further Environmental Permit FEP-01/429/2012/A)

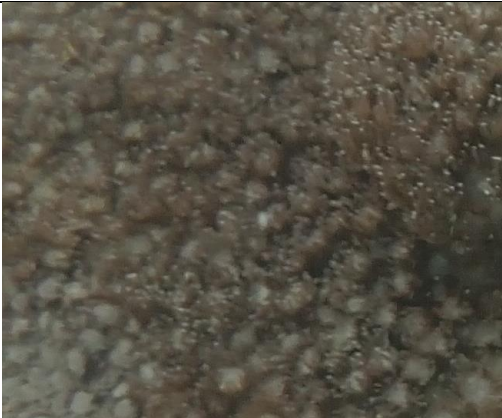
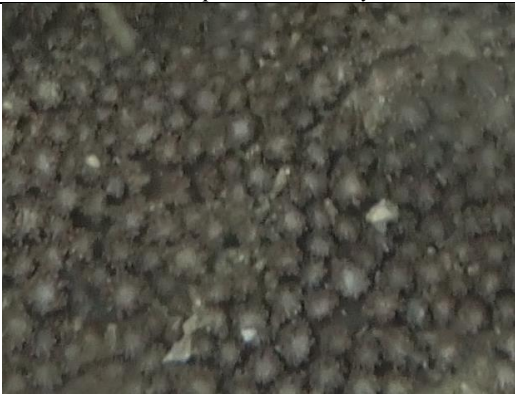
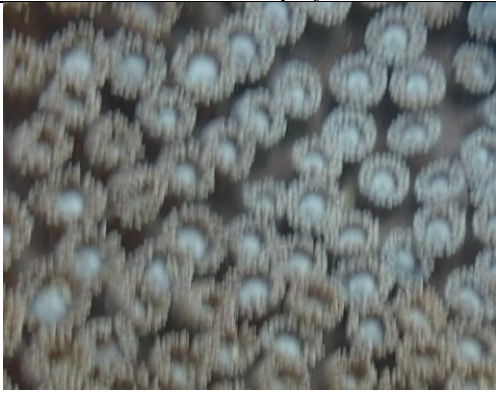
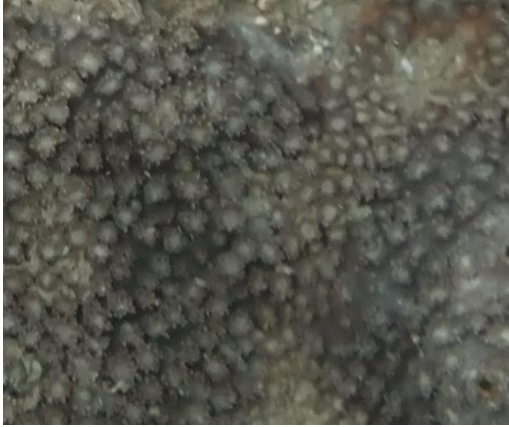
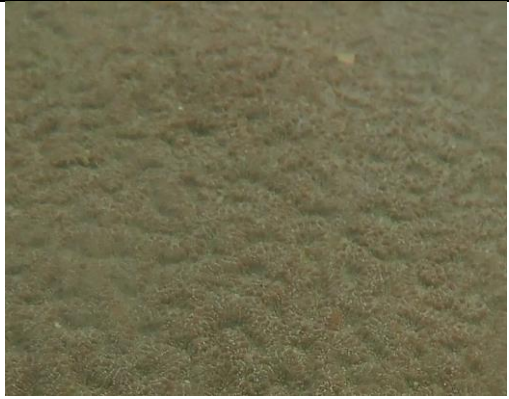
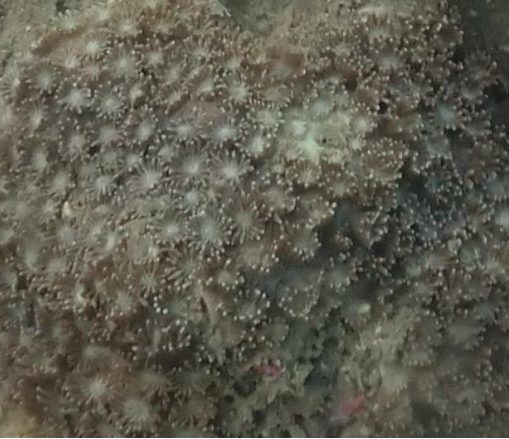
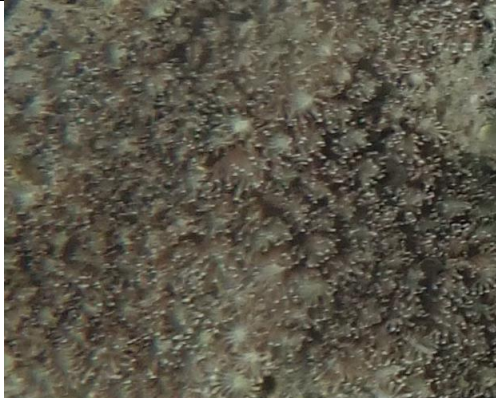
Photo Plate 5.1 Ten (10) Monitored Corals at Control Site

5.6.2 Ten (10) hard coral colonies were monitored at each Control site and Indirect Impact Site as suggested in the Construction Phase Monitoring Plan. The general health conditions (size, mortality, bleaching and sediment) were recorded and summarized in **Table 5.8** and **Table 5.9**. Photos of each coral colonies were taken during the monitoring activities shown in **Photo Plate 5.1** and **Photo Plate 5.2**.

Tag #	Species	Size (cm) – Max. Diameter	Condition	Mortality (%)		Bleaching (%)		Sediment (%)	
				Baseline	27/12	Baseline	27/12	Baseline	27/12
1	<i>Goniopora stutchburyi</i>	25	Good	0	0	0	0	0	0
2R	<i>Goniopora stutchburyi</i>	10	Good	0	0	0	0	0	0
3	<i>Psammodora superficialis</i>	18	Good	0	0	0	0	0	0
4	<i>Turbinaria peltata</i>	13	Good	0	0	0	0	0	0
5R	<i>Goniopora stutchburyi</i>	18	Good	0	0	0	0	0	0
6	<i>Cyphastrea serailia</i>	43	Good	0	0	0	0	0	0
7R	<i>Coscinaraea</i> sp.	15	Good	0	0	0	0	0	0
8	<i>Goniopora stutchburyi</i>	21	Good	0	0	0	0	0	0
9	<i>Goniopora stutchburyi</i>	11	Good	0	0	0	0	0	0
10R	<i>Goniopora stutchburyi</i>	20	Good	0	0	0	0	0	0

- 5.6.4 All tagged and re-tagged coral colonies showed good health condition during the 20th Quarterly Construction Phase Monitoring. There was no increased level of mortality, bleaching and sediment when compared with the baseline results.

- 5.6.5 No sediment, bleaching or increased mortality in the general condition of coral colonies were observed during the tenth construction phase monitoring period. No deterioration of the coral community was observed in the ecological monitoring results when compared with the baseline ecological monitoring results. There is no AL/LL exceedance during the monitoring period. Photos of each tagged corals colonies were taken and shown in **Photo Plates 5.1** and **Photo Plate 5.2**.

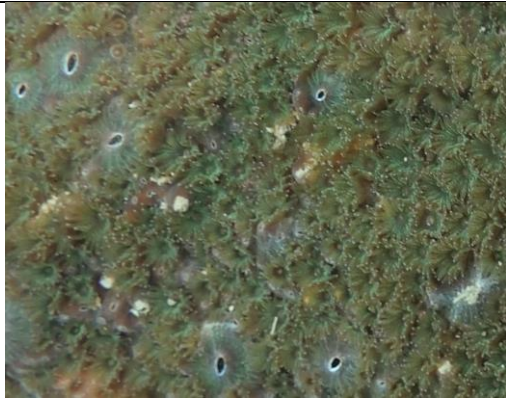
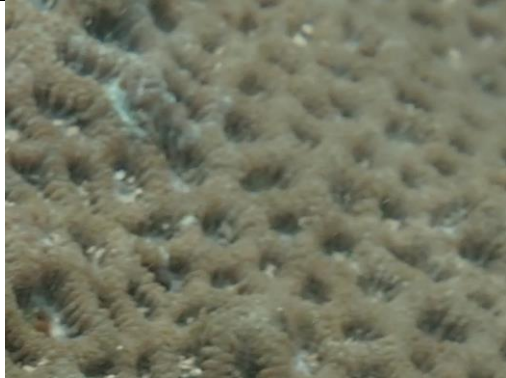
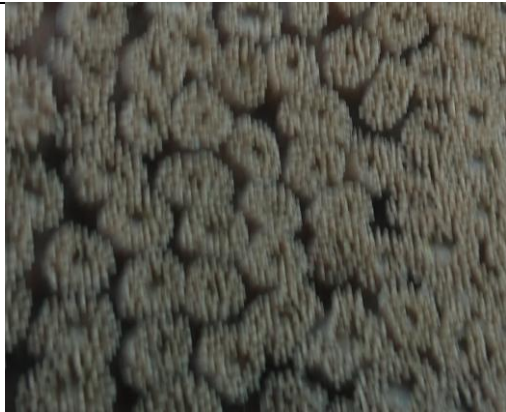
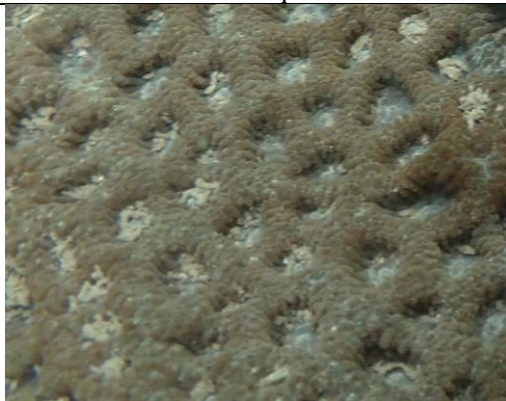
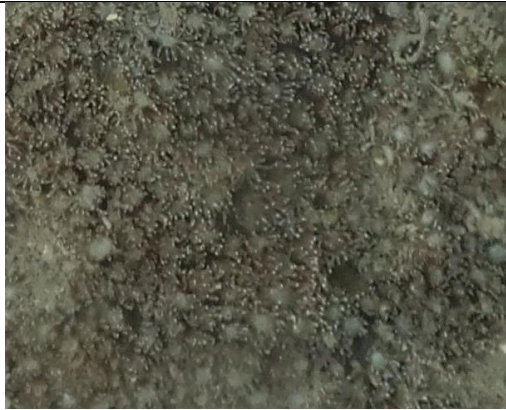
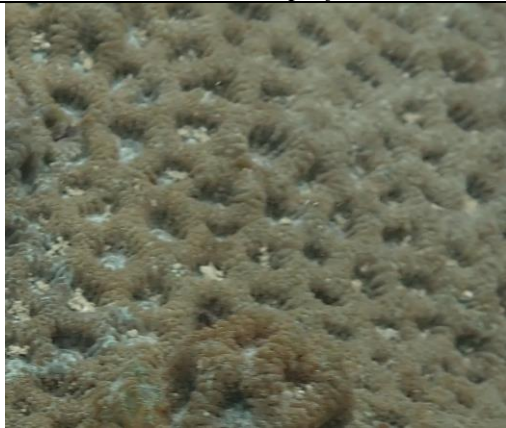
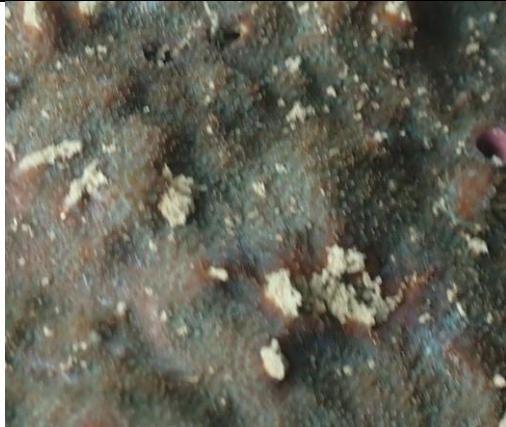
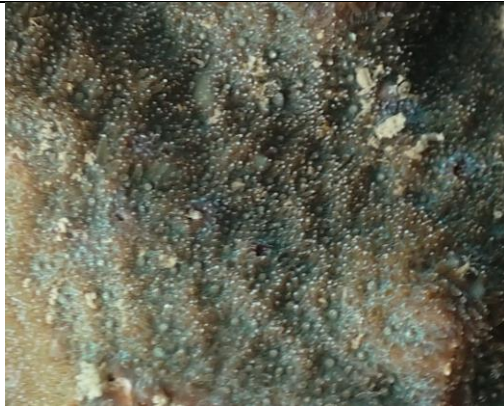
Photo Plate 5.2 Ten (10) Monitored Corals at Indirect Impact Site

Tag #	Species	Size (cm) – Max. Diameter	Condition	Mortality (%)		Bleaching (%)		Sediment (%)	
				Baseline	27/12	Baseline	27/12	Baseline	27/12
11R	<i>Cyphastrea serailia</i>	48	Good	0	0	0	0	0	0
12R	<i>Favites chinensis</i>	27	Good	0	0	0	0	0	0
13R	<i>Turbinaria peltata</i>	21	Good	0	0	0	0	0	0
14R	<i>Favites chinensis</i>	8	Good	0	0	0	0	0	0
15R	<i>Goniopora stutchburyi</i>	11	Good	0	0	0	0	0	0
16R	<i>Psammocora superficialis</i>	27	Good	0	0	0	0	0	0
17R	<i>Favites chinensis</i>	15	Good	0	0	0	0	0	0
18R	<i>Psammocora superficialis</i>	39	Good	0	0	0	0	0	0
19R	<i>Psammocora superficialis</i>	42	Good	0	0	0	0	0	0
20R	<i>Psammocora superficialis</i>	29	Good	0	0	0	0	0	0

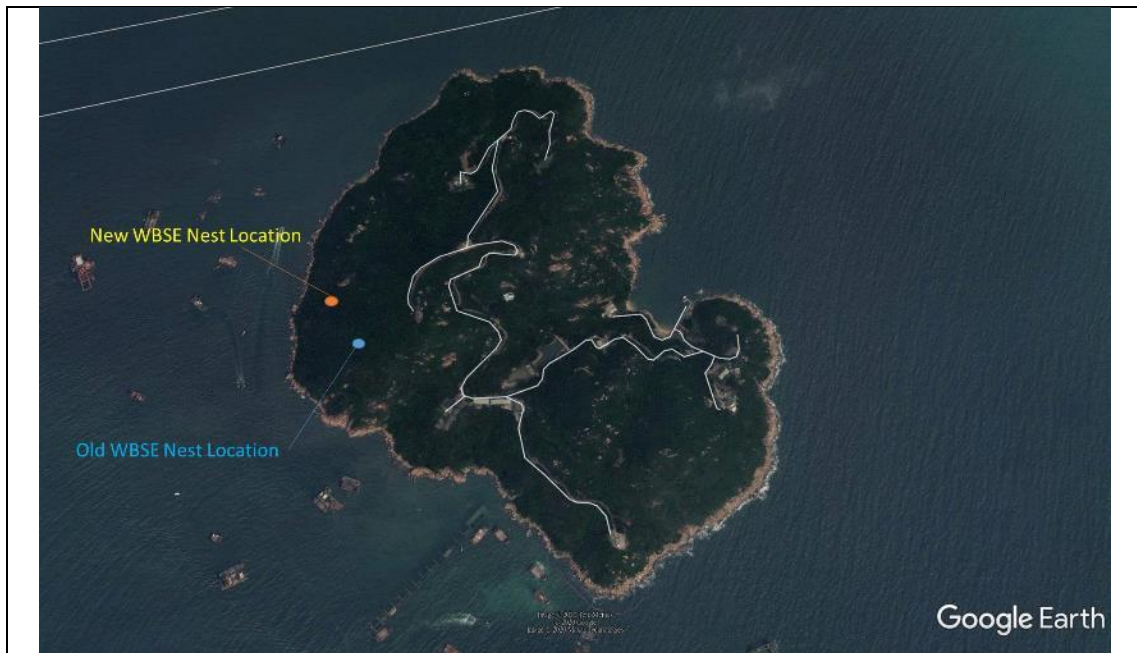
Figure 7.1 Location of WBSE Nest on SKC

7.1.2 The Pre-Construction WBSE monitoring was started on 30 January 2018 and the location of WBSE nest was confirmed on 21 February 2018 and it is located at the western part of SKC Island (**Figure 7.1**). Two adults and two chicks were also recorded on 5 March 2018 survey till the end of the Pre-construction monitoring on 15 May 2018. Construction Phase monitoring were carried out followed by the commencement of the Construction Phase on 28 June 2018.

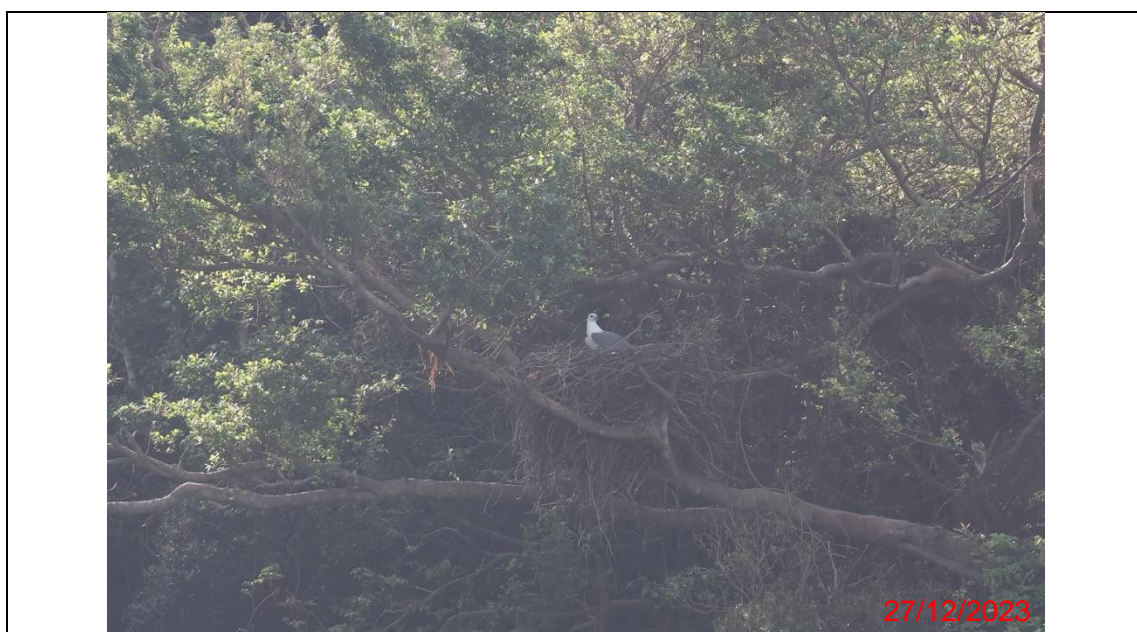
7.5.6 There was no sign of using the construction site as a foraging ground.

7.5.7 As the adult was undergoing incubation period during the breeding season, weekly construction phase monitoring will be started in January 2024 during the breeding season (between December to May) for 6 weeks in order to monitor the utilization of the area by WBSE and their responses to construction disturbance.

One Adult Female WBSE Staying in nest for incubation on 27 December 2023
