**Contract No. EP/SP/66/12**  
**Integrated Waste Management Facilities, Phase 1**  
**Monthly EM&A Report No.84**

## **Monthly EM&A Report No.84**

### **(Period from 1 June to 30 June 2025)**

*(Clause 3.3, Further Environmental Permit FEP-01/429/2012/A)*

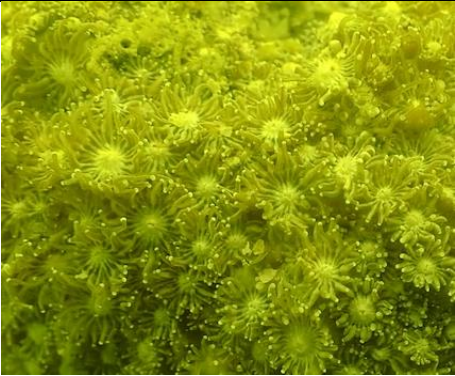
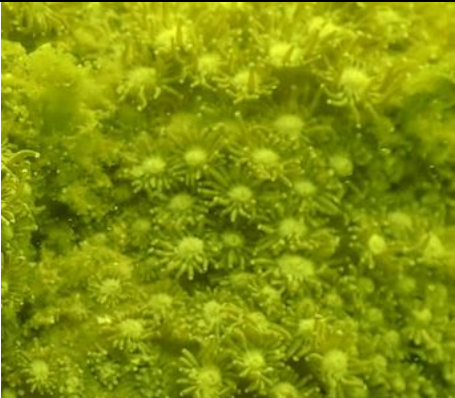
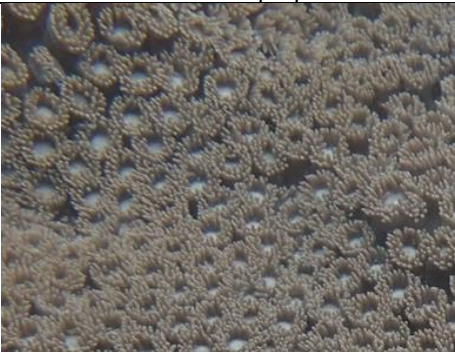
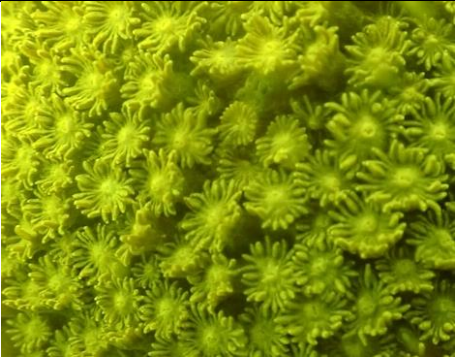
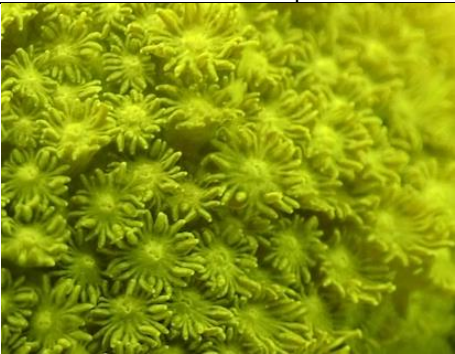
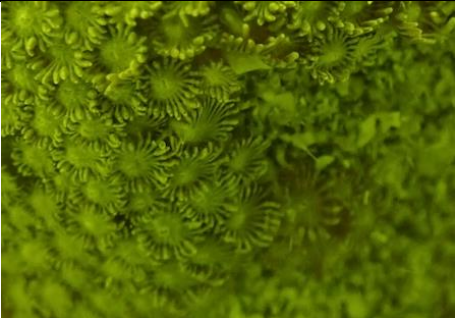
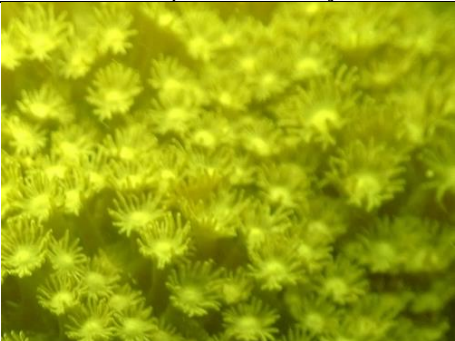
**Photo Plate 5.1      Ten (10) Monitored Corals at Control Site**

- 5.6.4 All tagged and re-tagged coral colonies showed good health condition during the 26<sup>th</sup> Quarterly Construction Phase Monitoring. There was no increased level of mortality, bleaching and sediment when compared with the baseline results.

- 5.6.5 No sediment, bleaching or increased mortality in the general condition of coral colonies were observed during the tenth construction phase monitoring period. No deterioration of the coral community was observed in the ecological monitoring results when compared with the baseline ecological monitoring results. There is no AL/LL exceedance during the monitoring period. Photos of each tagged corals colonies were taken and shown in **Photo Plates 5.1** and **Photo Plate 5.2**.
