Contract No. EP/SP/66/12
Integrated Waste Management Facilities, Phase 1
Monthly EM&A Report No.85

Monthly EM&A Report No.85 (Period from 1 July to 31 July 2025)

(Clause 3.3, Further Environmental Permit FEP-01/429/2012/A)

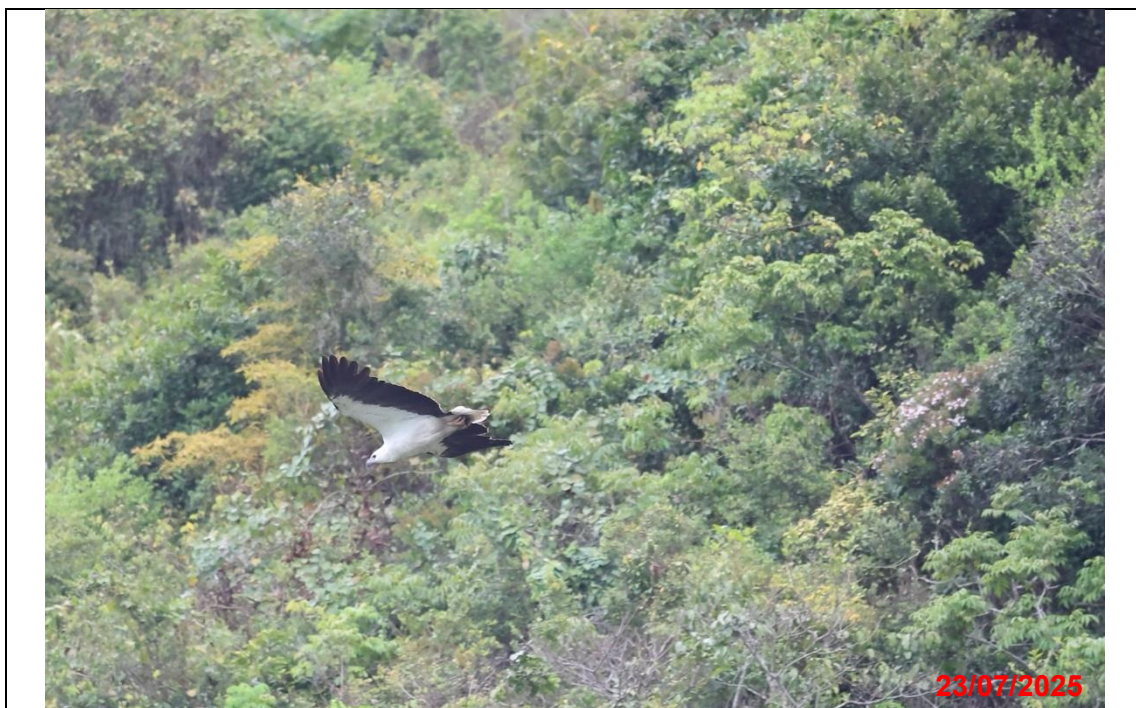
7.5.2 During the whole monitoring survey period, the two adult WBSEs were recorded staying around the nest during the monitoring period and no chick was observed in the nest. No abnormal behaviors of the adults were recorded.

One WBSE adult recorded next to the nest on 23 July 2025
