**Contract No. EP/SP/66/12**  
**Integrated Waste Management Facilities, Phase 1**  
**Monthly EM&A Report No.88**

## **Monthly EM&A Report No.88**

### **(Period from 1 October to 31 October 2025)**

*(Clause 3.3, Further Environmental Permit FEP-01/429/2012/A)*

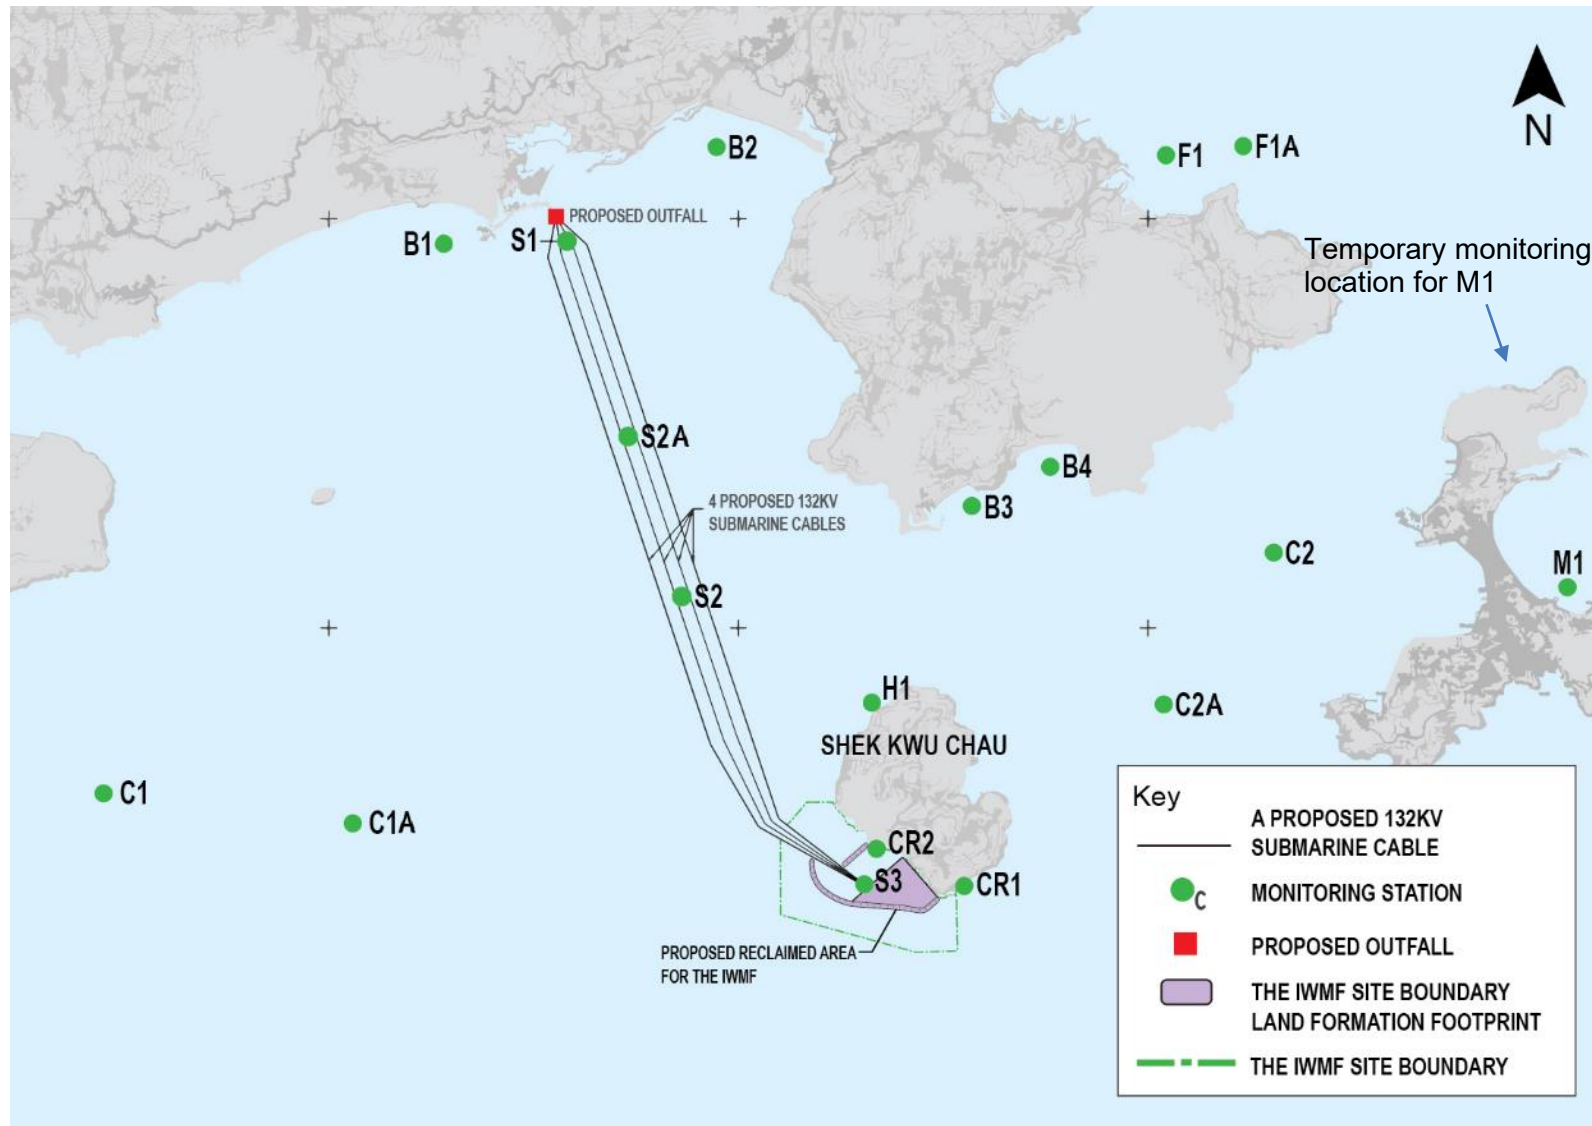
Figure 2.1 Water monitoring locations at Artificial Island near SKC

- 2.1.3.1 Impact water quality monitoring was conducted at eleven monitoring locations (B1-B4, H1, C1, C2, F1, CR1, CR2 & M1) during general water quality monitoring in the reporting period as shown in **Figure 2.1**. As per the relocation proposal verified by IEC and approved by EPD, the monitoring location C1, C2, S2, F1 are relocated at C1A, C2A, S2A, F1A as equivalent points respectively to clear up the concerns from stakeholders.

2.1.3.2 B1 to B4 are located at 4 beaches respectively at the southern shore of Lantau Island. Monitoring station H1 is located at the horseshoe crab habitat at northern SKC, while CR1 and CR2 are located at the coral communities at southwestern shore of SKC. Monitoring station F1 is located at the Cheung Sha Wan Fish Culture Zone while monitoring station M1 is located at Tung Wan at Cheung Chau. Monitoring station F1A is relocated for F1 at the Cheung Sha Wan Fish Culture Zone. S1, S2 and S3 are located at the northern landing site, midway and southern landing site of the proposed submarine cable, respectively. S2A is the relocated monitoring station of S2 which represents the midway landing site of the proposed submarine cable. S1, S2/S2A and S3 are required for monitoring due to the laying of submarine cable. Control stations C1 and C2 at far field locations are for comparison. Control stations C1A and C2A are relocated for C1 and C2 respectively as equivalent far field locations for comparison.

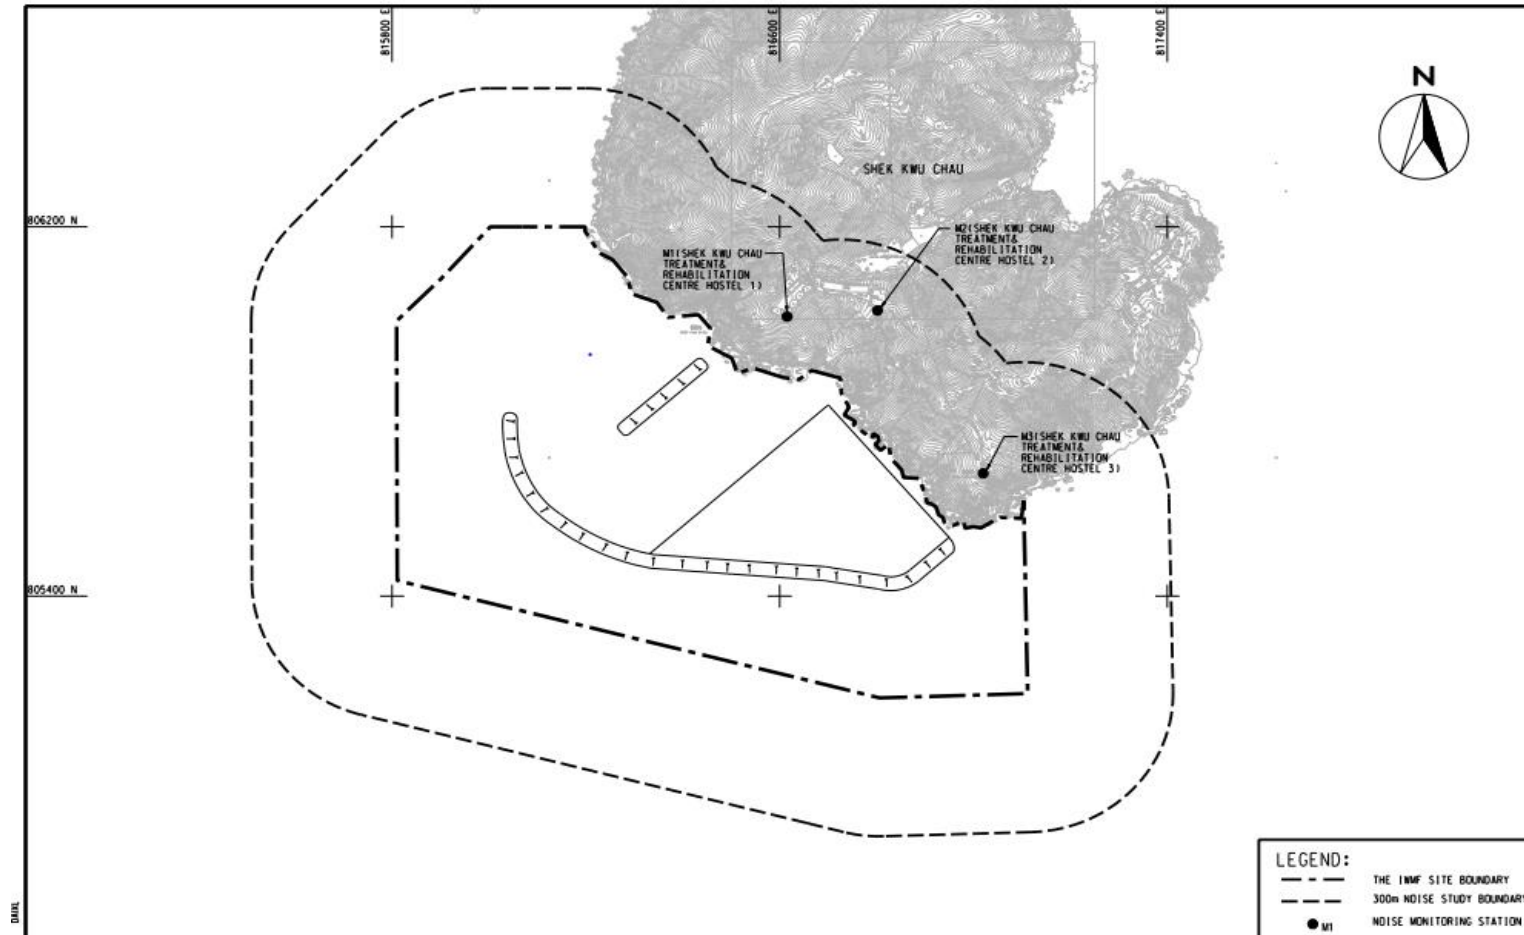
**Figure 3.1 Noise monitoring locations at SKC**

3.3.2 M1, M2 and M3 are Shek Kwu Chau Treatment and Rehabilitation Centre Hostel 1, 2 and 3 respectively of The Society for the Aid and Rehabilitation of Drug Abusers (SARDA) located at southern part of Shek Kwu Chau.

3.3.3 Measurements at M1 & M3 were conducted at a point 1m from the exterior of the sensitive receivers building façade and at a position 1.2m above the ground. Measurement setup at M3 has been varying with minor adjustment to minimize the disturbance to the users of Treatment Centre. Measurement at M2 was conducted at a point 1m from building façade of the ceiling of 1st floor level for avoidance of mutual disturbance with users of Treatment Centre. The minor adjustment of monitoring locations, which were in favour to mutual convenience with the users of Treatment Centre, were found with no effect on monitoring result based on on-site observation and experience from the Baseline monitoring of the Project. The noise monitoring stations are summarized in **Table 3.2** below.

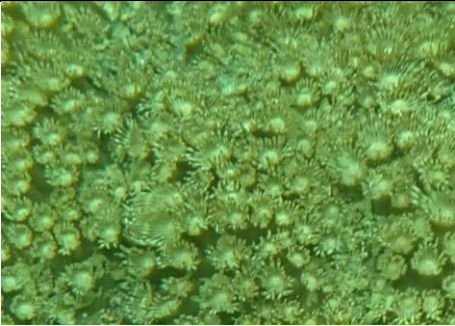
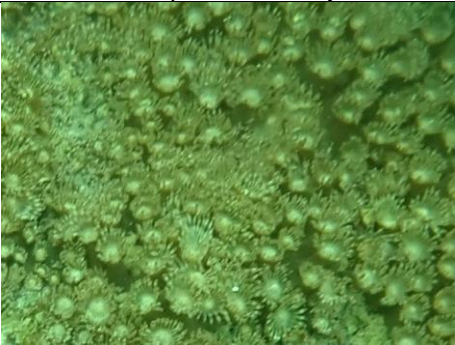
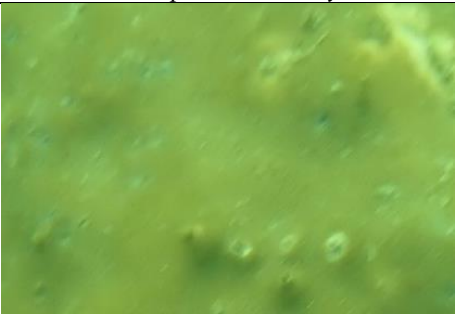
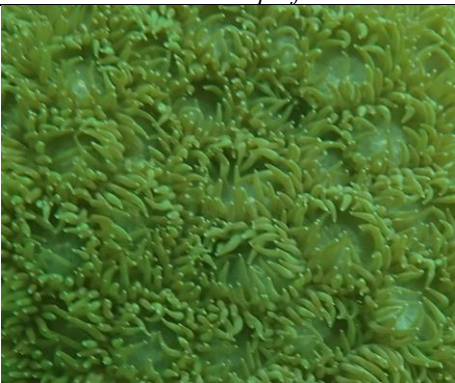
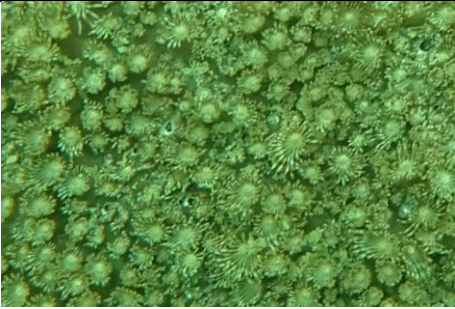
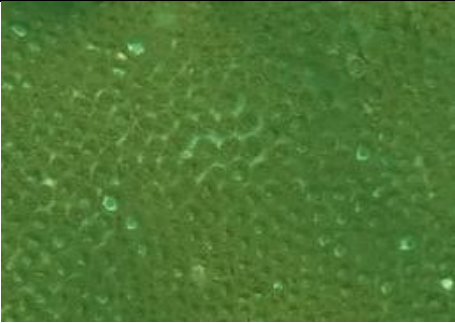
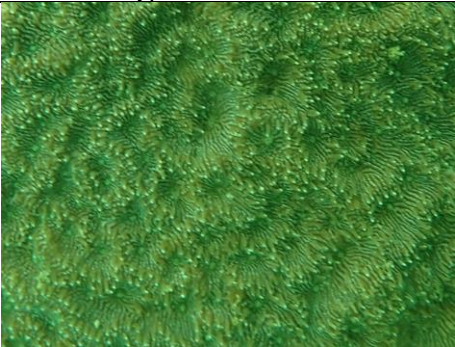
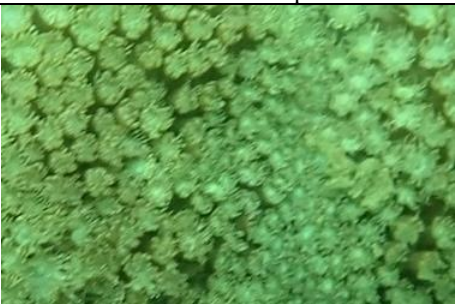
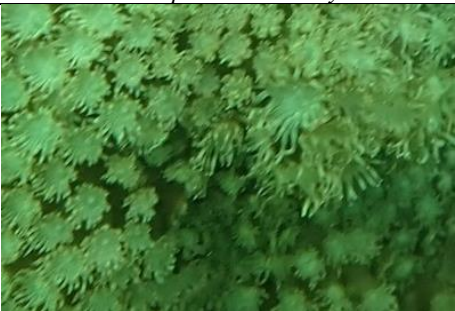
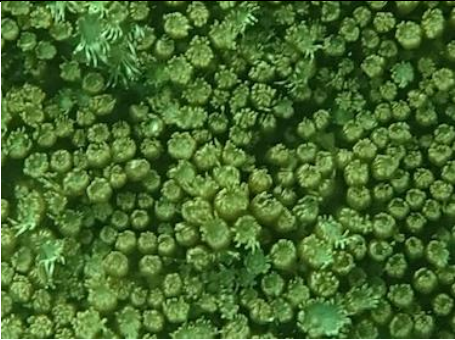
**Photo Plate 5.1      Ten (10) Monitored Corals at Control Site**

- 5.7.4 All tagged and re-tagged coral colonies showed good health condition during the 27<sup>th</sup> Quarterly Construction Phase Monitoring. There was no increased level of mortality, bleaching and sediment when compared with the baseline results.

- 5.7.5 No sediment, bleaching or increased mortality in the general condition of coral colonies were observed during the tenth construction phase monitoring period. No deterioration of the coral community was observed in the ecological monitoring results when compared with the baseline ecological monitoring results. There is no AL/LL exceedance during the monitoring period. Photos of each tagged corals colonies were taken and shown in **Photo Plates 5.1** and **Photo Plate 5.2**.

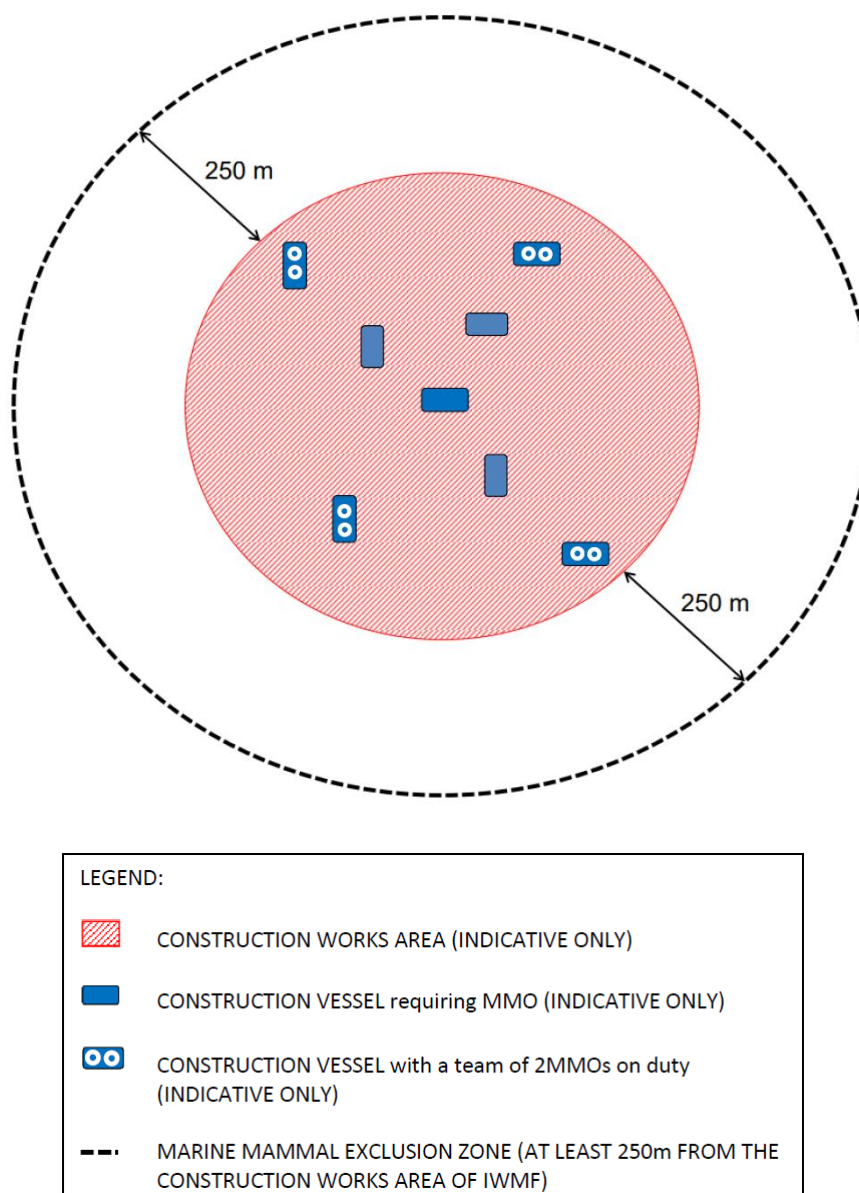
**Figure 6.4 Illustration of Typical MMEZ**

- 6.3.1.3 A MMEZ with 250 m distance from the boundary of a work area shall be established during the above situation. A typical MMEZ is indicated in **Figure 6.4** for reference. The MMEZ serves as a monitoring approach to provide appropriate and immediate actions once finless porpoise or Chinese White Dolphin is sighted within the MMEZ. All MMEZ will be monitored by competent Marine Mammal Observers (MMOs) to be provided by the Environmental Team (ET) for the IWMF and trained by the Marine Mammal Monitoring Specialist of the ET who is independent from KSZHJV.

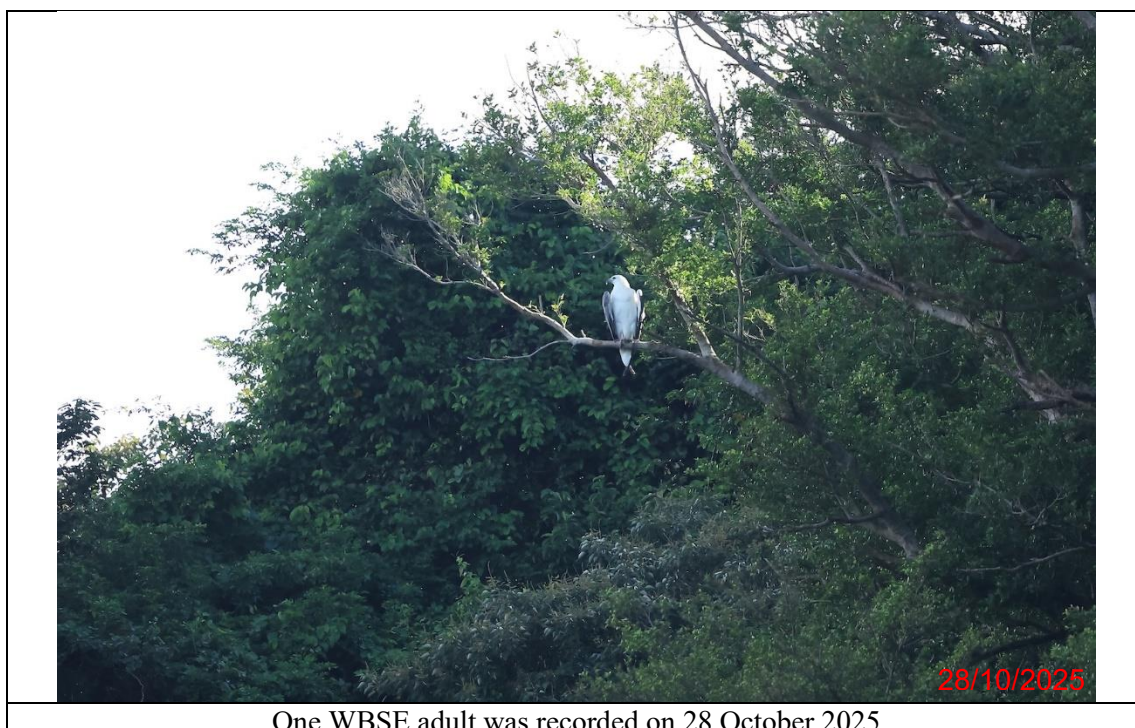
**One WBSE adult was recorded on 28 October 2025**
