**Contract No. EP/SP/66/12**  
**Integrated Waste Management Facilities, Phase 1**  
**Monthly EM&A Report No.95**

## **Monthly EM&A Report No.95**

### **(Period from 1 May to 31 May 2026)**

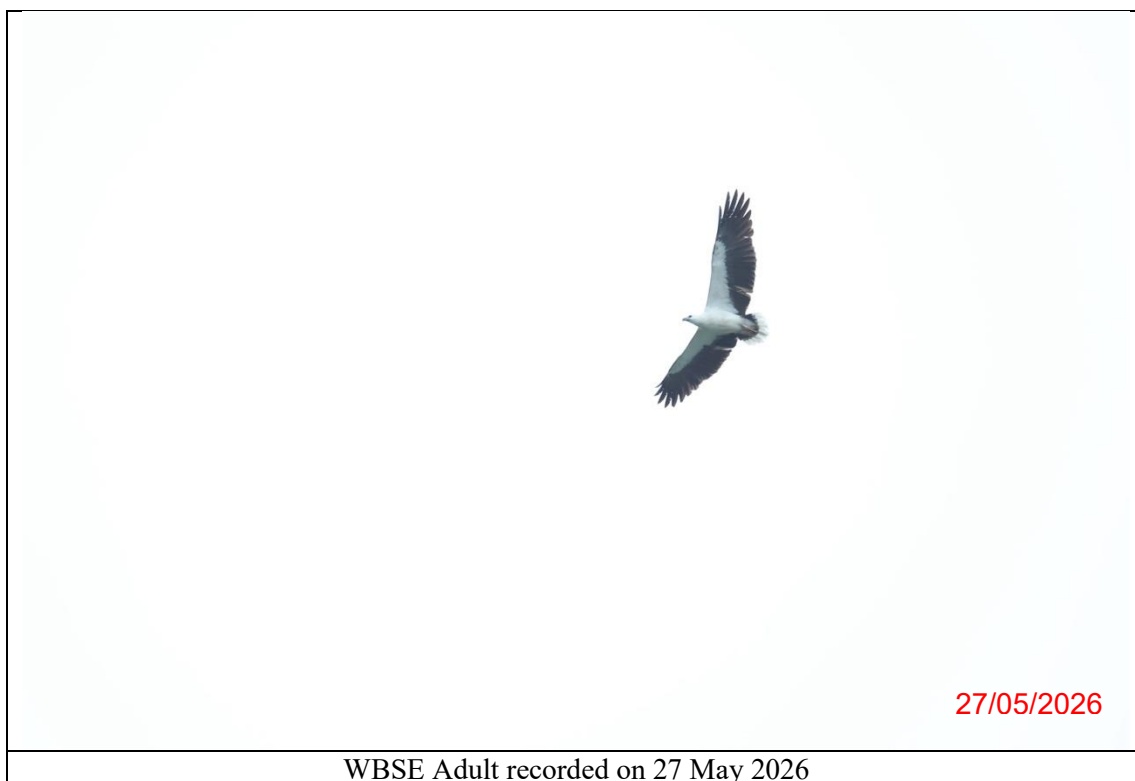
7.5.8 Photo record of WBSE from the survey in this reporting month is shown below:
